## Meeting Agenda

### Design Review Committee

# 221 Lewisburg Ave

Permitting Proposal

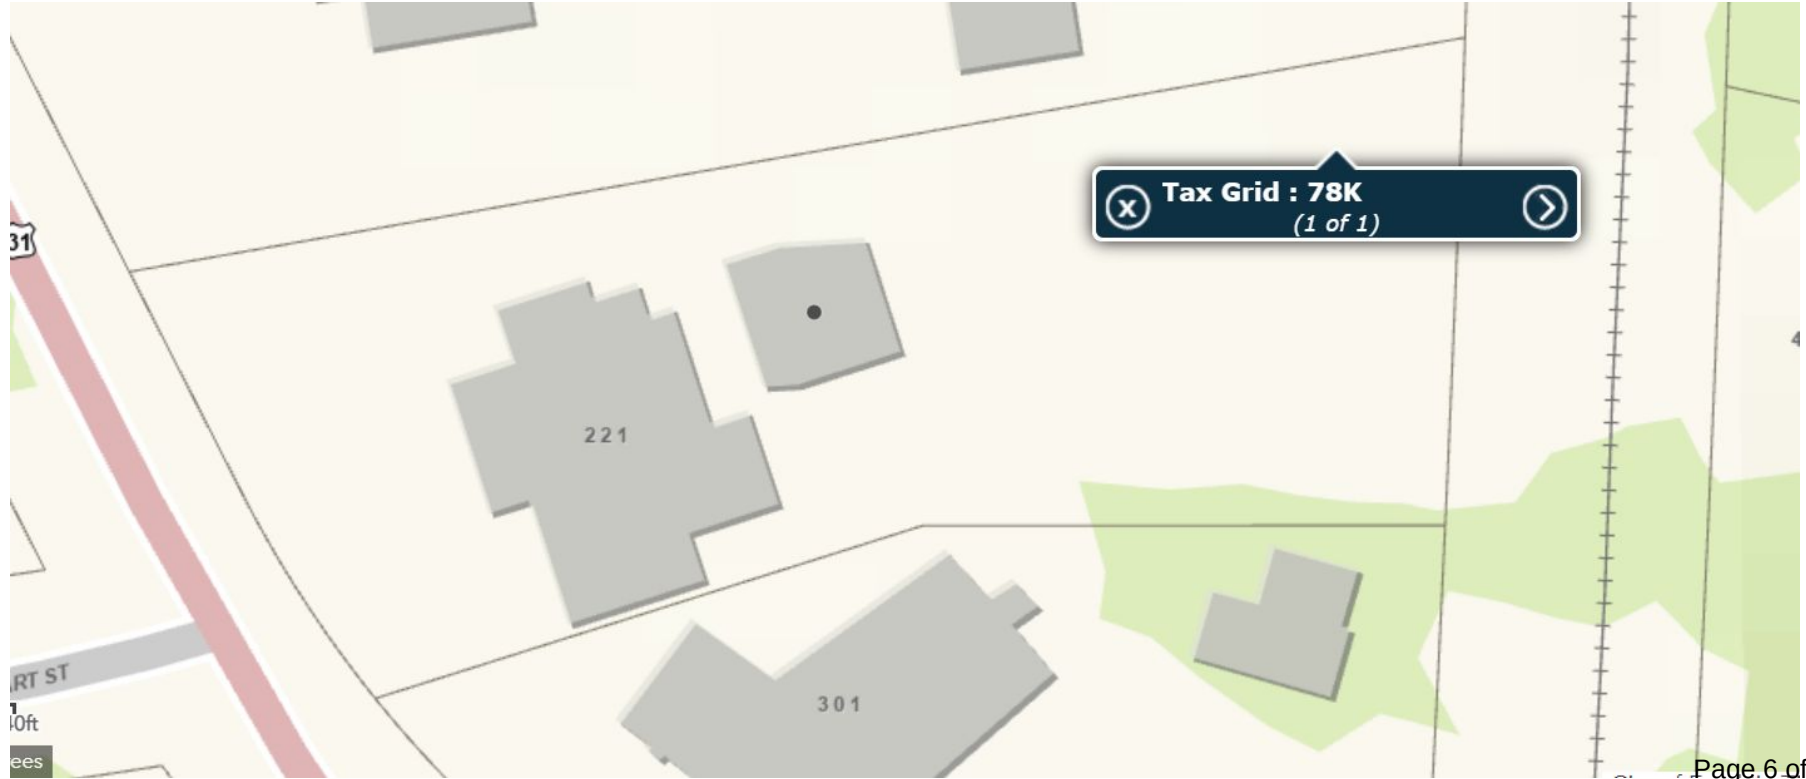
# 221 Lewisburg Ave: Plot

No changes will be made to the footprint of the home.

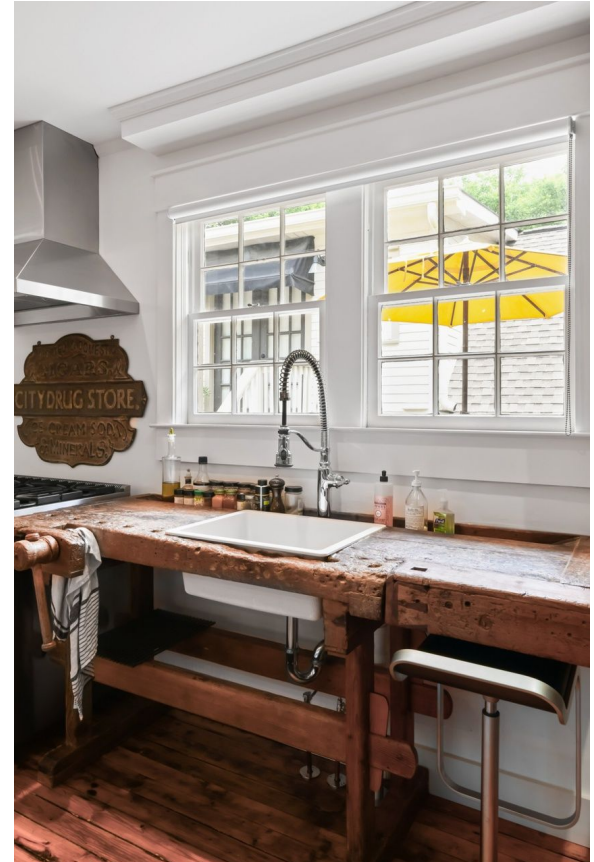
This mull configuration complies with AAMA 450 standards and is professional engineer-approved.

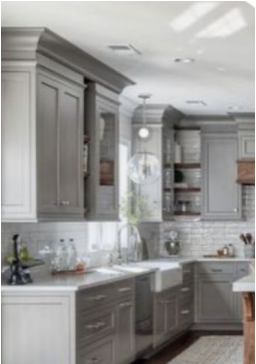
# Kitchen Cabinets

Doors: Inset shaker doors  
with beadboard  
Finish: Painted  
Soft close glides  
soft close hinges

Measurements will vary  
depending on actual wall measurements.  
Everything will be adjusted accordingly  
to be centered.

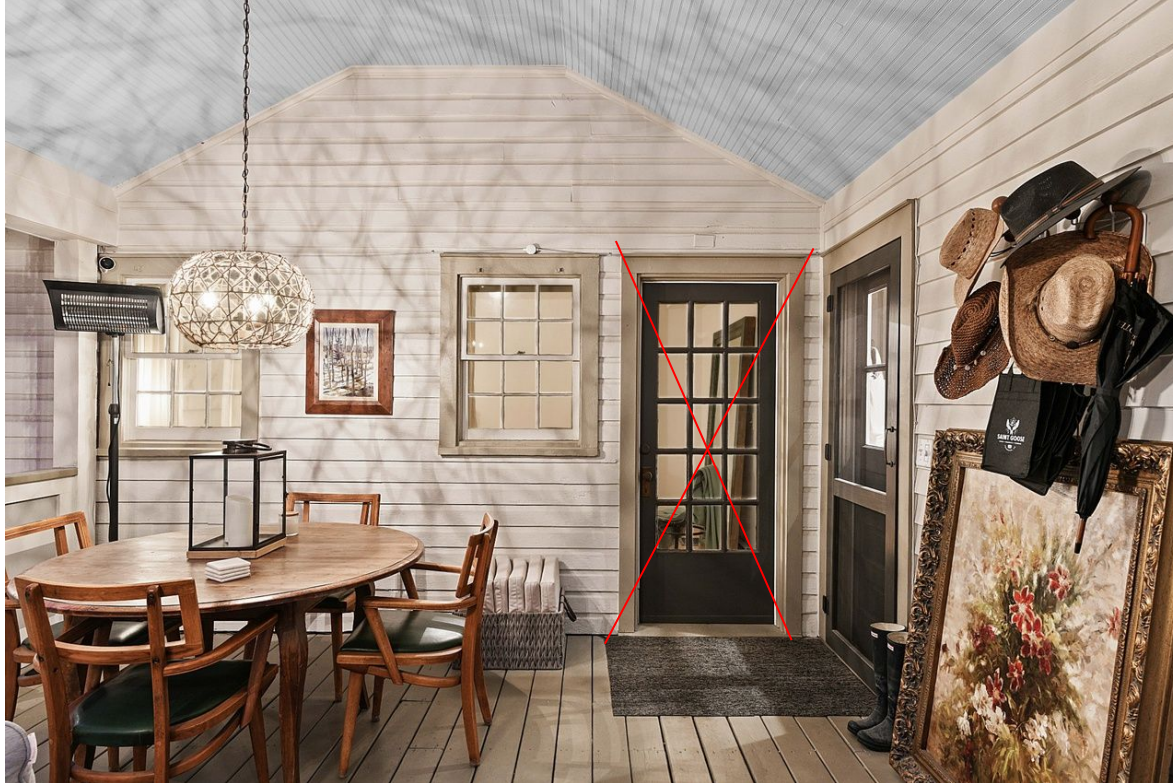
# Bedroom Door Removal Request

Would remove window to the left and replace door with a windows to meet egress.

The primary suite renovation will include moving the vanity, toilet and shower towards the front of the home to allow for a better layout and flow. Walls will be adjusted and added using 2x4 16" O.C. No load bearing walls will be removed. Please see the attached plans above for more clarification of the existing space vs what we are proposing. Depending on the new closet layout the back window facing the backyard may need to be removed to provide functional storage. If not able to remove then we can try and work around the window. In the bedroom there is a door leading to the back porch and my clients would love to turn that into a window allowing them more safety and privacy. We will be lightly adjusting electrical as needed for this portion of the project.

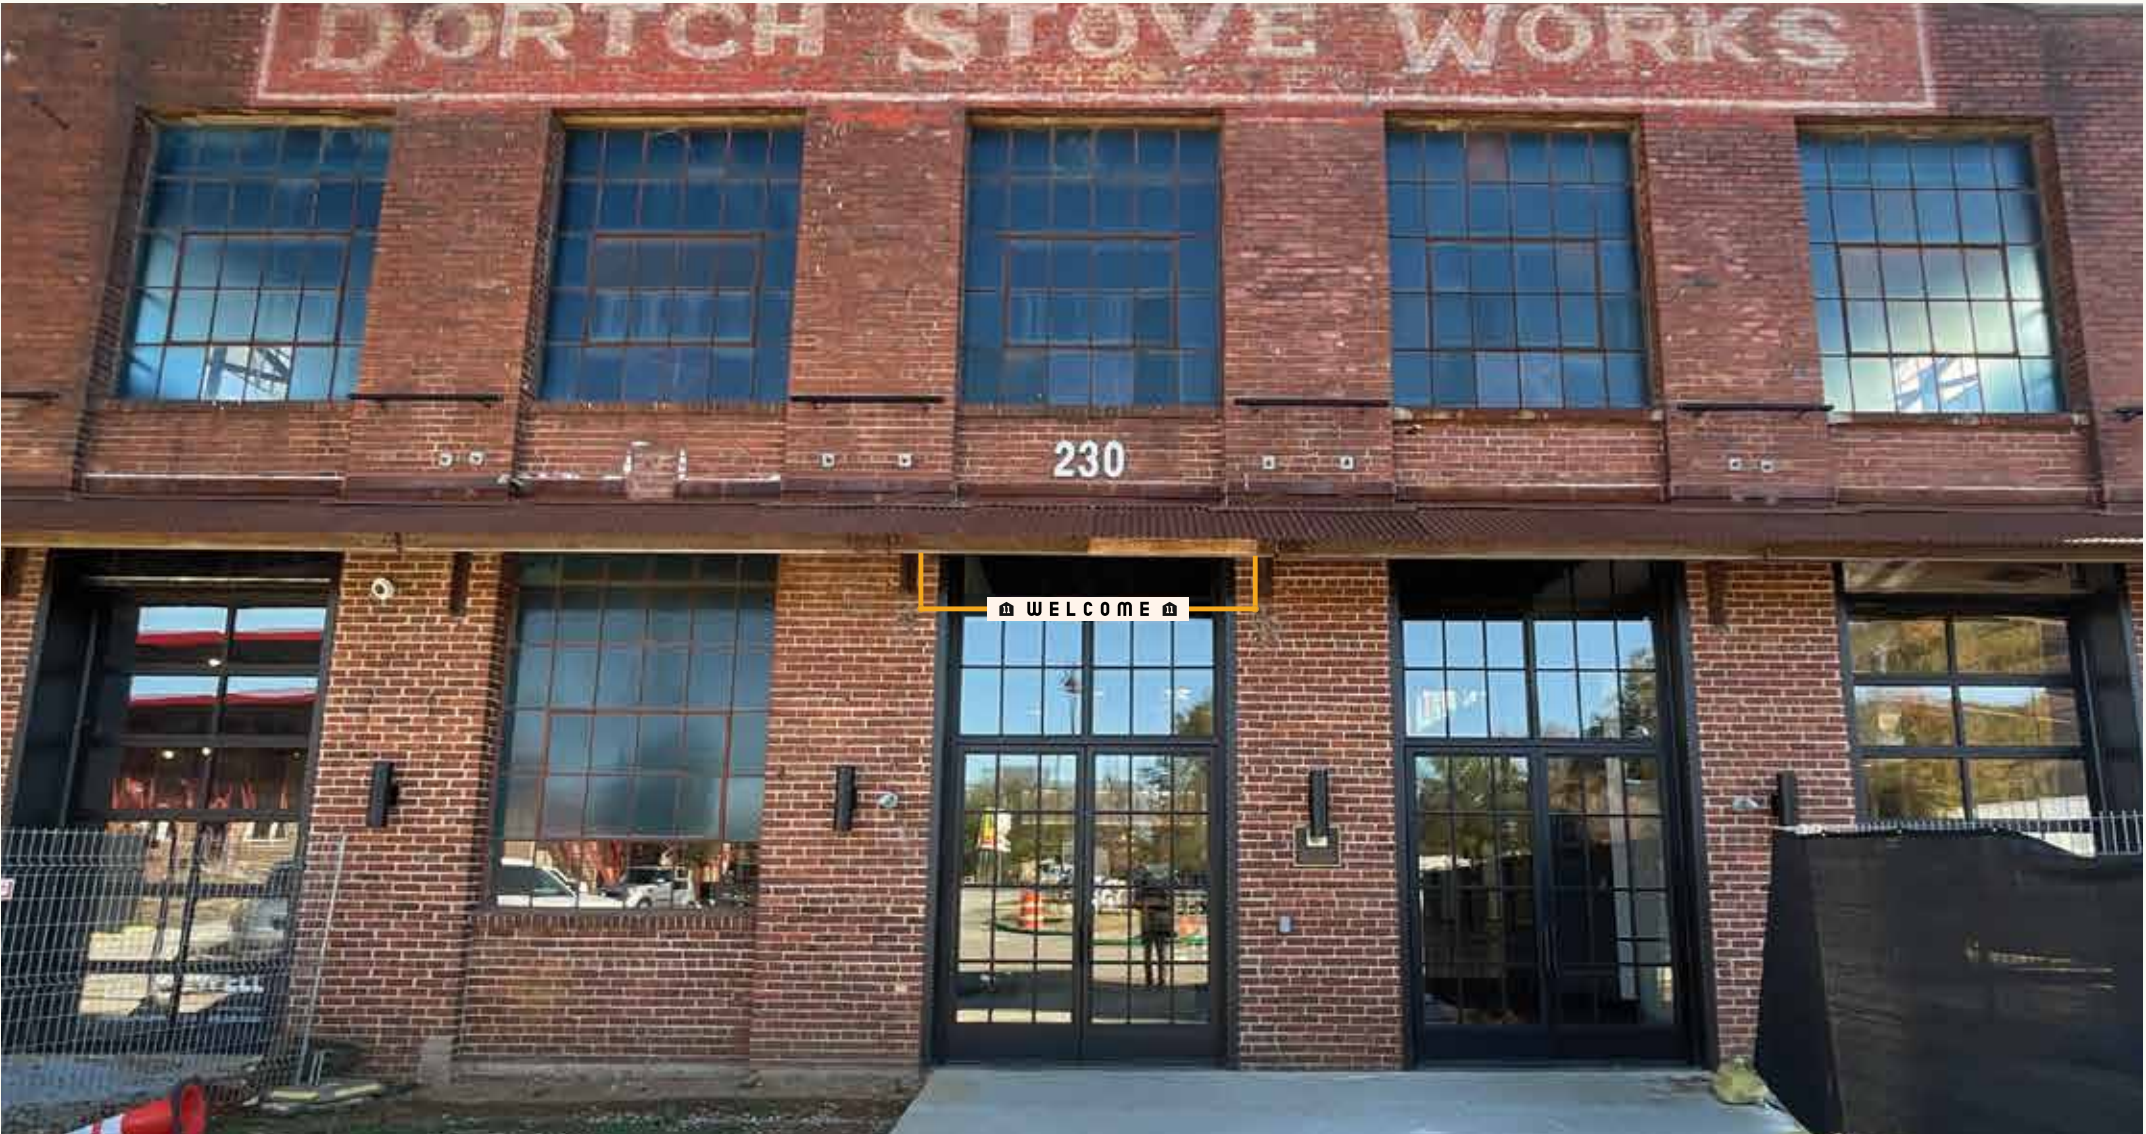
Entrance Sign — Building 12

Located near entrance to Liberty Hall.

- (KEY)
- A → ALUMINUM SQUARE TUBING WITH APPLIED VINYL
  - B → PAINTED STEEL PIPE BOLTED TO WALL
- (NOTES)
- 1 → SIGNAGE AREA = 6 SQ FEET

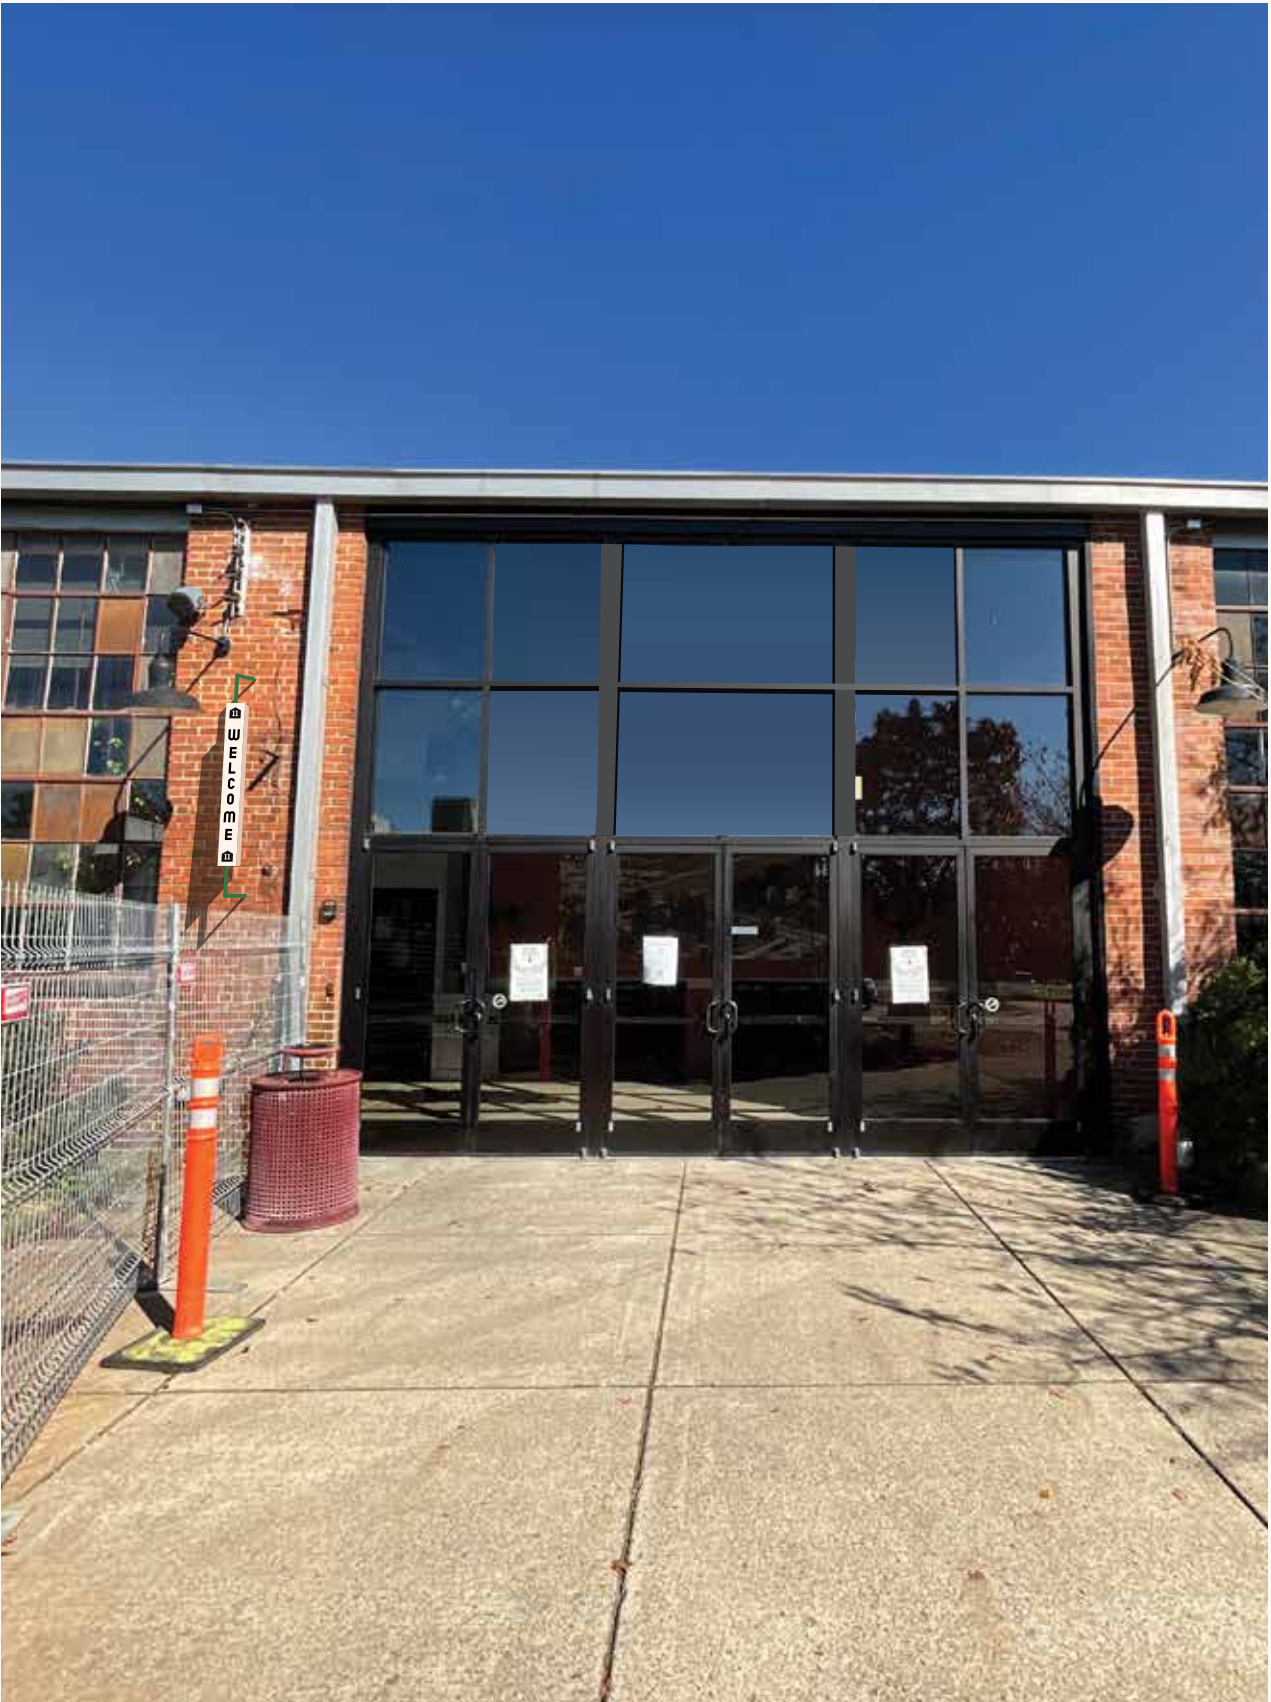
Entrance Sign — Building 11

Located near entrance to Liberty Hall.

(KEY)

- A → ALUMINUM SQUARE TUBING WITH APPLIED VINYL
- B → PAINTED STEEL PIPE BOLTED TO WALL

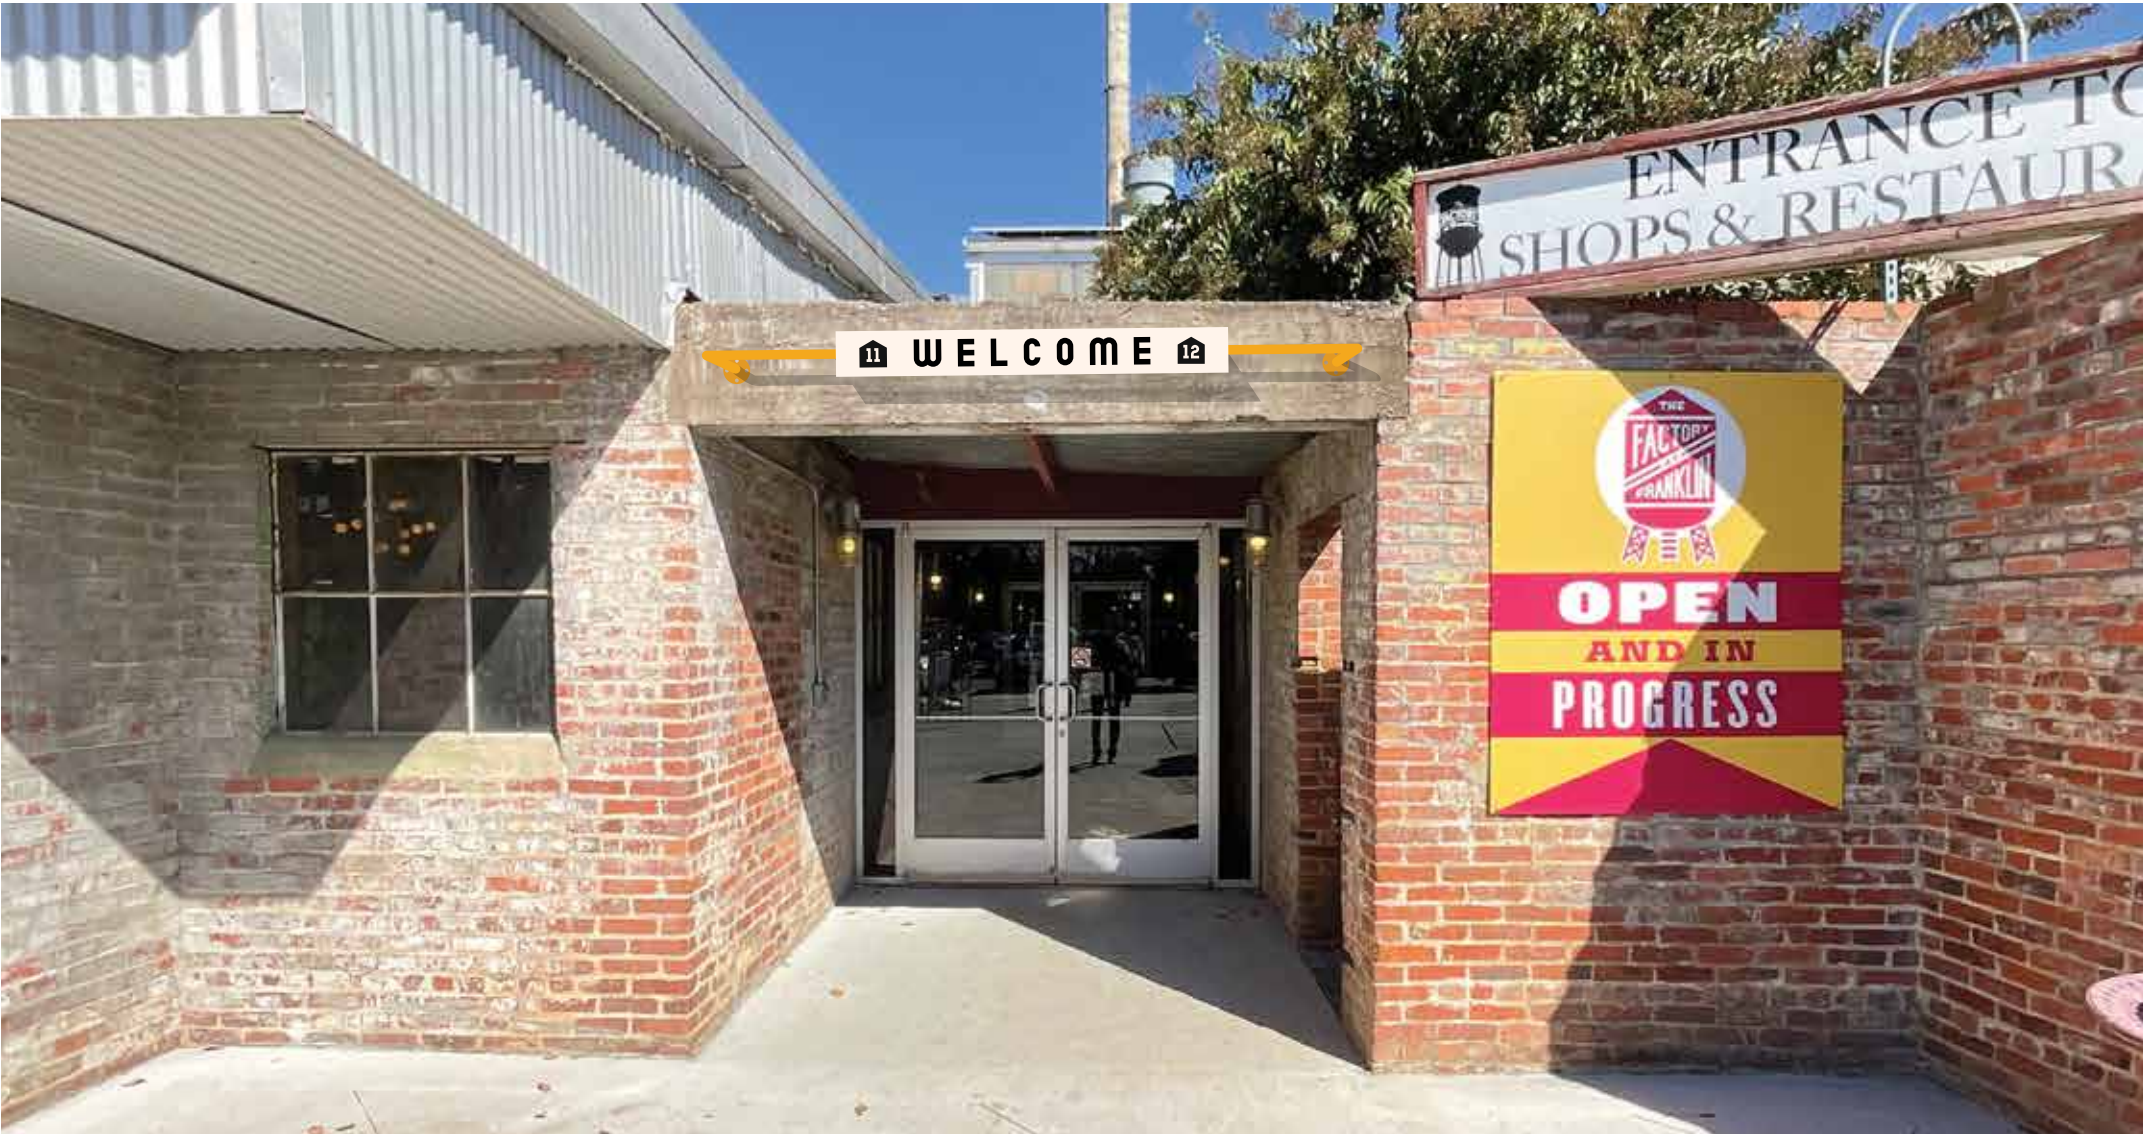
Convenience Signs

QTY: 4 signs total. One sign located at each parking lot entrance. Signs double-sided and for two-way visibility.

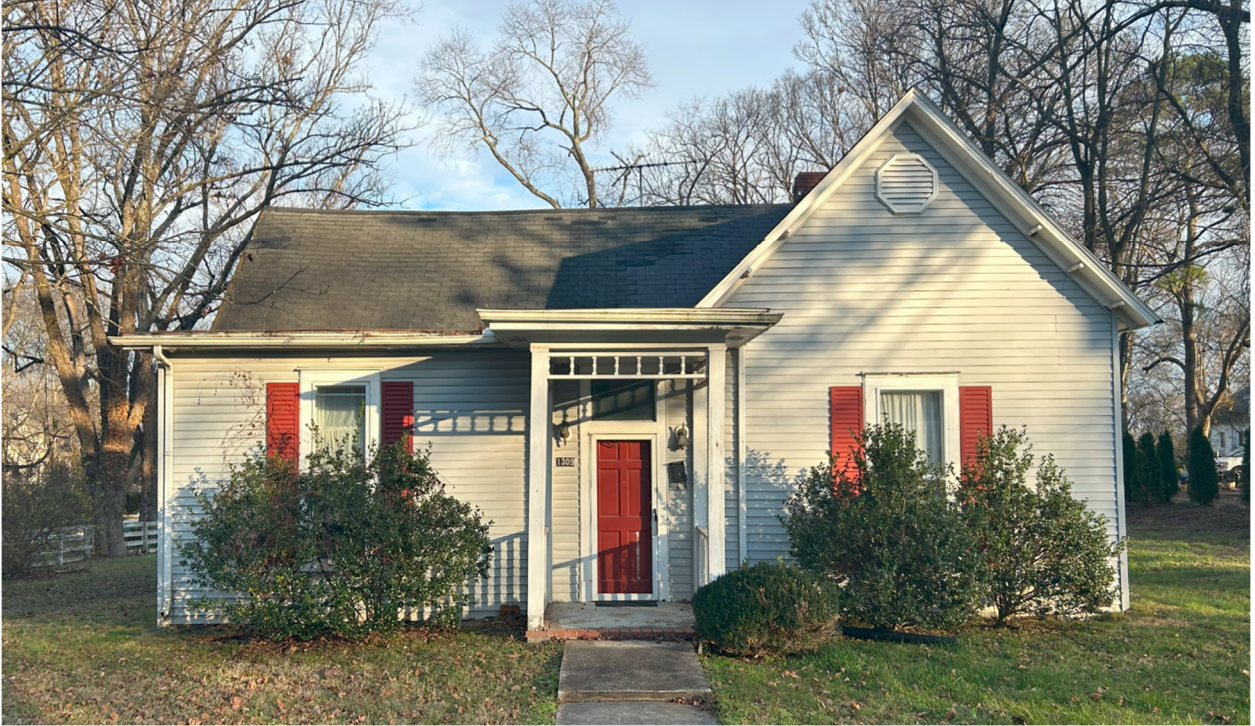
Image 1 - Front of the home as seen from Adams Street

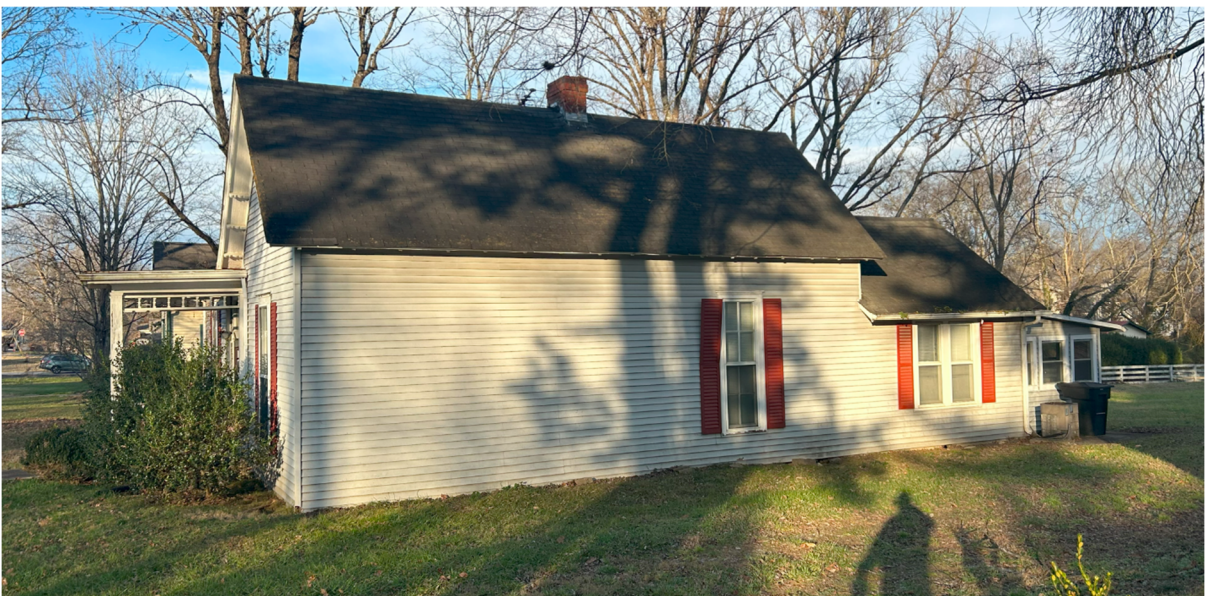
Image 2 - Right side (from standing at the front) view of the home

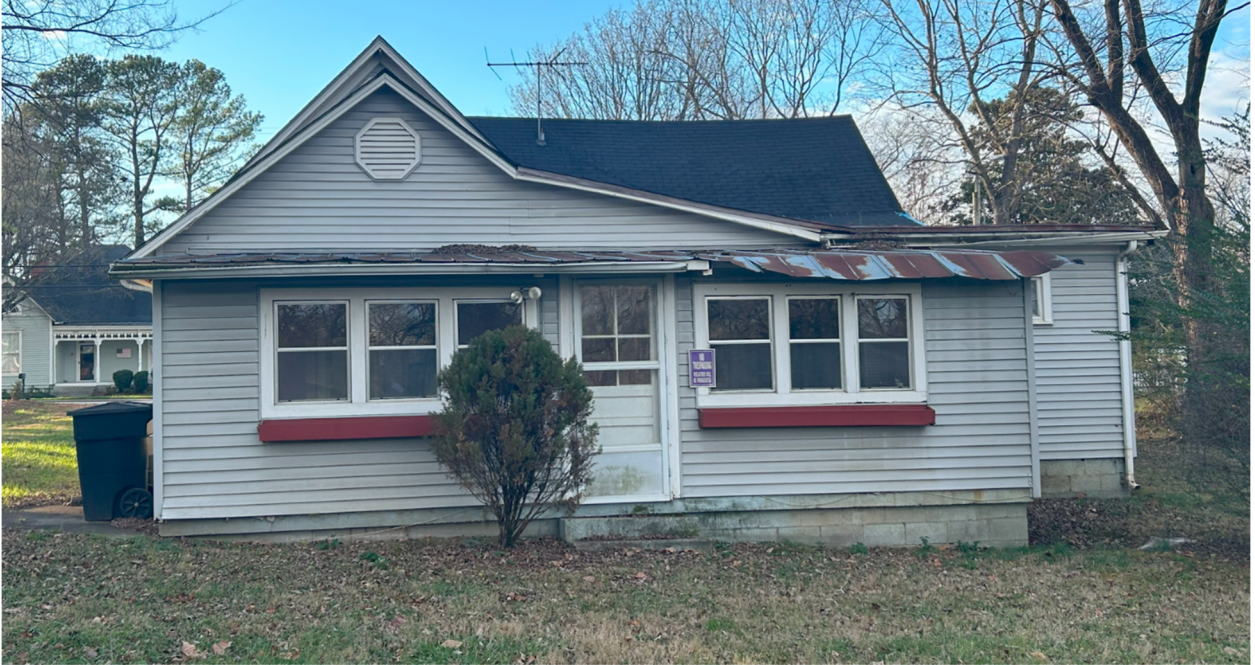
Image 3 - Rear view of the home

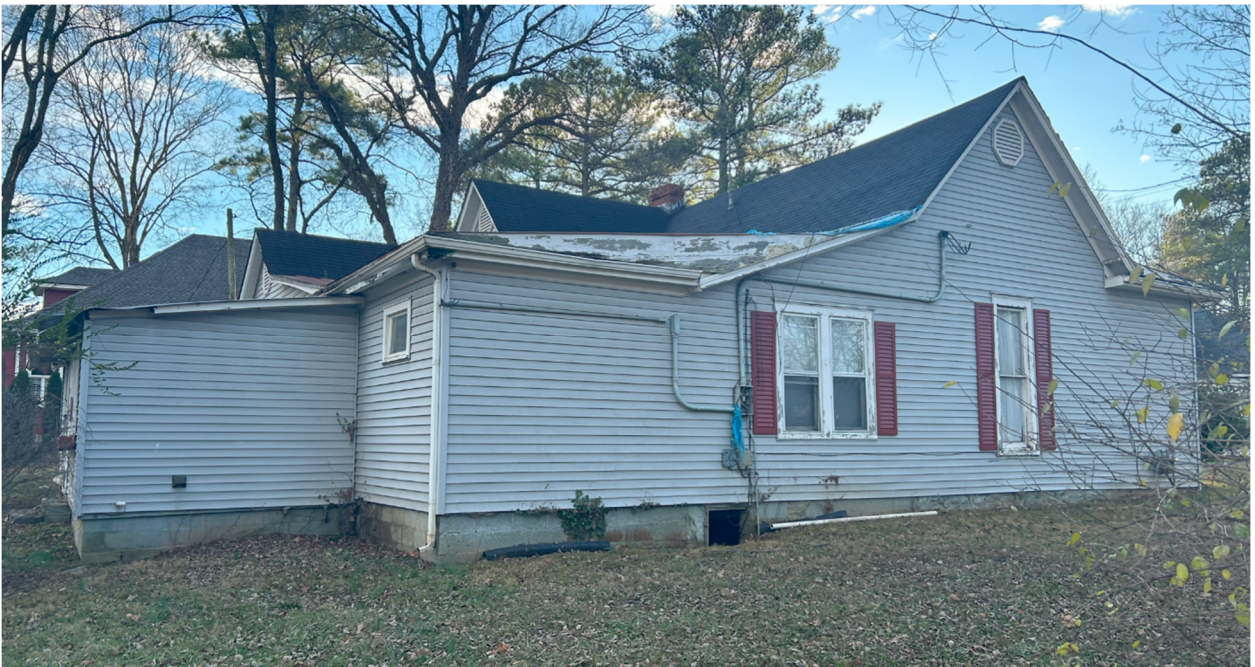
Image 4 - Left side (from standing at the front) view of the home

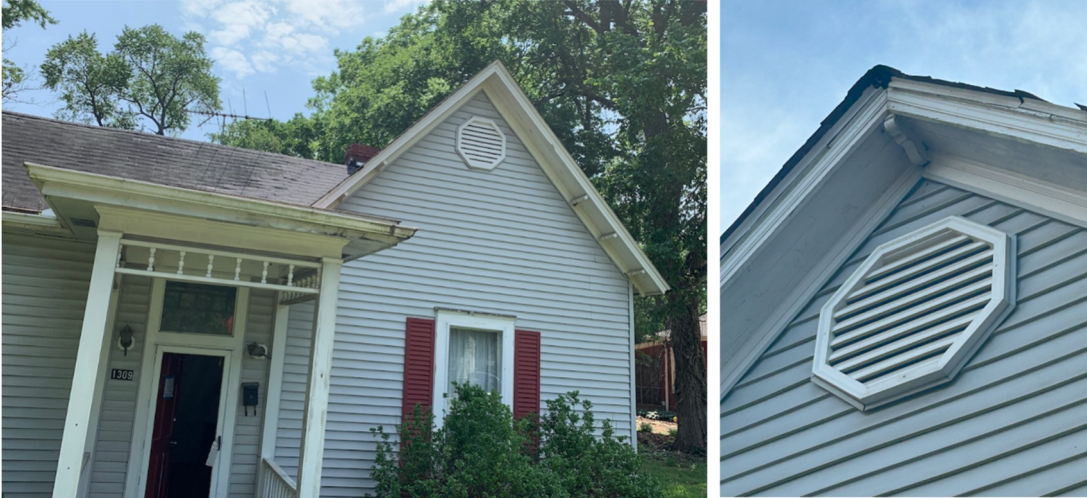
Images 5 & 6 - Front gable has minimal ornament – scrolled rafter extensions & octagonal vent which has been added and is not period appropriate

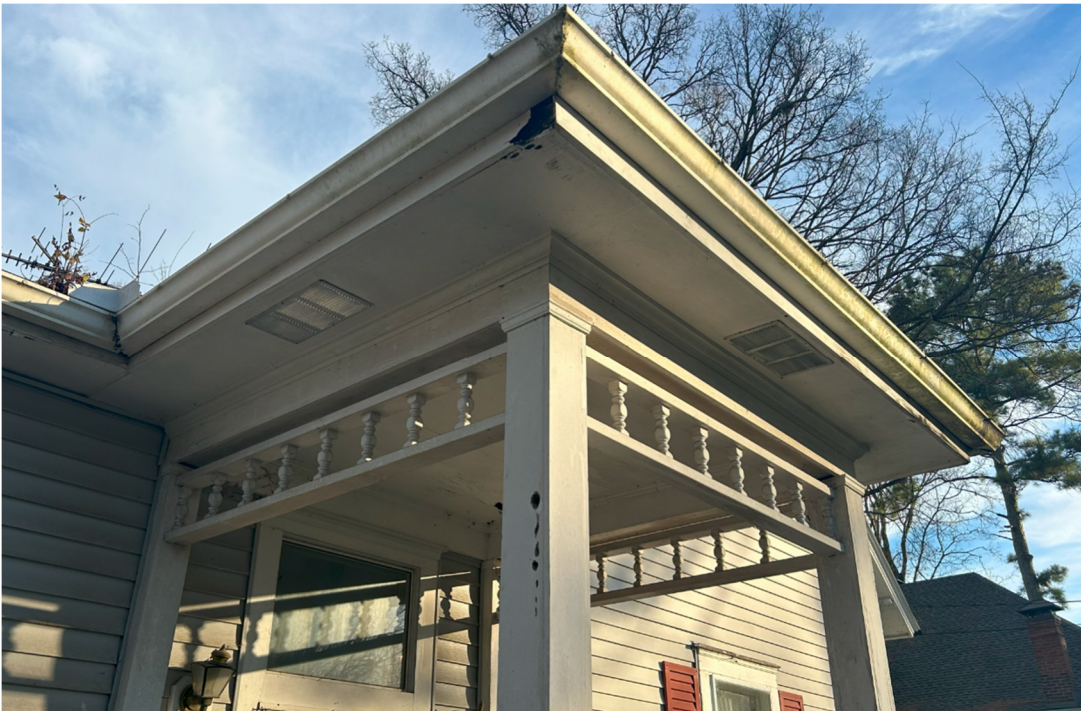
Image 7 - Porch has minimal detailing – overhead spindles are not original

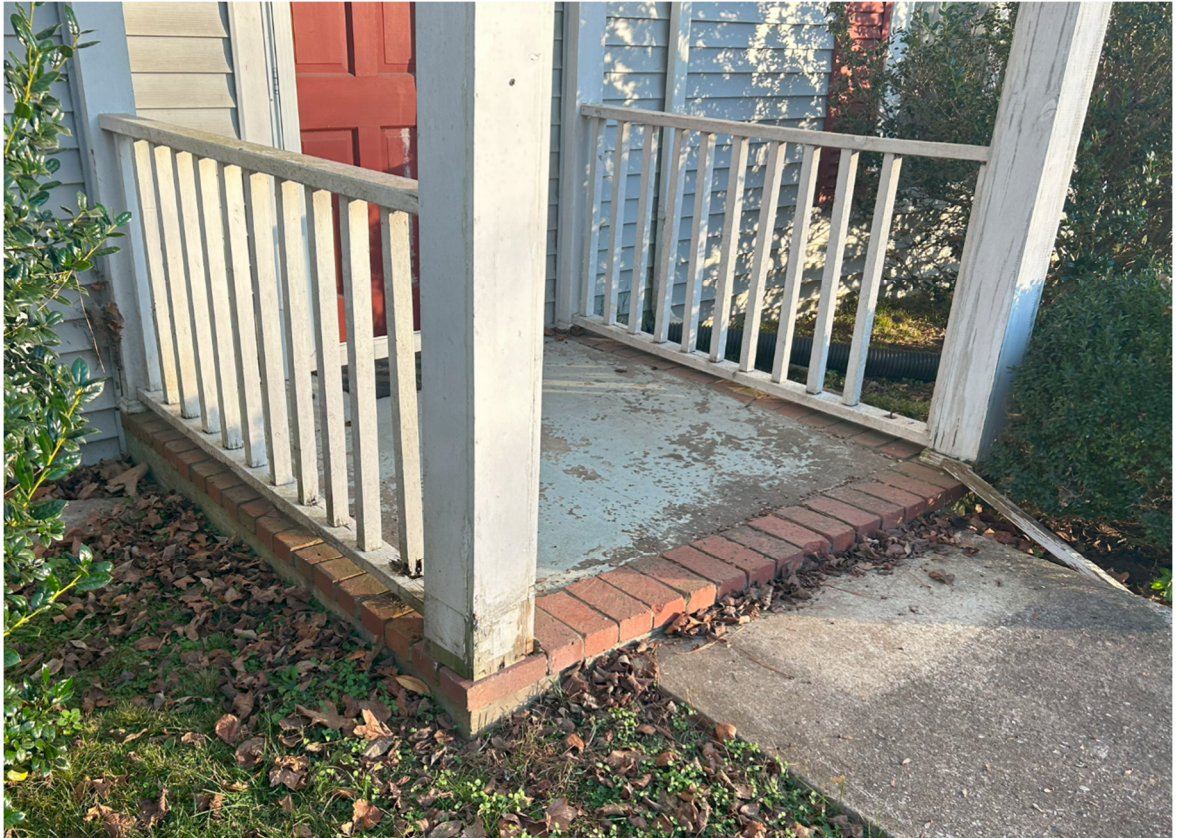
Images 8 & 9 - Porch railing is plain and not original – posts have begun to deteriorate at base

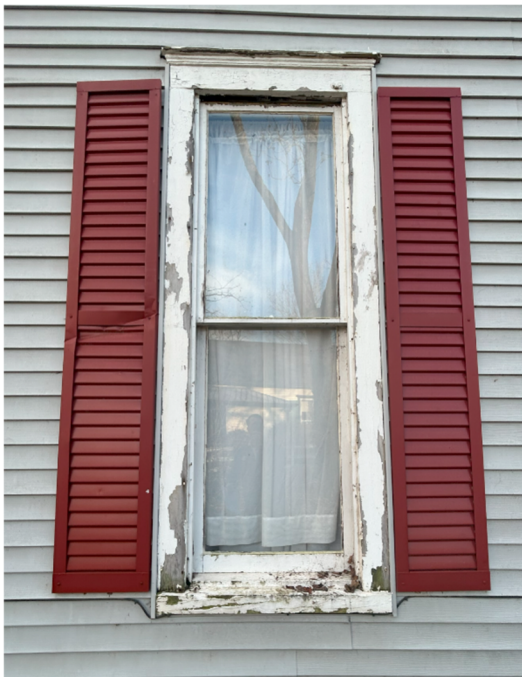
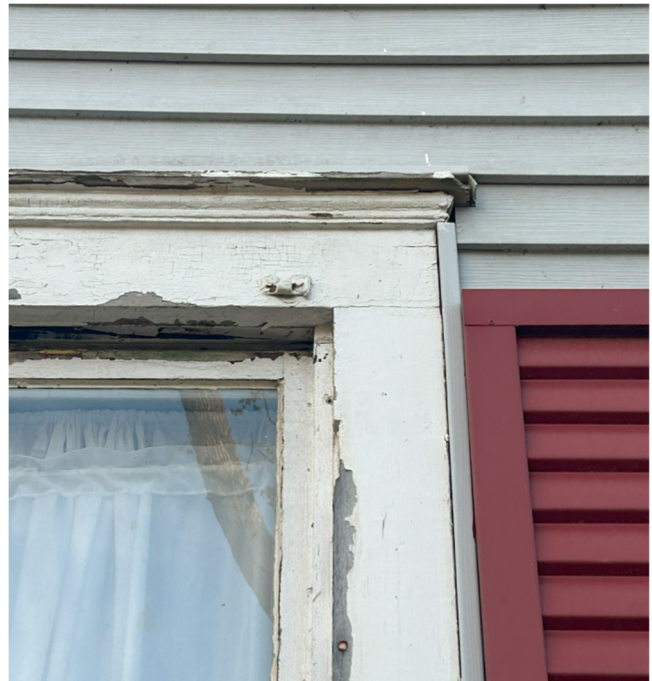
Images 9 & 10 - Vinyl siding & non-operable vinyl shutters have been added around window trim and poor detail has caused deterioration

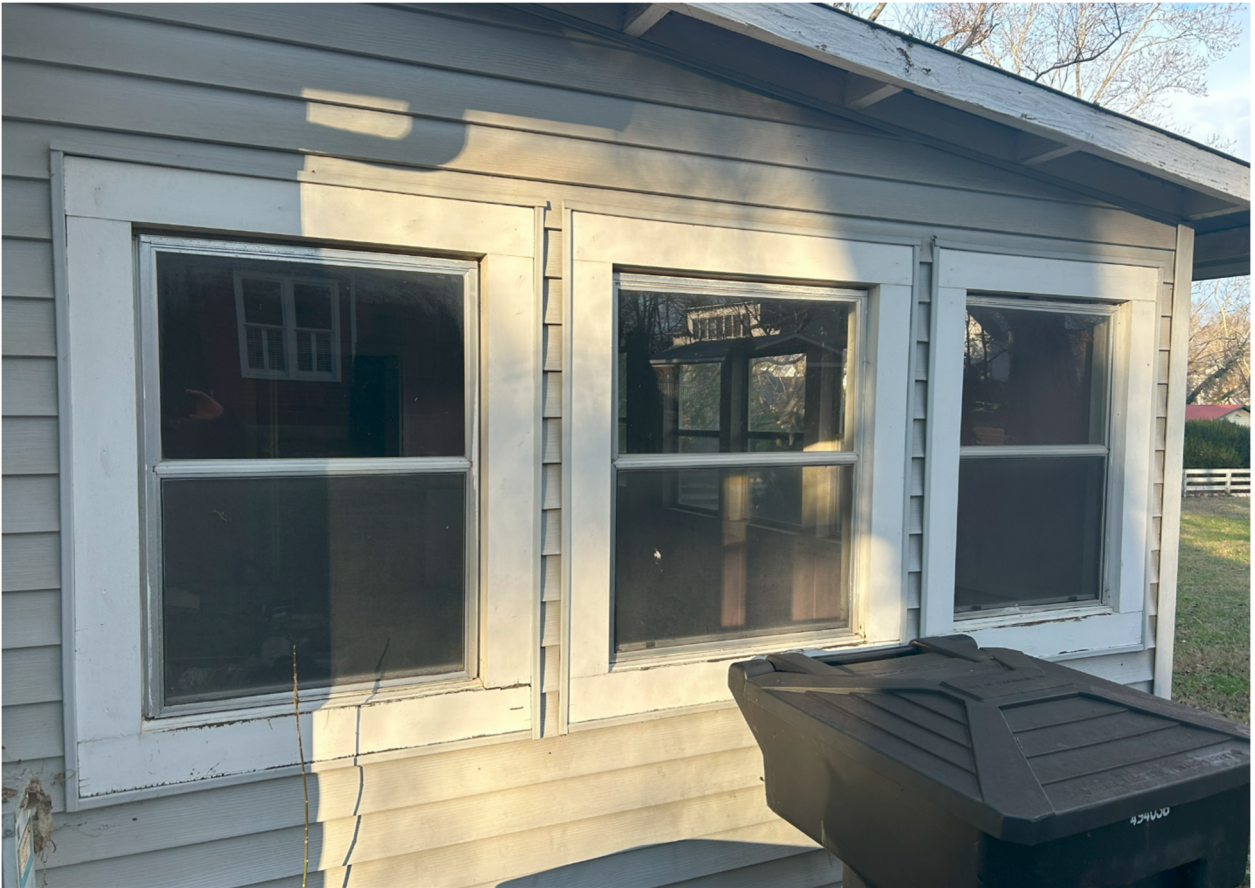
Image 11 - Windows at rear addition do not match vertical proportion of original windows and have no trim detail

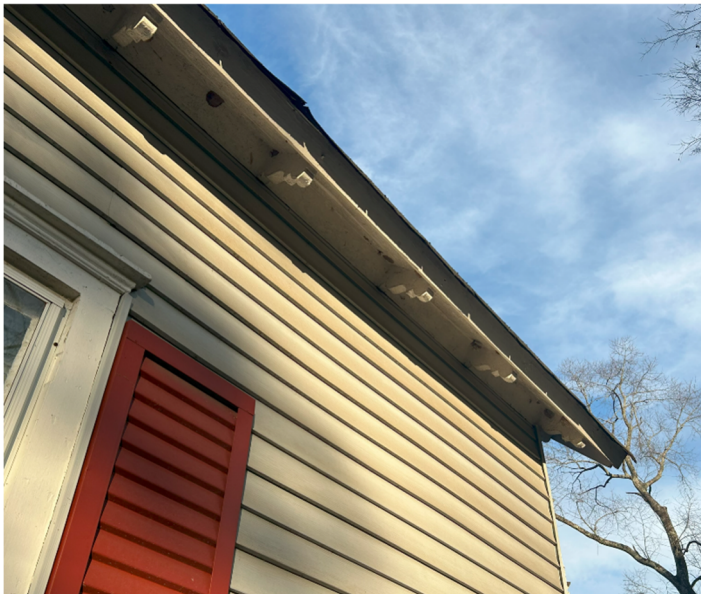
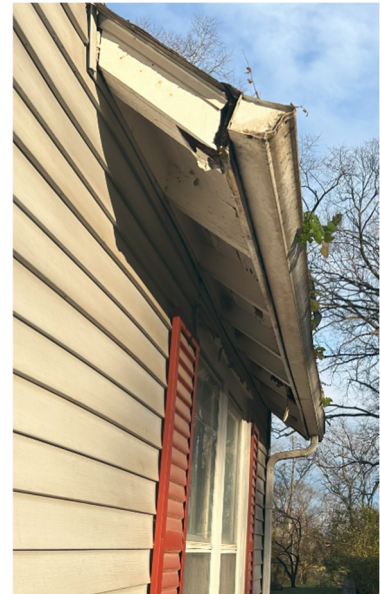
Images 12 & 13 - Left image: Original rafter extensions with scroll detail  
Right: rafter extensions at rear addition (no scrolled detail)

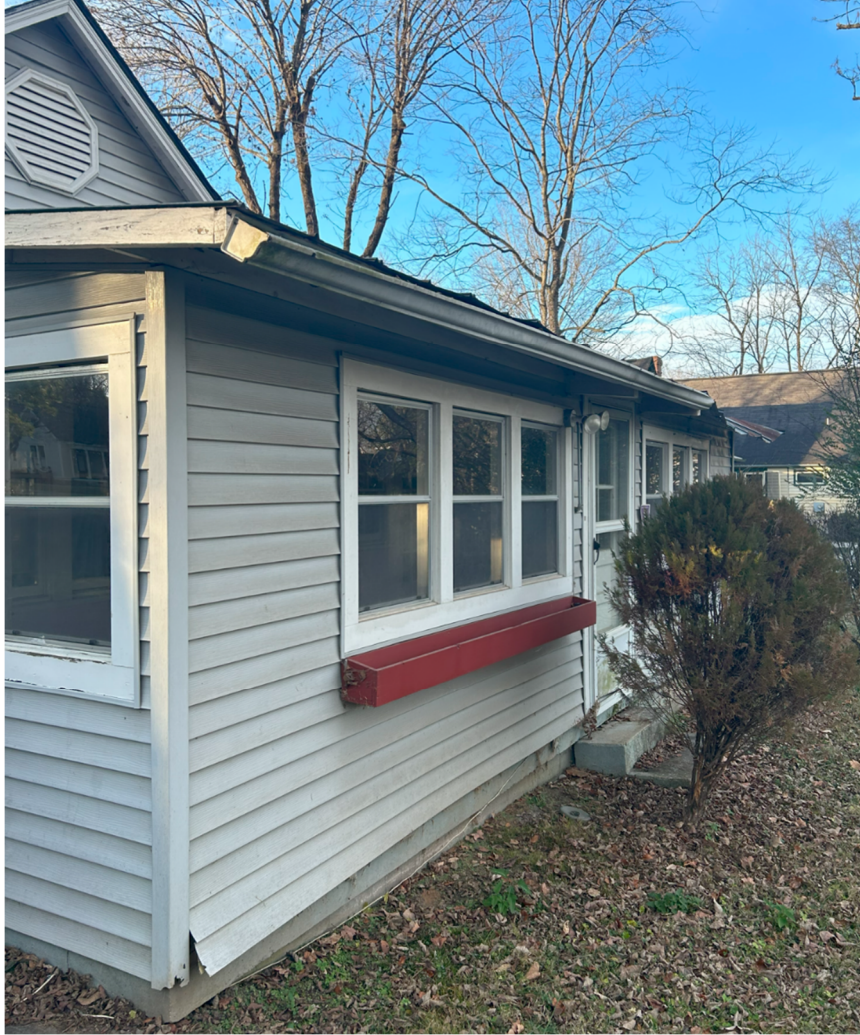
Image 14 - Rear addition has no distinctive detailing

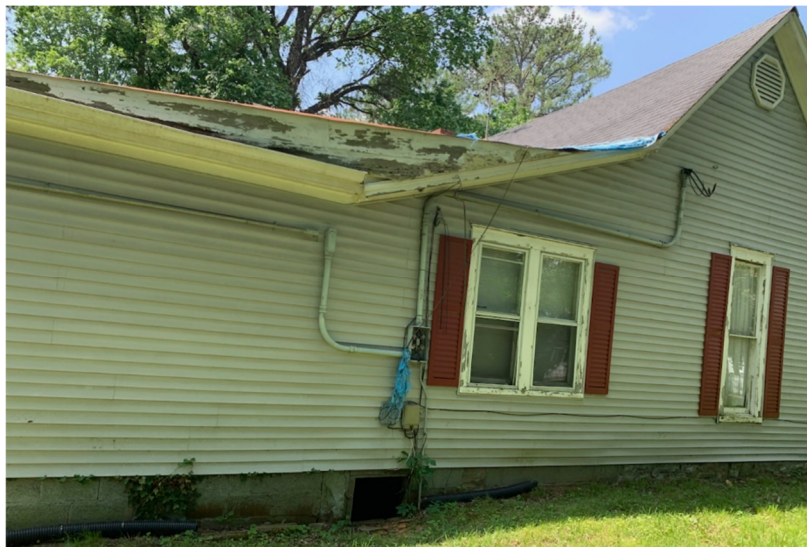
Image 15 - Severe deterioration to fascia where addition joins with original structure

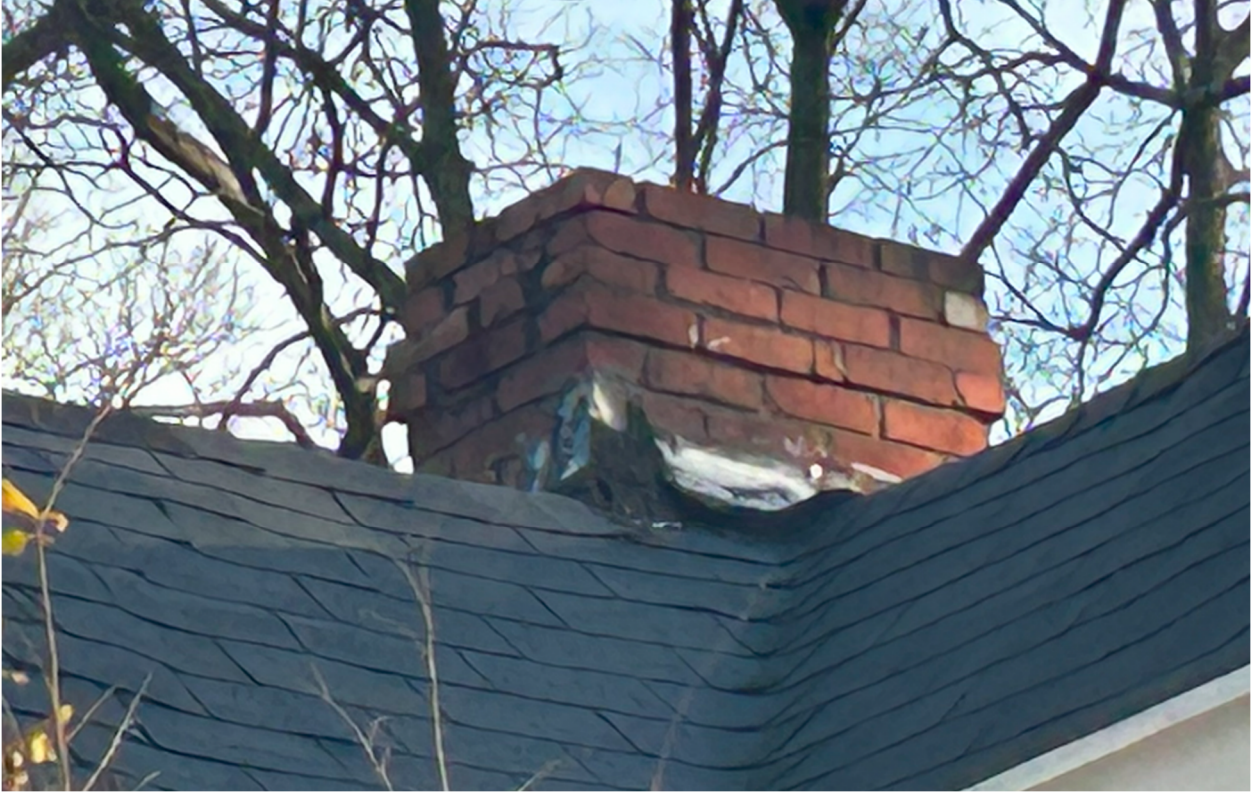
Image 16 - No distinctive brick detailing at chimney

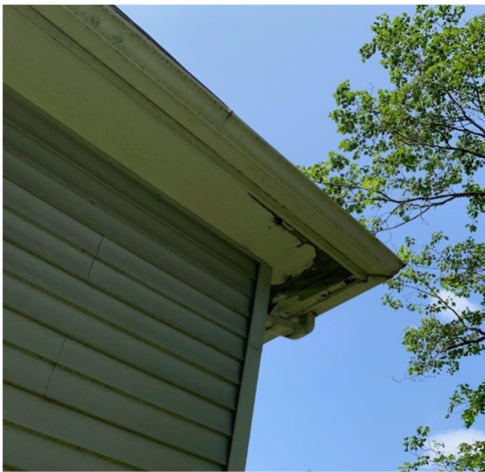
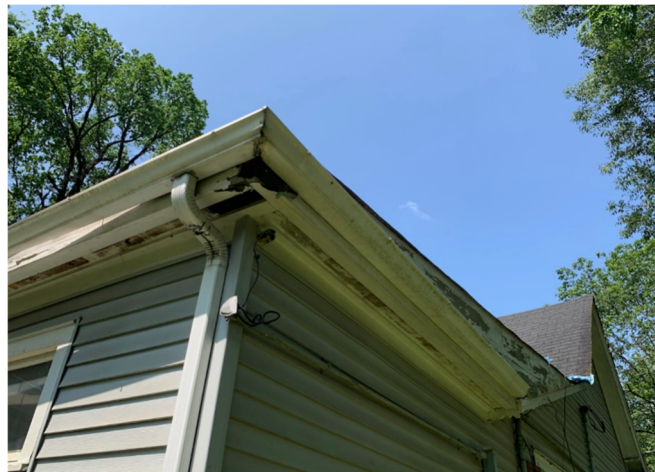
Image 17 & 18 - Severe deterioration at eave

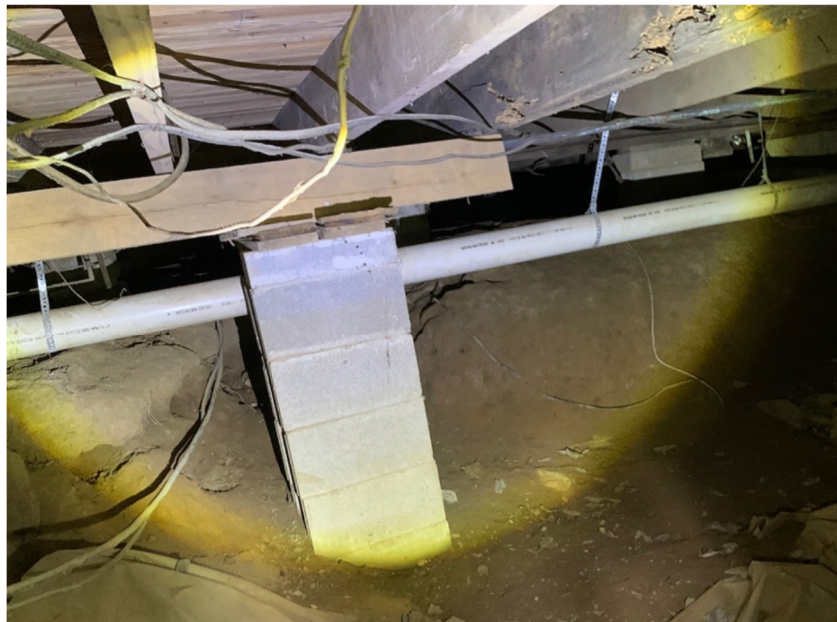
this image shows the deterioration of floor joints (see cracks in upper right hand corner)

- House foundation is a combination of concrete masonry units (CMU) and stone perimeter foundation walls with dry-stacked CMU piers to the crawlspace interior supporting floor framing. Cracking in the foundation walls was observed. The presence of a footing could not be determined.
- Soil within the crawlspace appeared to be damp in places
- In some areas floor framing has deflected to the extent that framing appears to bear on earth within the crawlspace

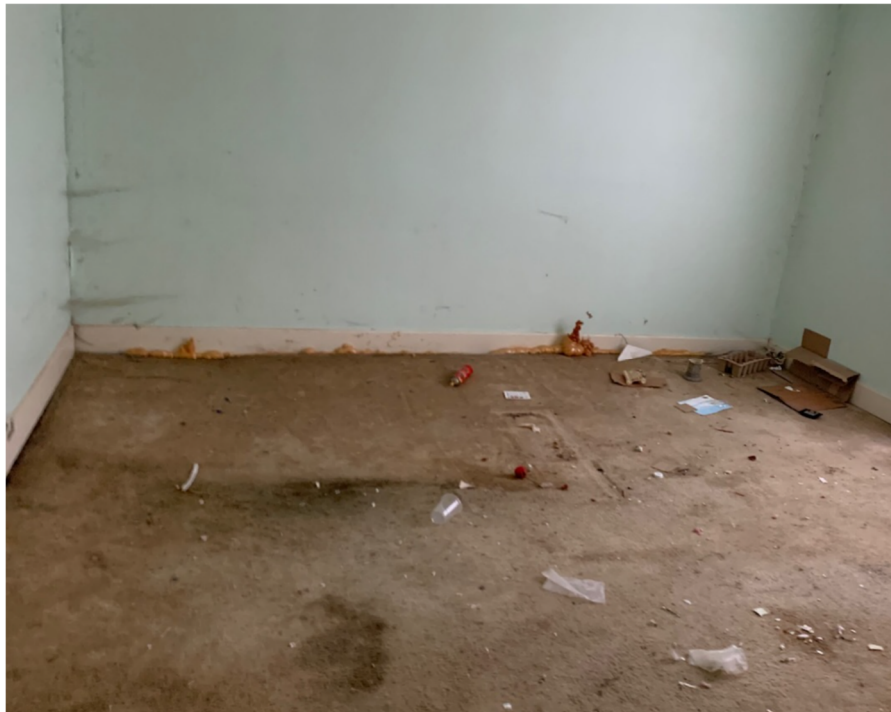
In this room a depression in the middle measured at 6" – 8" demonstrated a failure of the floor joists
