## Meeting Agenda

### Design Review Committee

# 221 Lewisburg Ave

Permitting Proposal

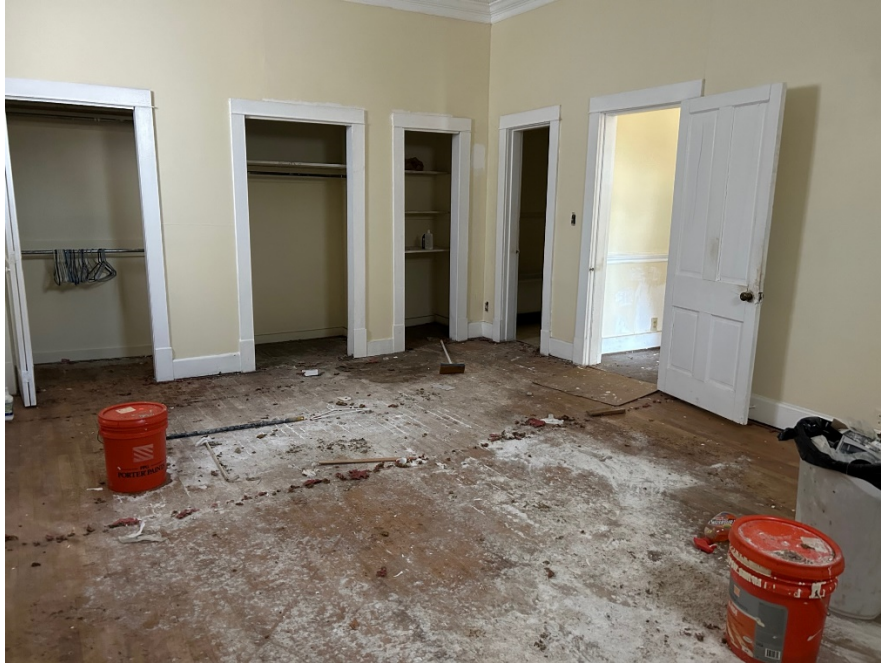
In this room a depression in the middle measured at 4" – 6" demonstrated a failure of the floor joists

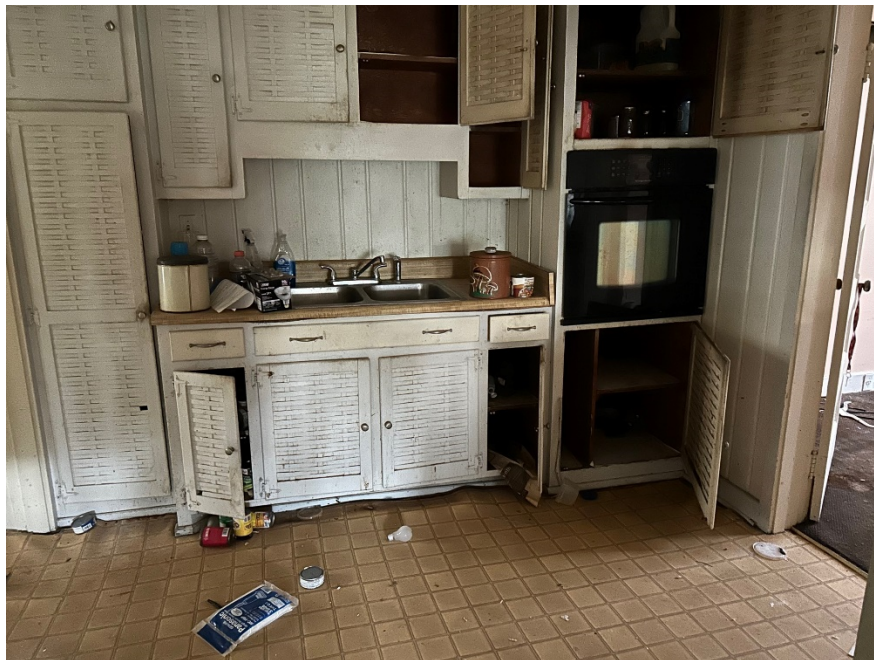
In this room a depression in the middle measured at 5" – 7" demonstrated a failure of the floor joists

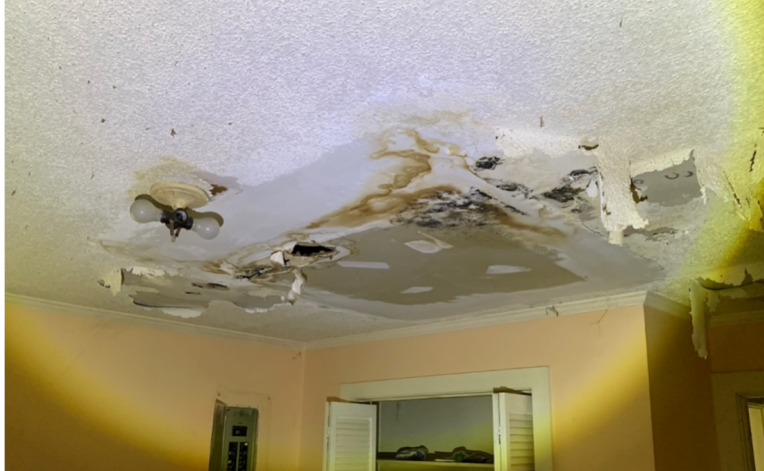
Significant water damage in the ceiling and sagging of 2" – 4" shows partial failure of ceiling structure

- Walls and door frames throughout the home were observed to be out of plumb
- The right exterior wall was observed to be bowing outward horizontally. Spray foam had been injected into the space between the wall and the floor.
- Ceiling rafters throughout the home were observed to be deflecting downward (sagging).
- Water staining in the drywall ceiling and deterioration of the visible wood framing in the back left bedroom was observed.

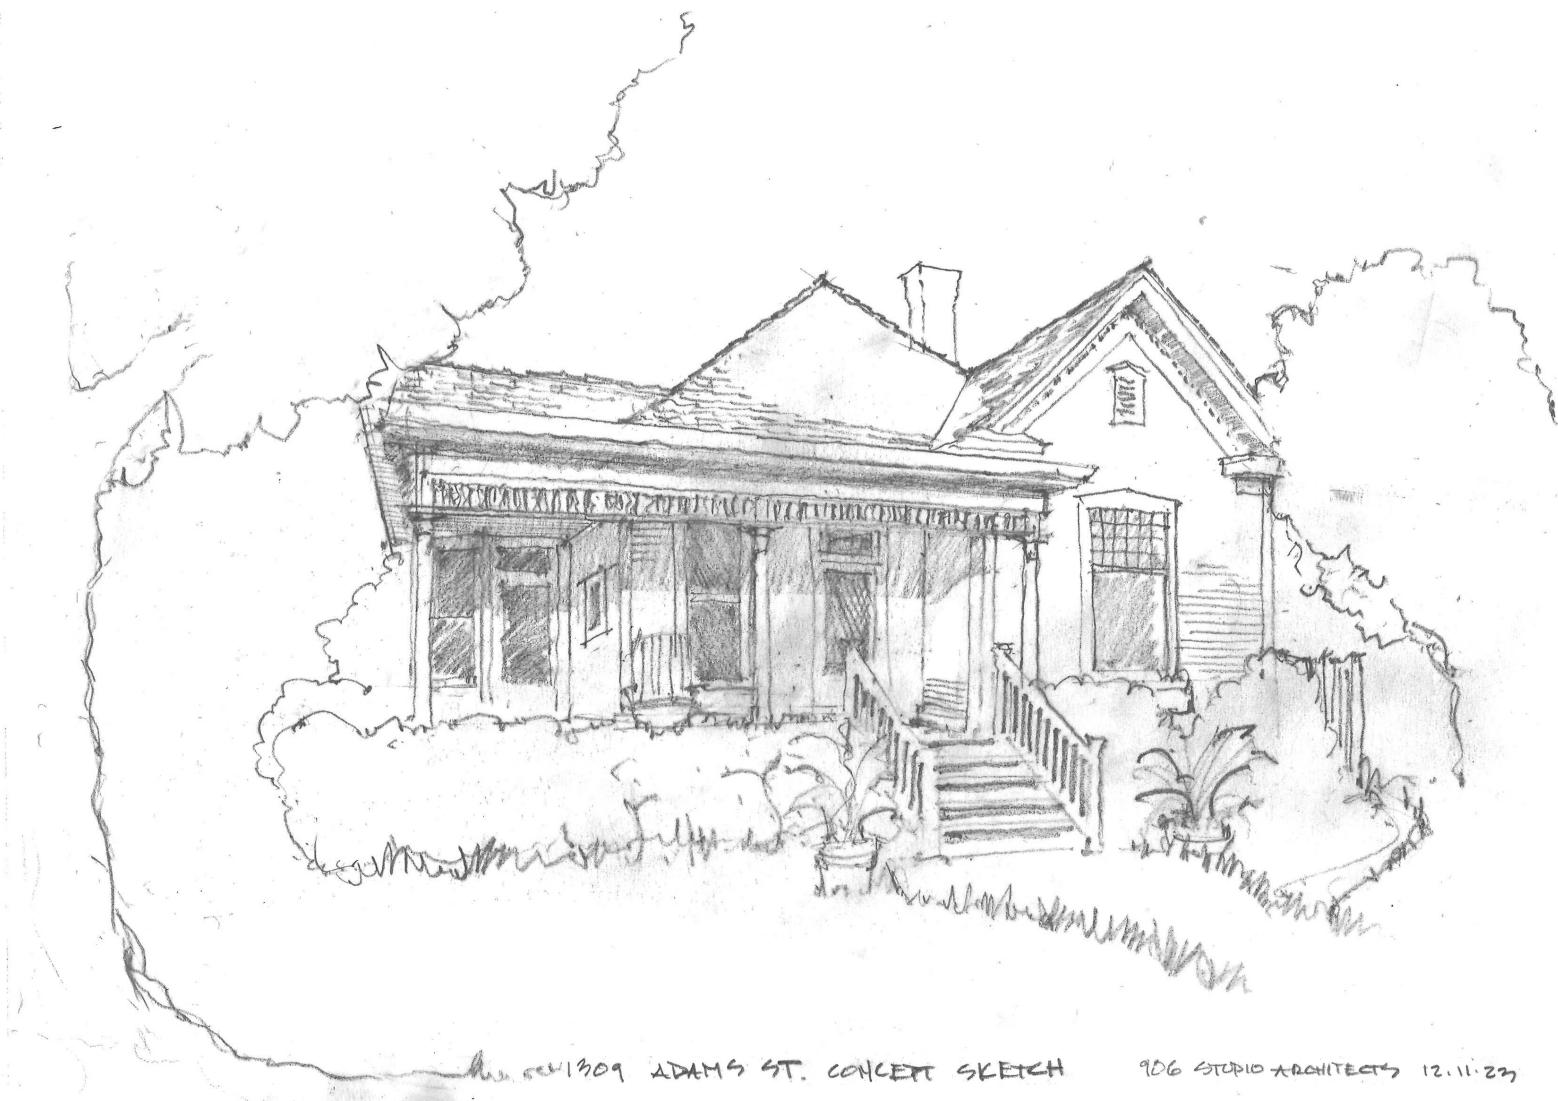
1309 ADAMS ST. CONCEPT SKETCH

2 STORIES IN THE CRAFTSMAN OR BUNGALOW STYLE

CONFORM TO LANDSCAPE AREA REQUIREMENTS AS WELL AS  
DESIGN GUIDELINES FOR THIS HISTORIC OVERLAY AREA
