## Meeting Agenda

### Design Review Committee

1. Discussion Of Alterations (Loading Dock) At 252 5th Ave. N.; Sam Johnson, Applicant.
2. Discussion Of Fencing (Rear Yard) And Vehicular Gate At 112 Lewisburg Ave.; Jennifer Lombard, Applicant.
3. Discussion Of Signage And Alterations (Refuse Enclosure) At 94-98 E. Main St.; Mark Kozevski, Applicant.

4. Discussion Of Alterations (Courtyard) At 159 1st Avenue N.; Brandon Priddy, Applicant.
5. Discussion Of Site Alterations At 328 Franklin Rd.; Linda Childs, Applicant.
6. Discussion Of Alterations (Site Alterations) And Additions (Principal And Accessory) At 720 W. Main St.; Amanda McCreary, Applicant.
7. Discussion Of An Addition (Accessory Structure) And Site Alterations At 1303 Adams St.; Zachary Correa, Applicant.
8. Discussion of Preliminary Historic Zoning Commission Recommendation For A Proposed Hotel, Parking Structure, And Partial Demolition At 230 Franklin Rd. (The Factory); Greg Gamble, Applicant.

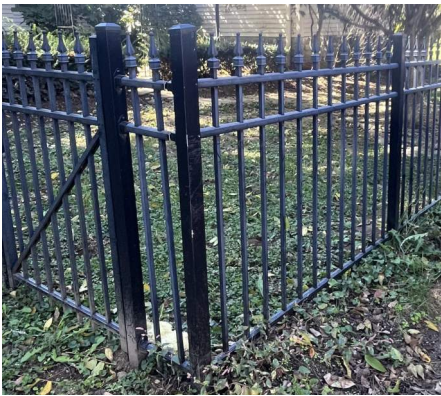
STONE PIERS

WROUGHT IRON FENCE STYLE TO  
MATCH ADJACENT PROPERTY

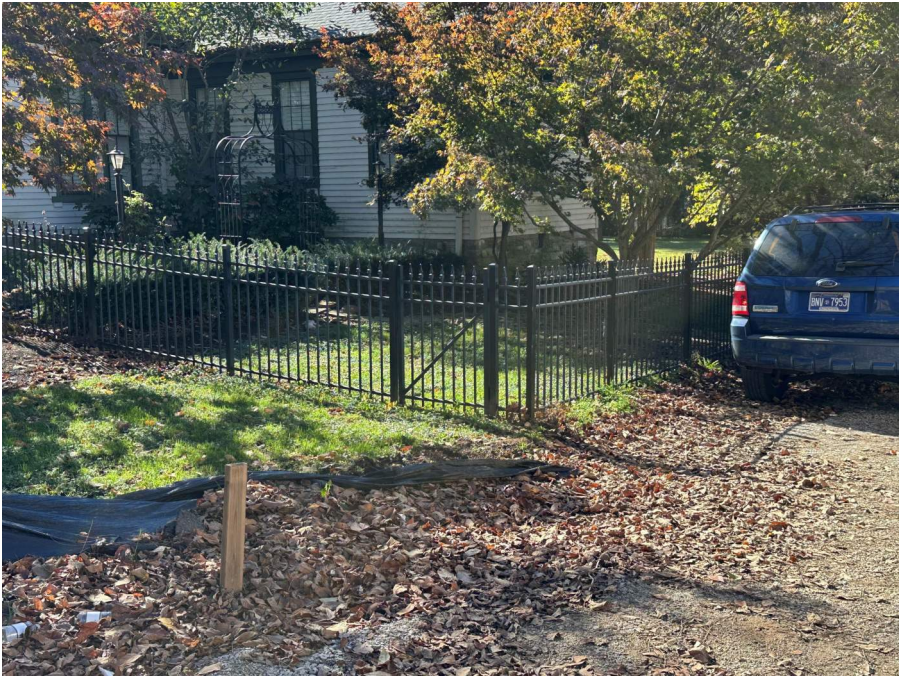
EXISTING IRON FENCE ON ADJACENT PROPERTY TO THE LEFT

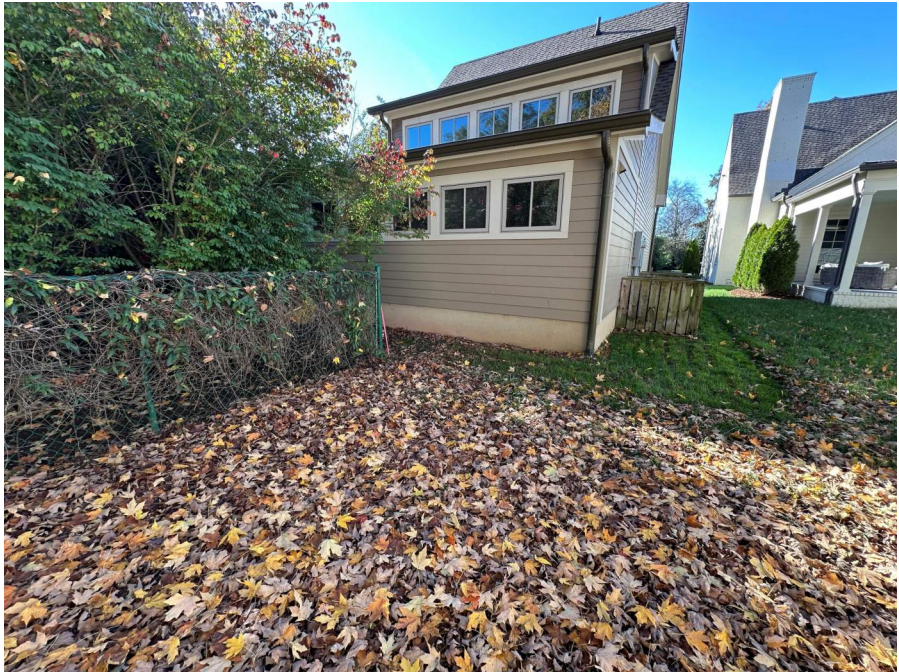
EXISTING CHAIN LINK FENCE ON ADJACENT PROPERTY TO THE LEFT

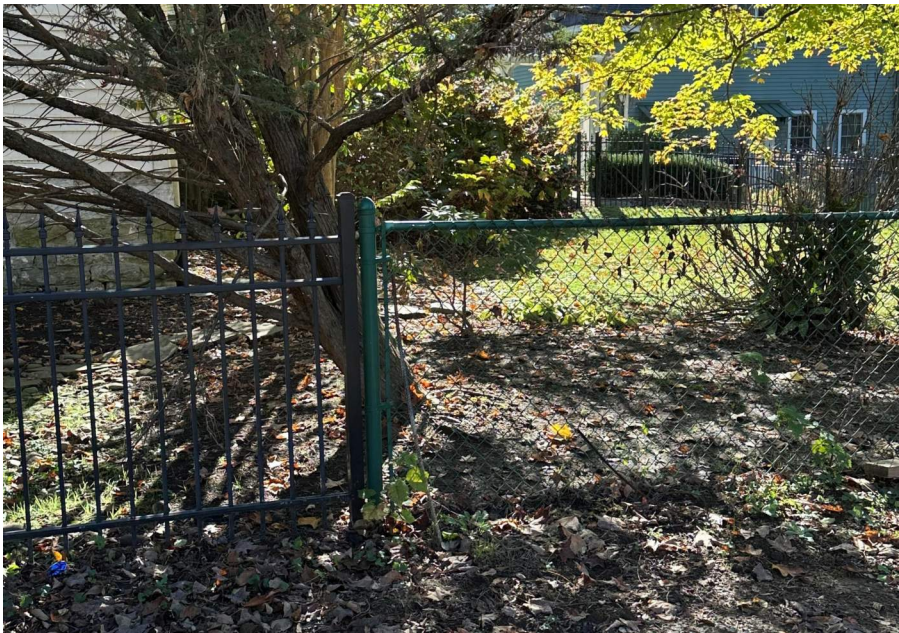
EXISTING IRON FENCE AND CHAIN LINK CONNECTION AT  
ADJACENT PROPERTY TO THE LEFT

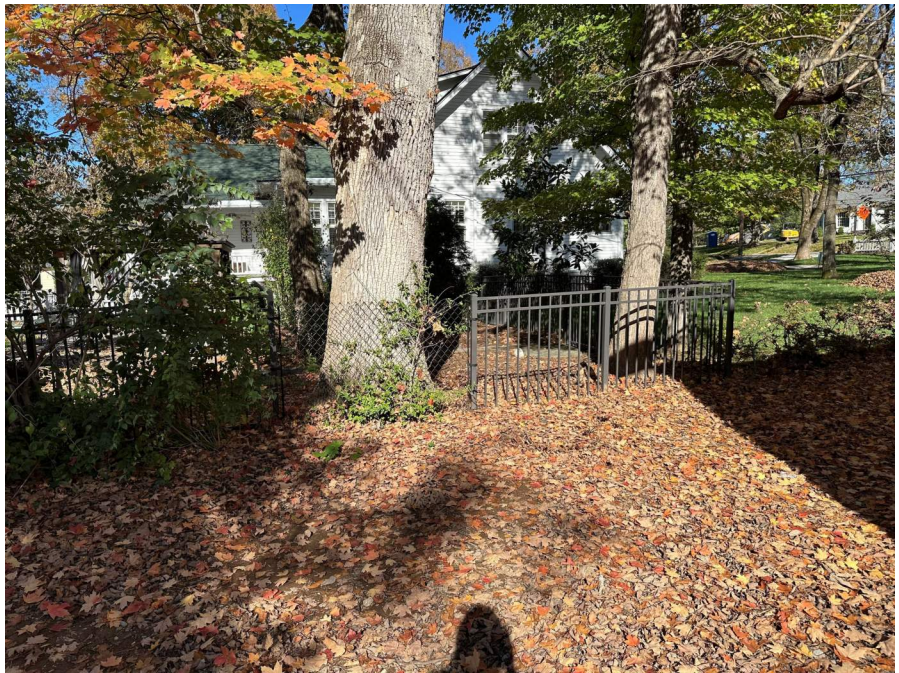
EXISTING IRON FENCE ON ADJACENT PROPERTY TO THE RIGHT

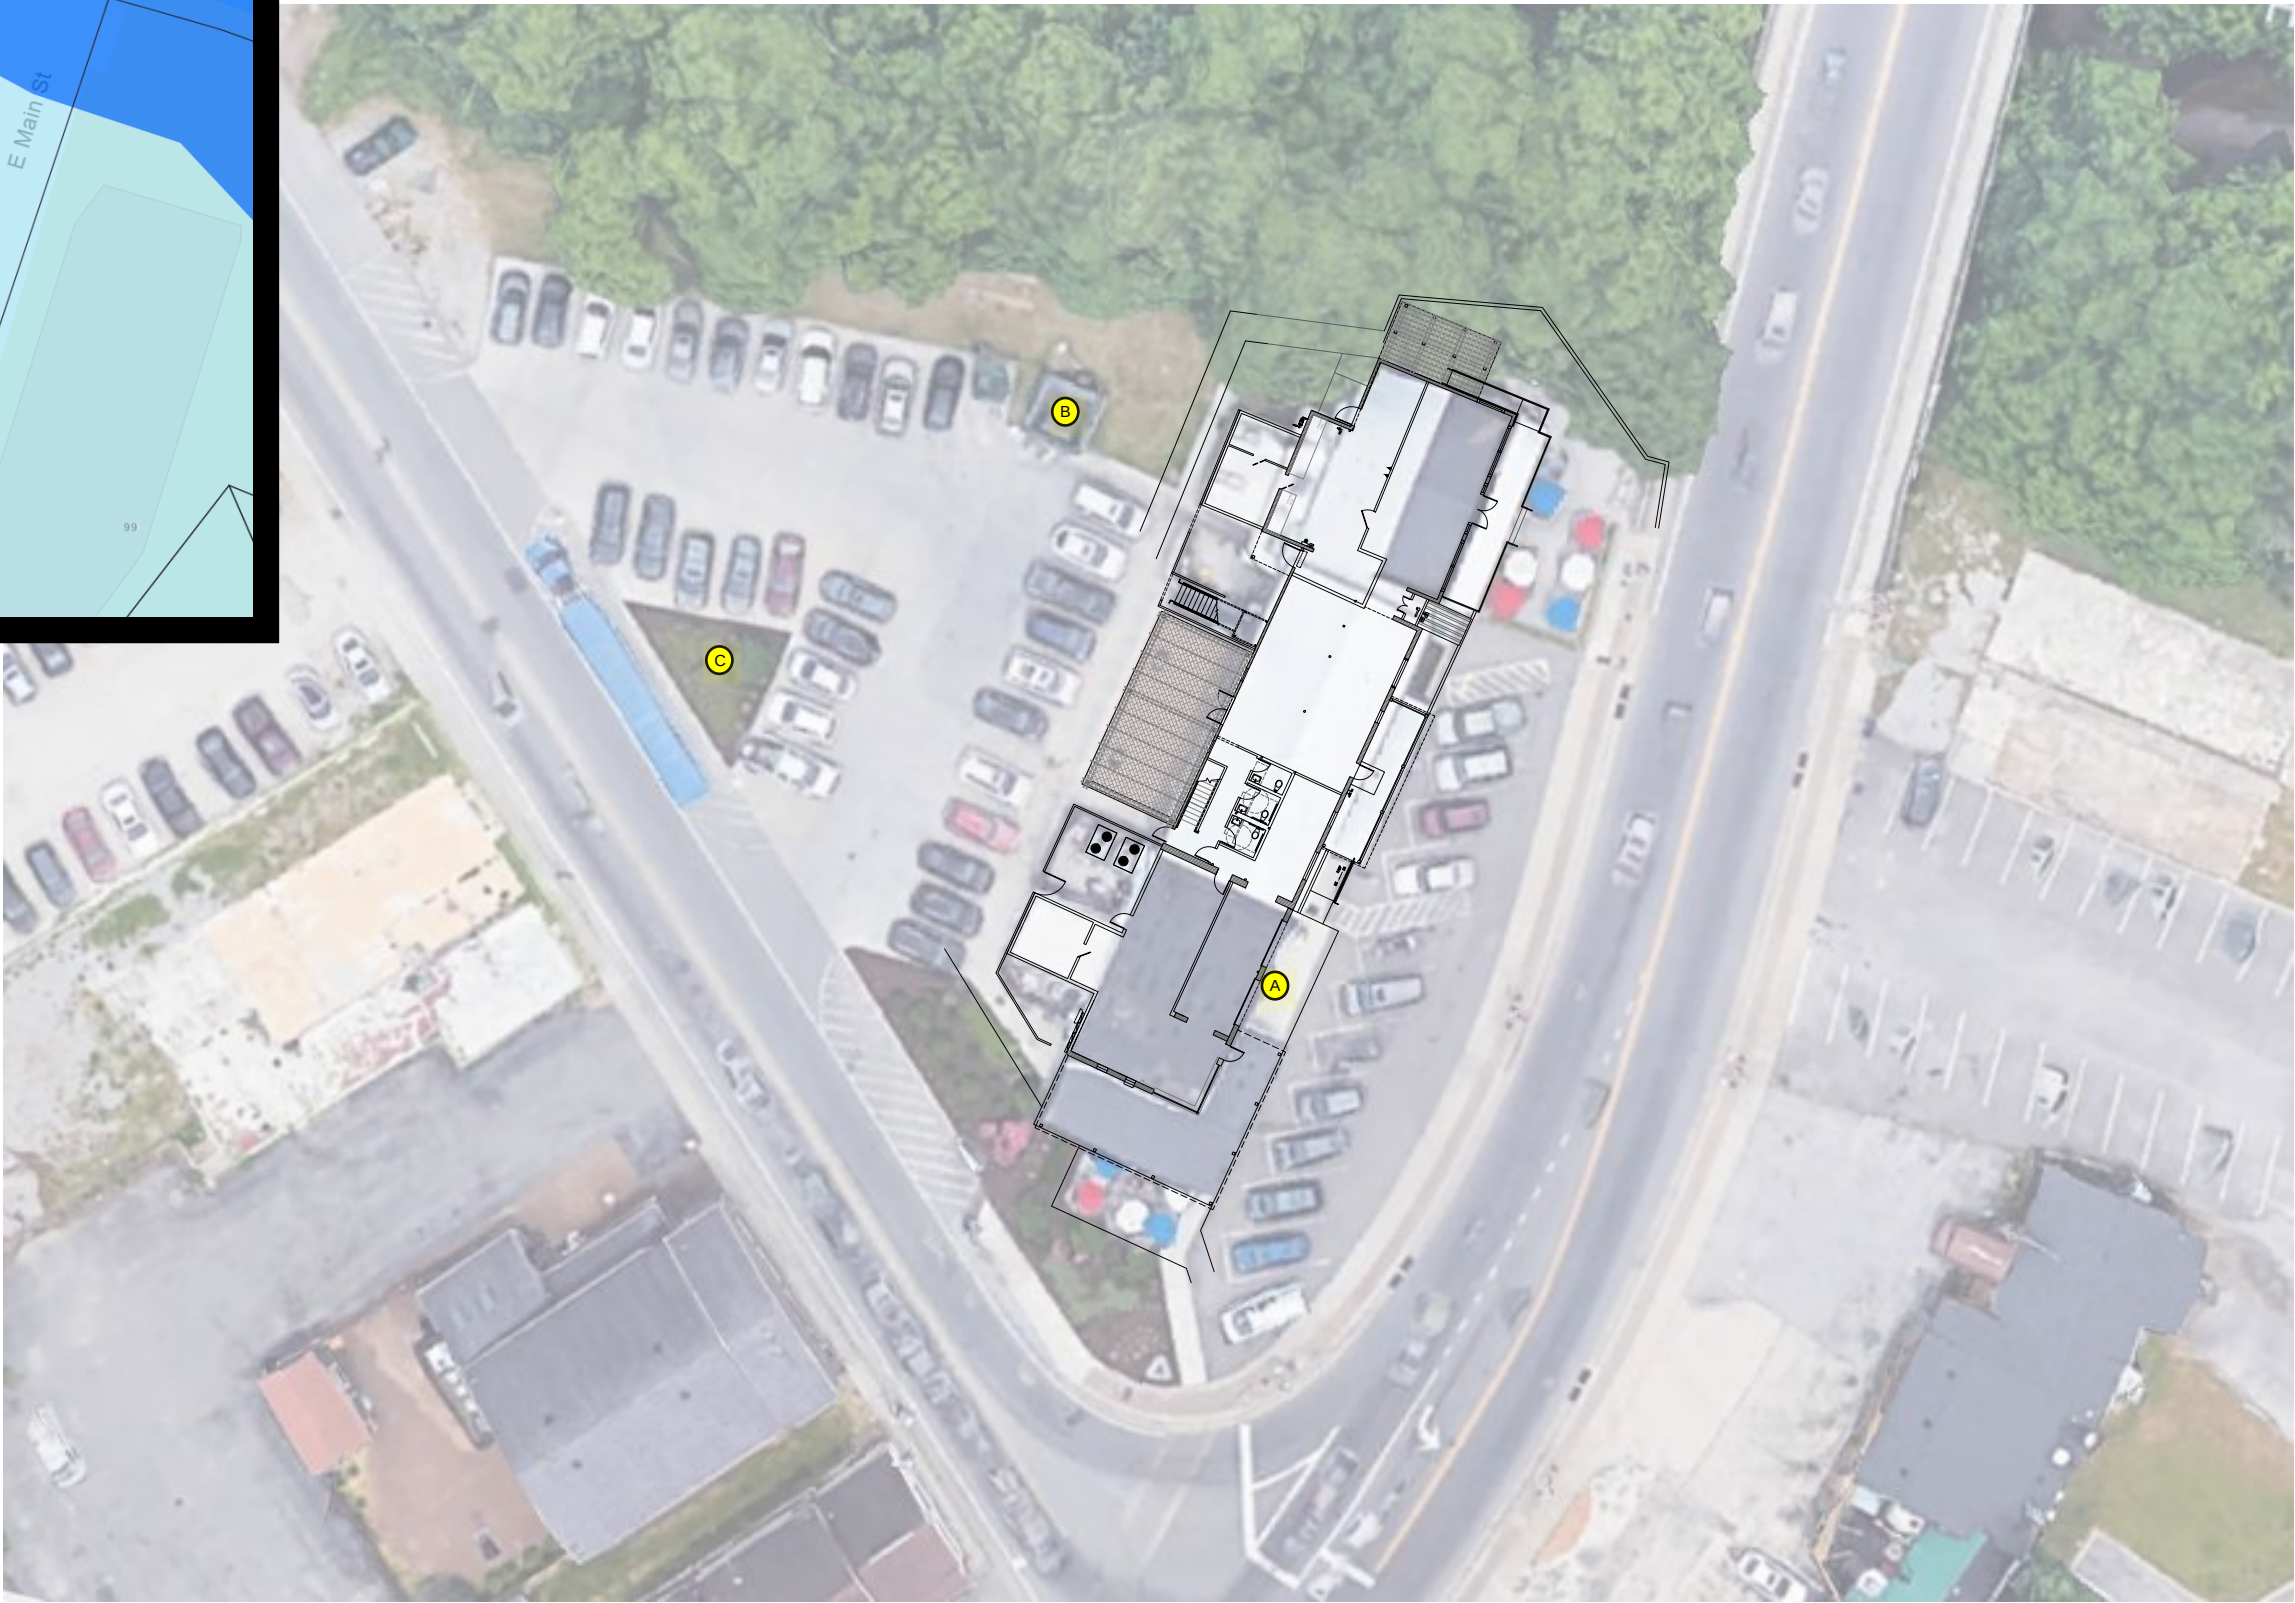
# 1ST & MAIN - SCOPE OF WORK OVERVIEW

- PROPOSED MODIFICATIONS:**
- A. NEW TENANT SIGNAGE WITH STEM-MOUNTED LIGHTING, SEE INCLUDED SIGN PACKAGE
  - B. EXISTING DUMPSTER ENCLASURE LOCATION. EXISTING ENCLASURE TO BE REMOVED.
  - C. NEW DUMPSTER PAD & ENCLOSURE. SEE ATTACHED DETAILS.

**PROPOSED**

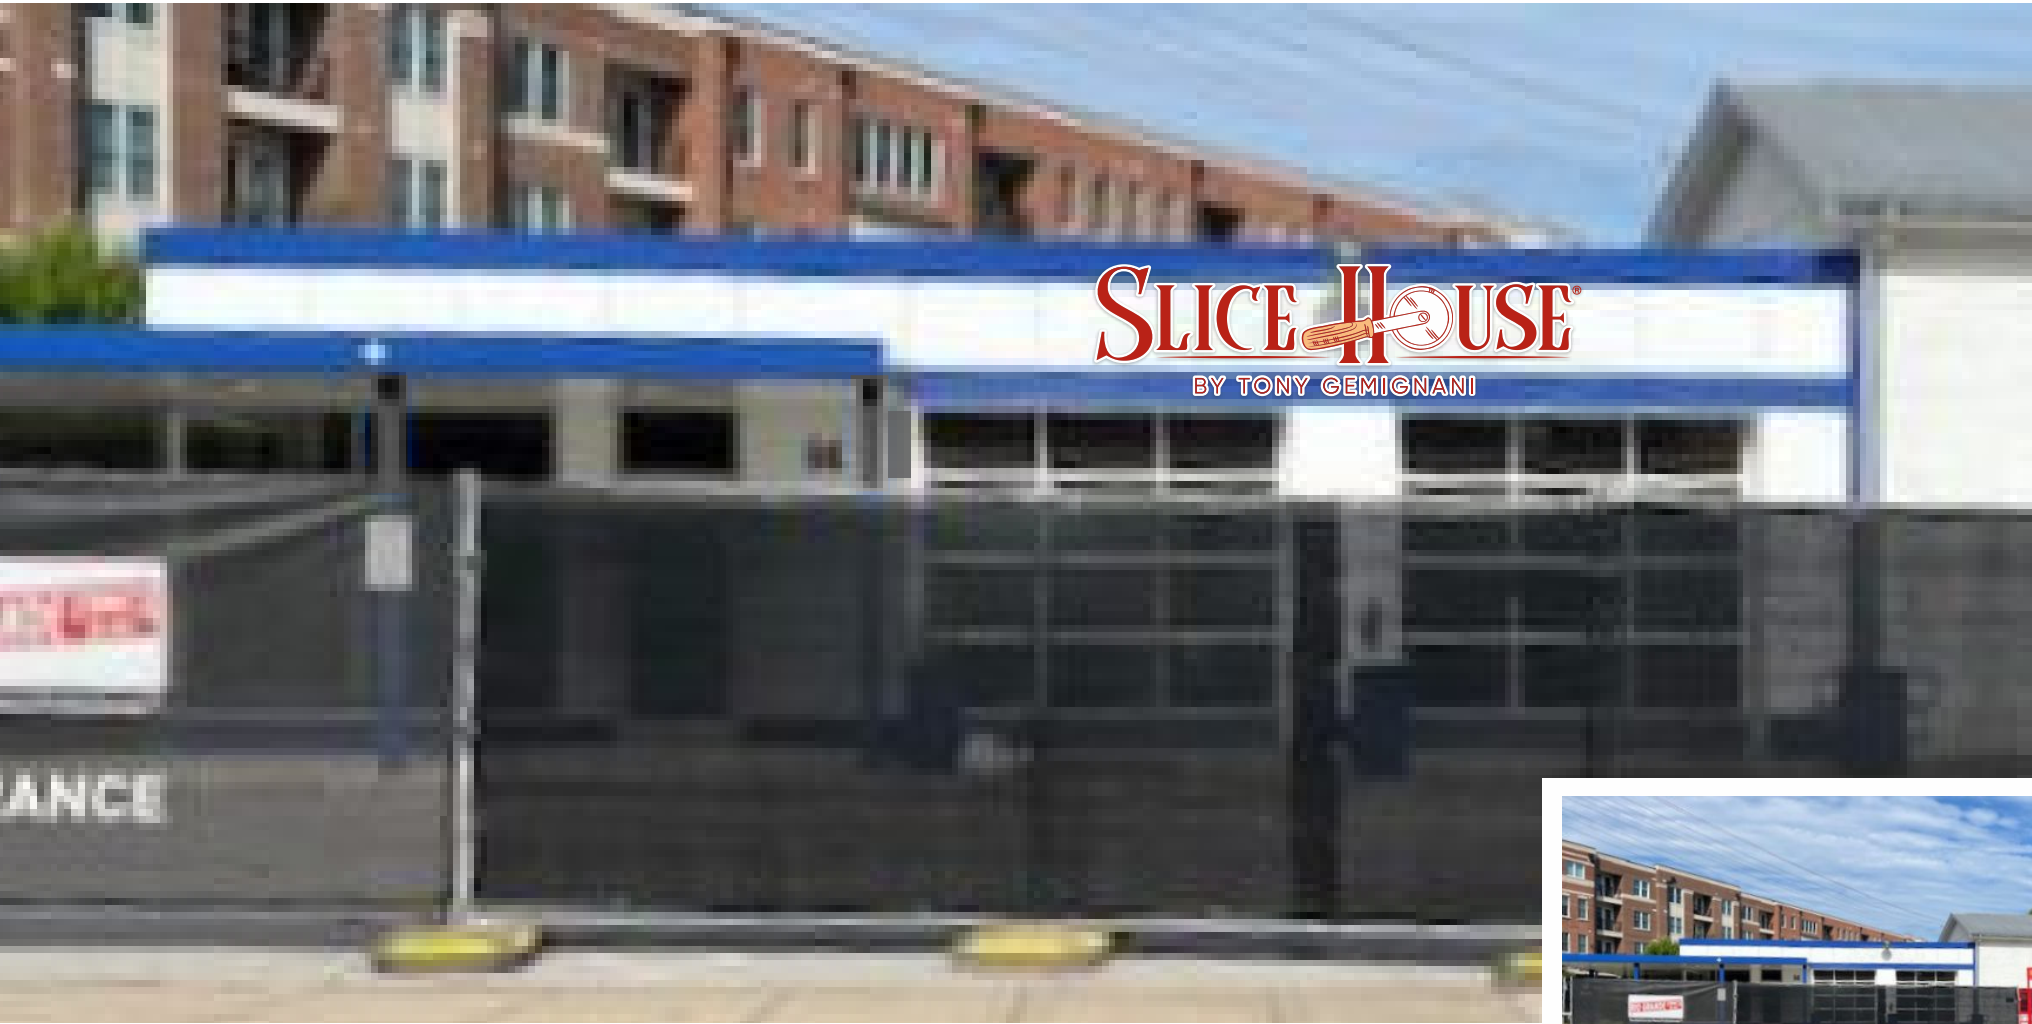
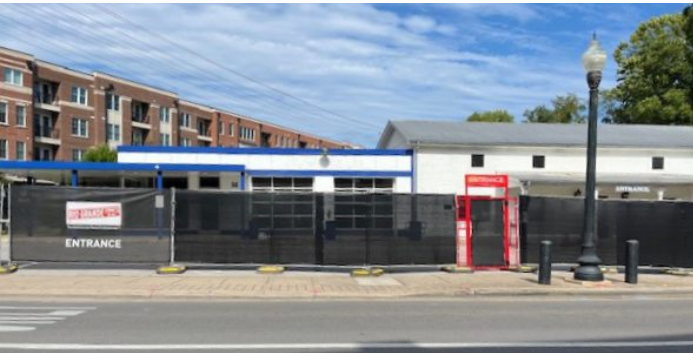
43.7 SQ FT

ONE (1)  
**PLATE LETTERS**

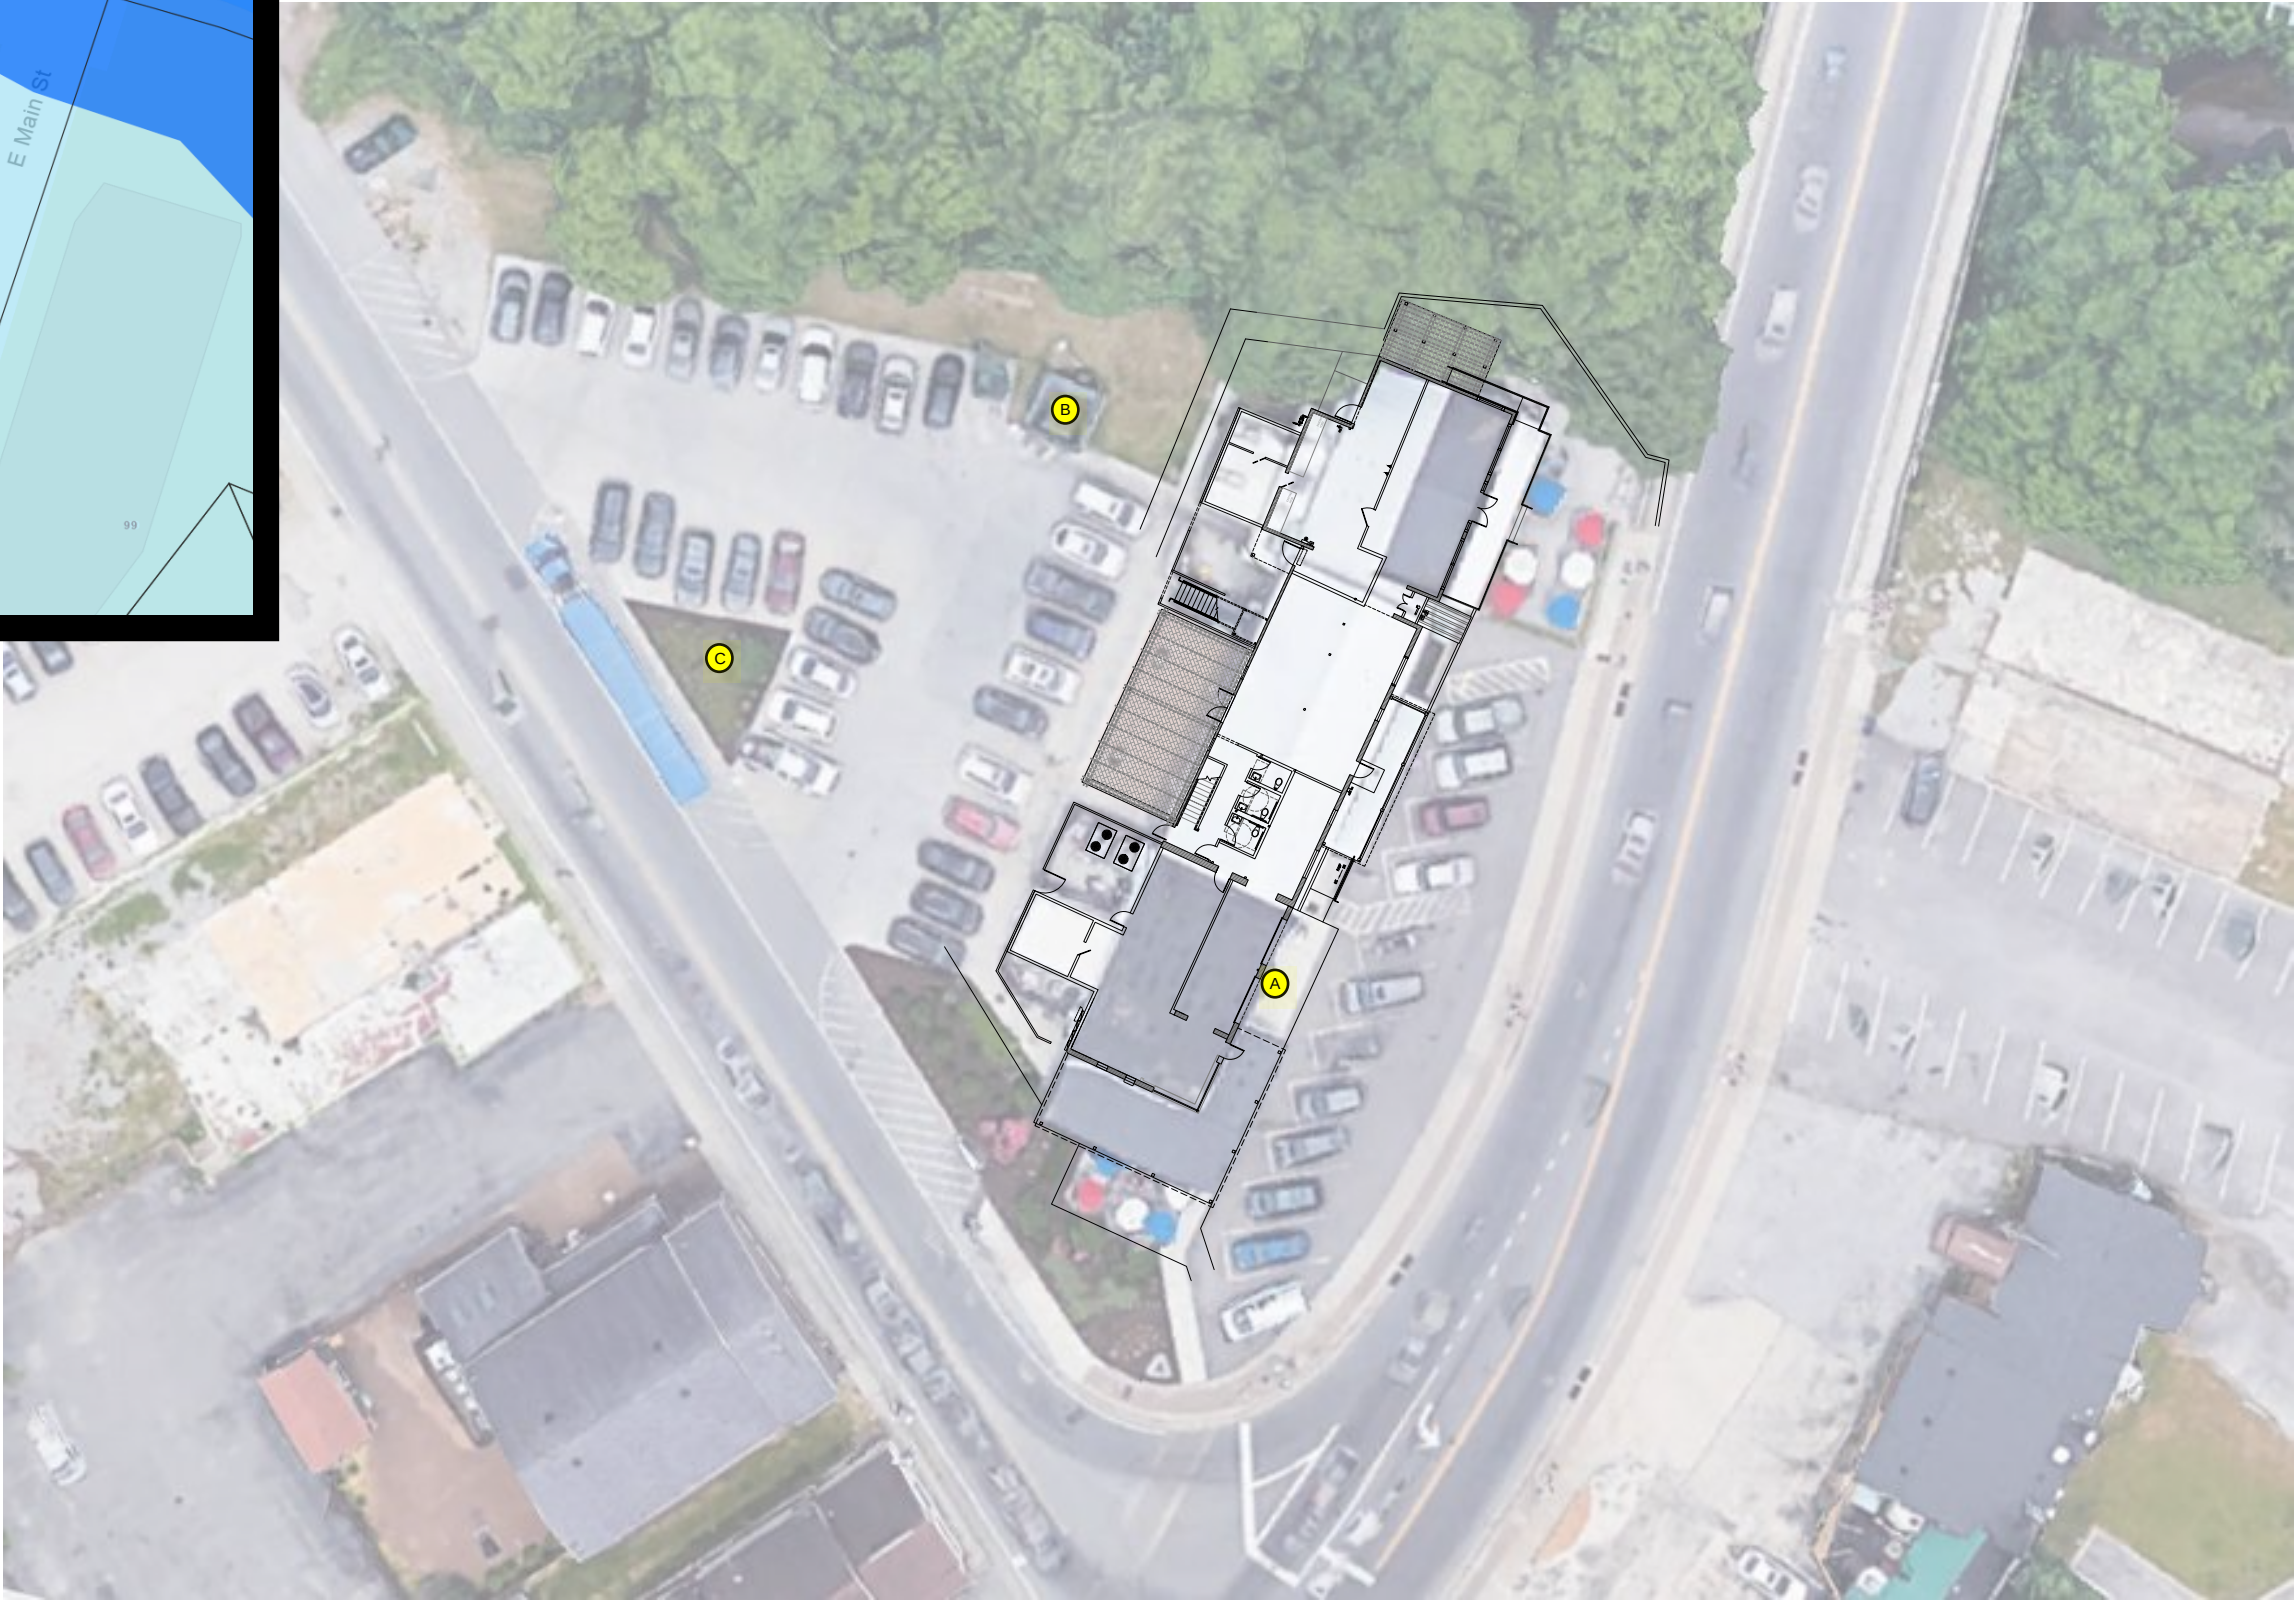
- PROPOSED MODIFICATIONS:**
- A. NEW TENANT SIGNAGE WITH STEM-MOUNTED LIGHTING, SEE INCLUDED SIGN PACKAGE
  - B. EXISTING DUMPSTER ENCLASURE LOCATION. EXISTING ENCLASURE TO BE REMOVED.
  - C. NEW DUMPSTER PAD & ENCLOSURE. SEE ATTACHED DETAILS.

**PROPOSED**

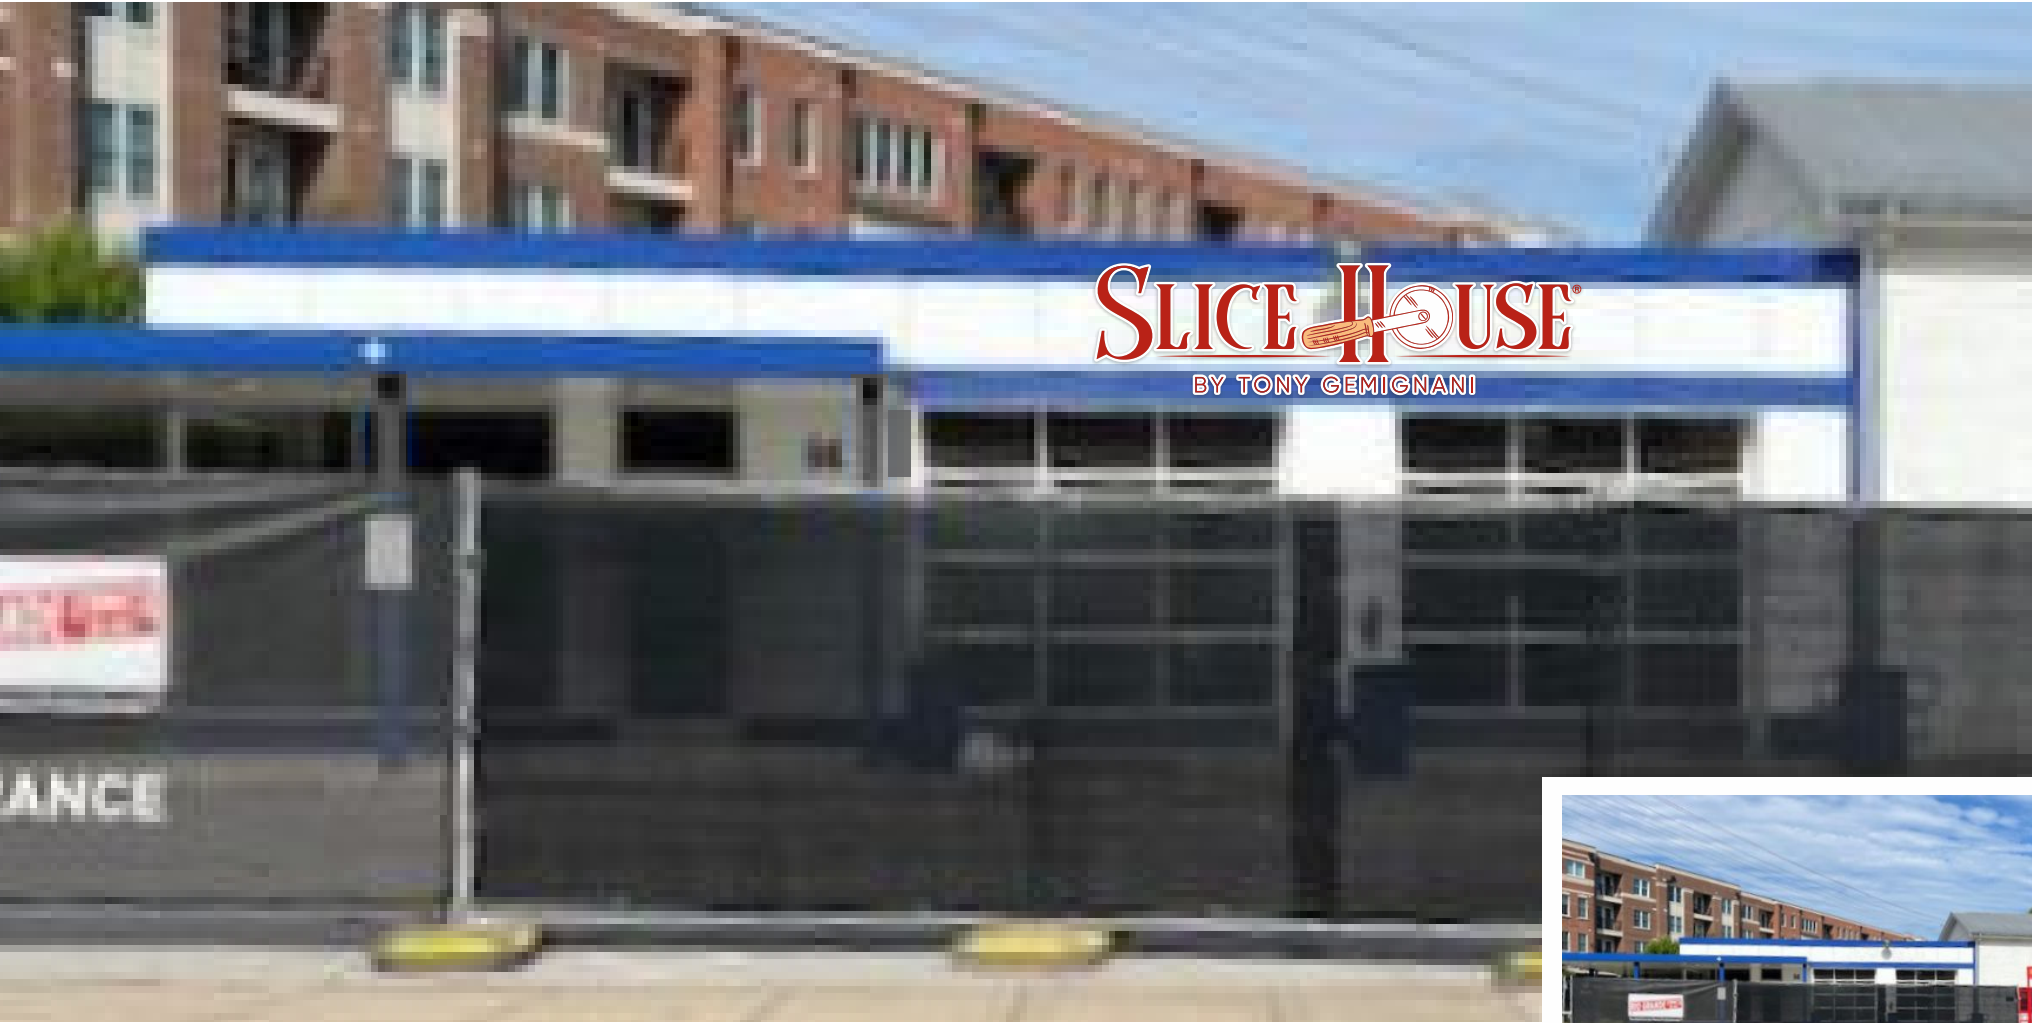
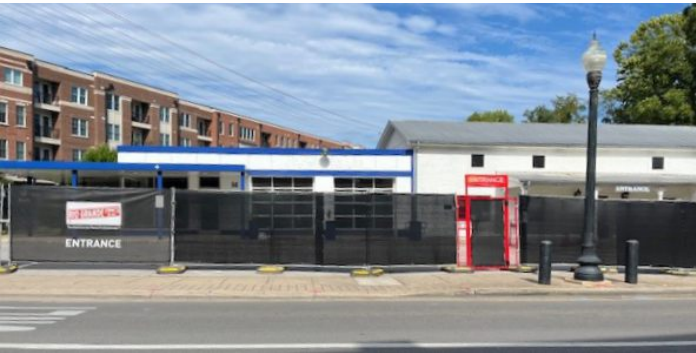
43.7 SQ FT

ONE (1)  
**PLATE LETTERS**

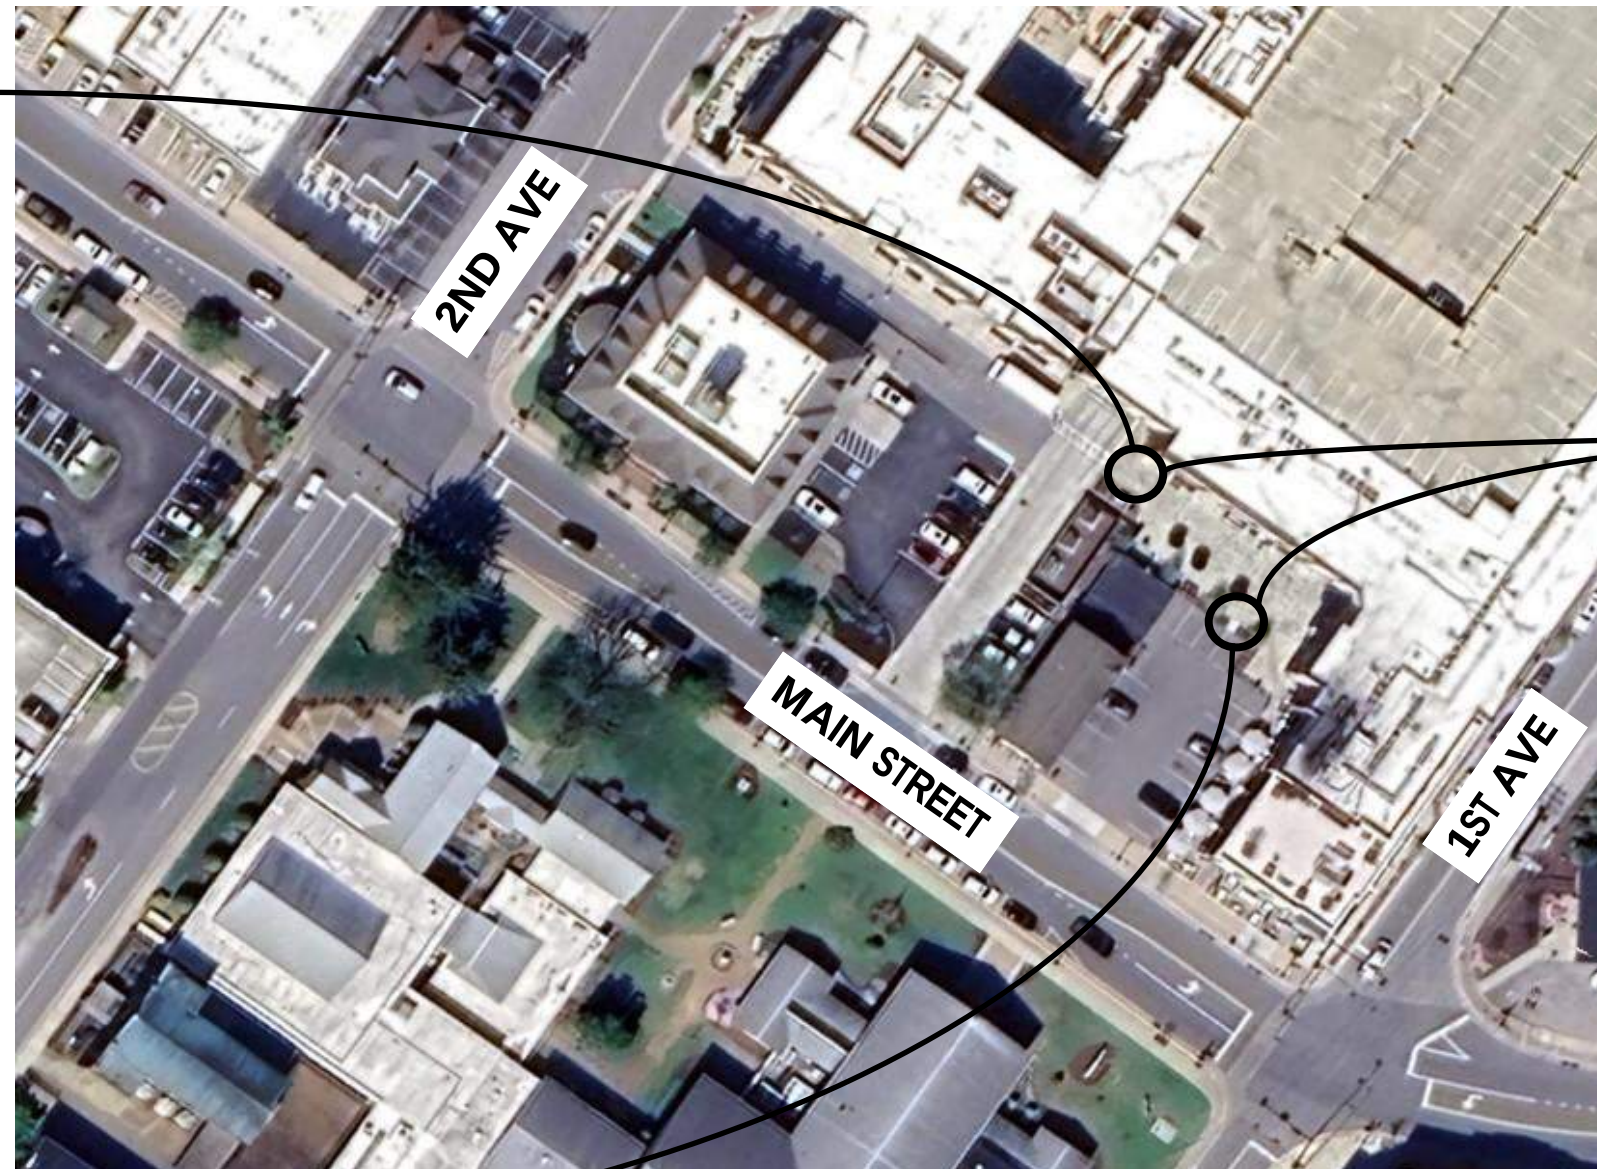
LOCATION OF EXISTING PILLARS AND  
NEW PROPOSED METAL ARCHWAY

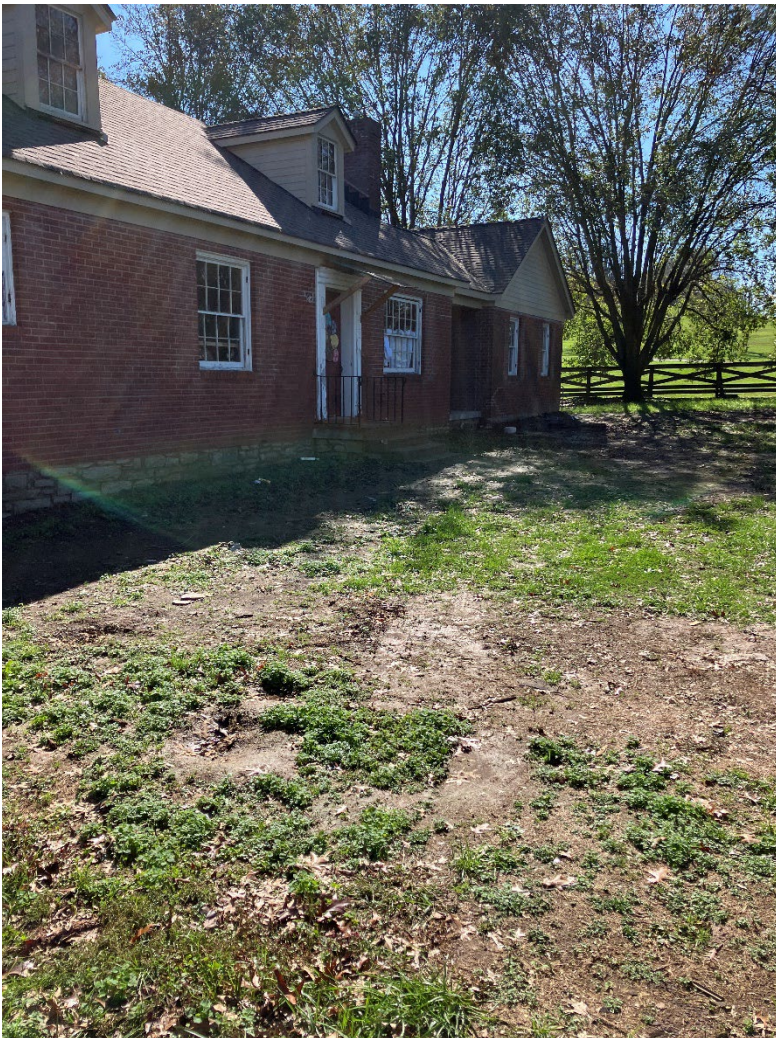
CLOSE UP VIEW OF WALKWAY &  
TERRACE LOCATION

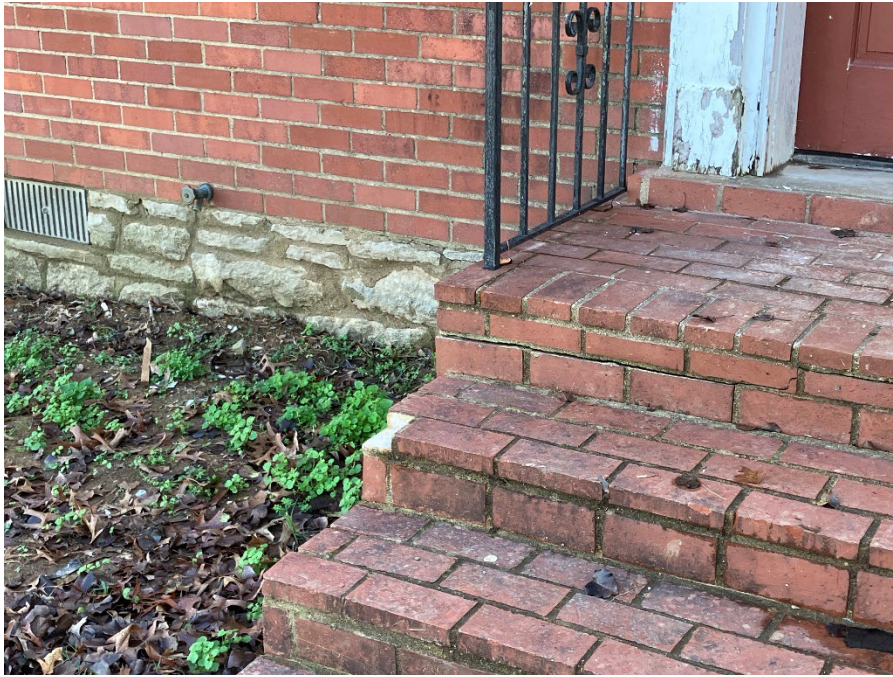
VIEW OF EXISTING  
LIMESTONE  
FOUNDATION

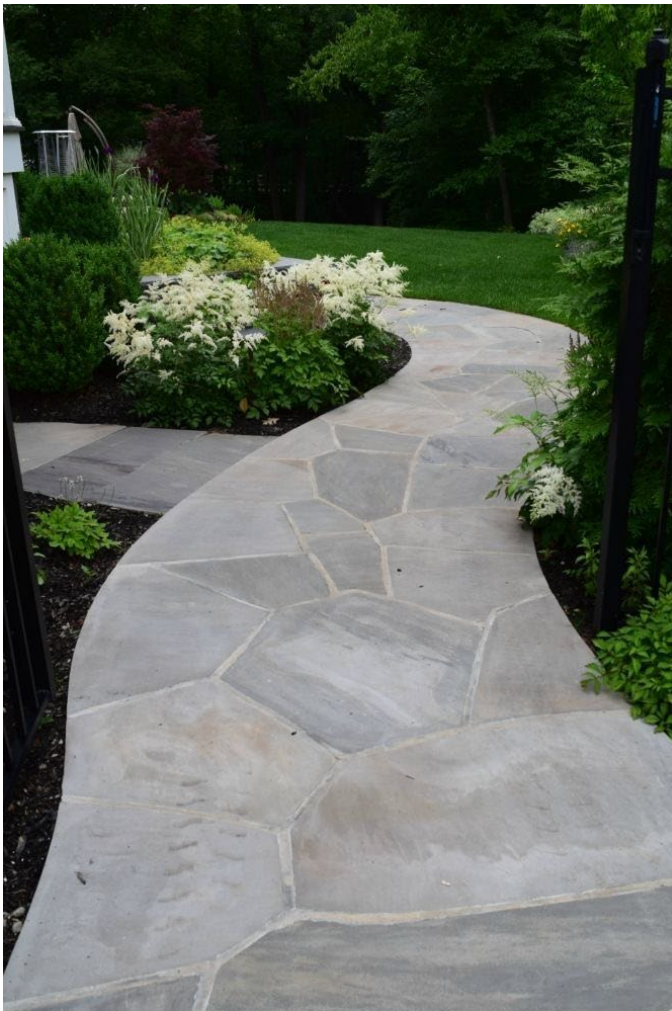
IRREGULAR BREAK  
SANDSTONE SAMPLE FOR  
WALKWAY & TERRACE

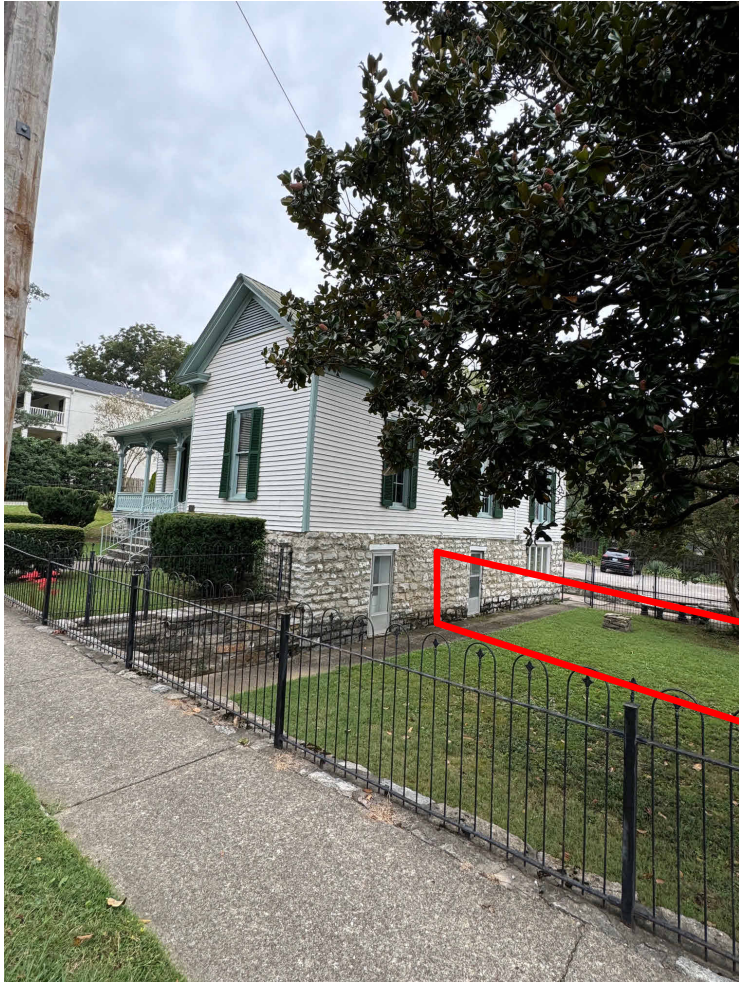
ADD PRIVACY FENCE TO SIDE YARD:  
-DISCUSS MATERIALS  
-DISCUSS HEIGHT

RELOCATE HVAC SYSTEMS  
-DISCUSS LOCATION

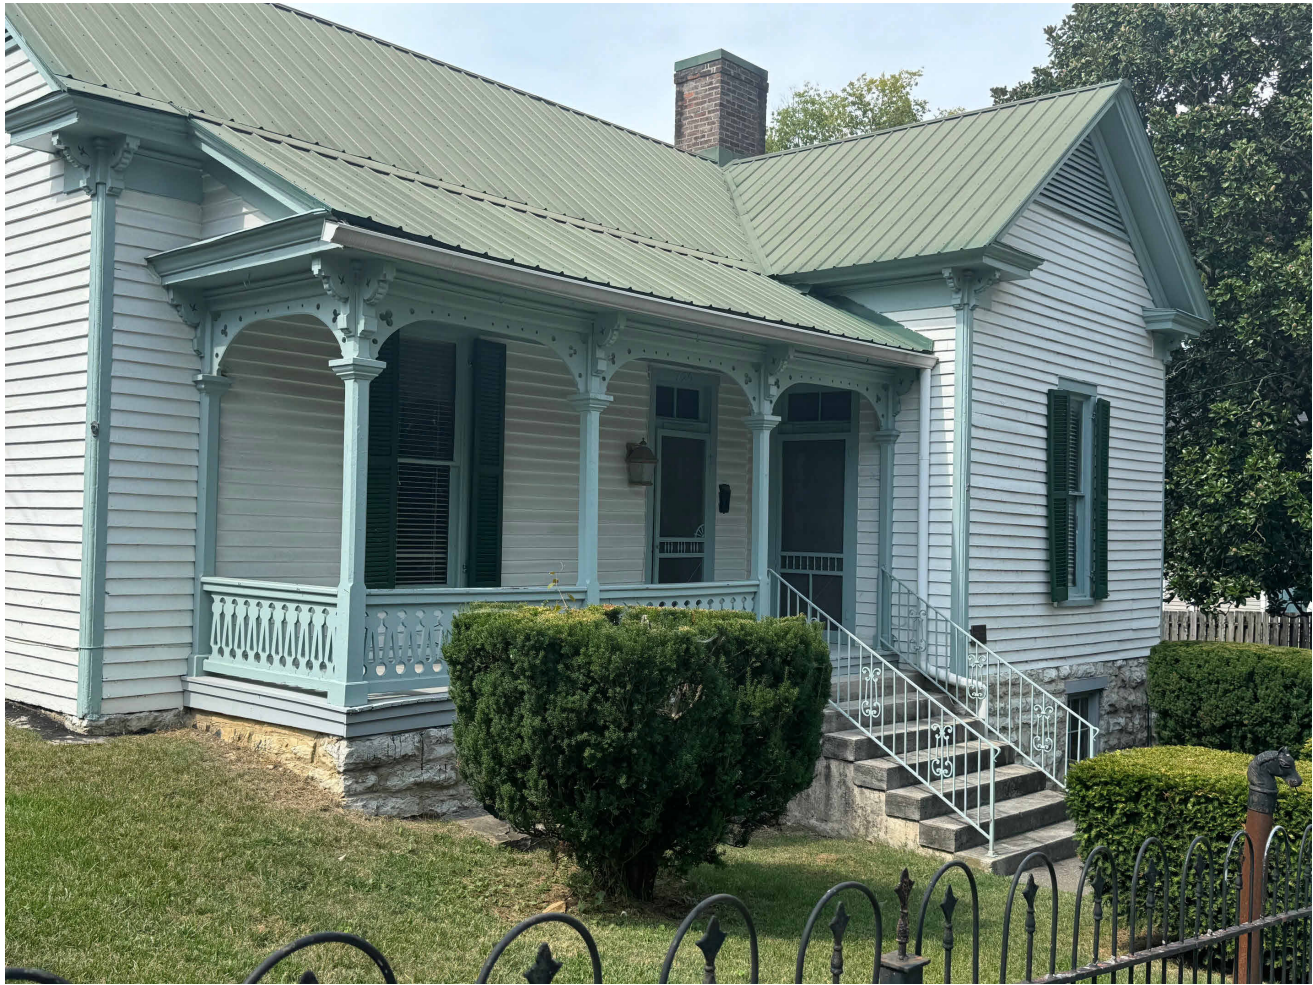
REWORK FRONT STAIR RAILINGS TO MATCH PORCH  
-DISCUSS MATERIALS OF STAIRS  
-SIMILAR TO IT'S SISTER HOUSE ON FAIR STREET

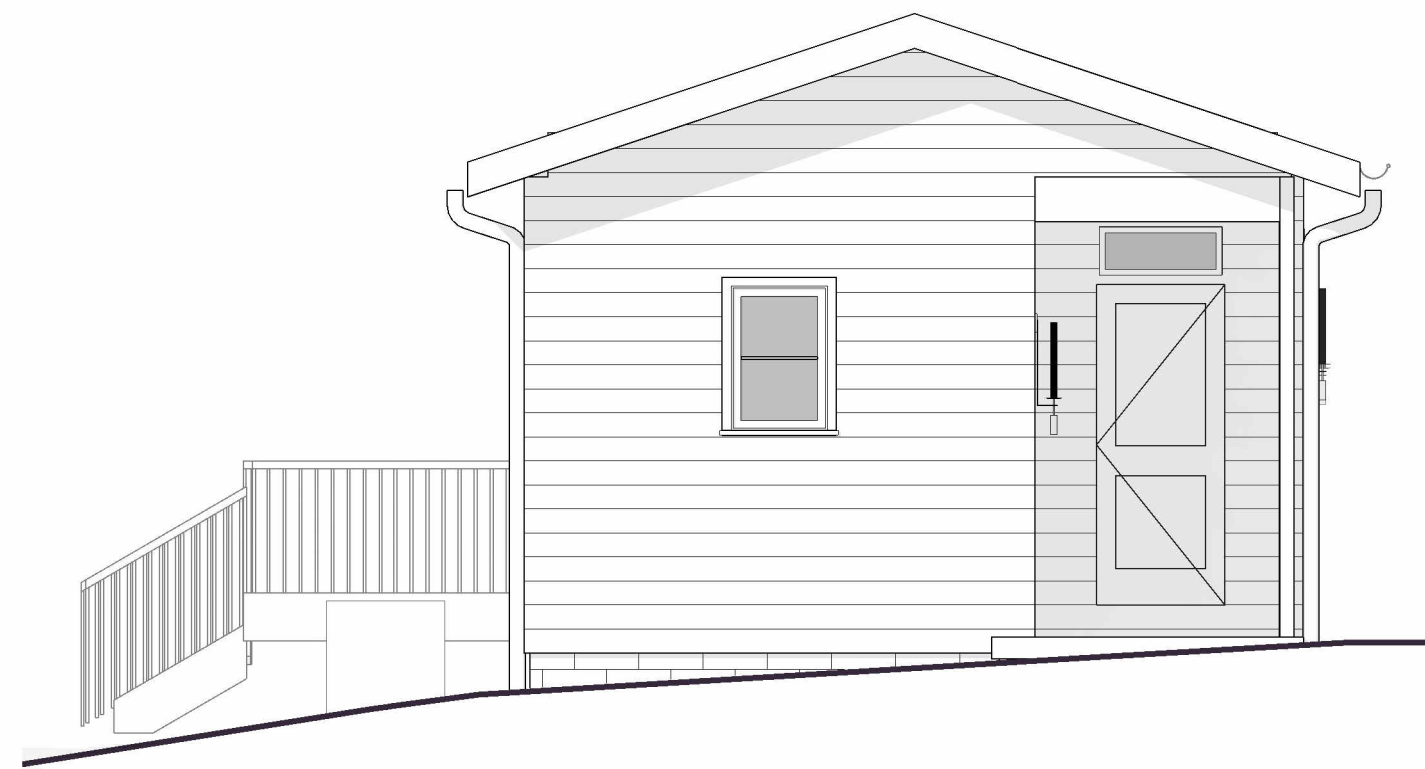
3 EXISTING POOL HOUSE - 3D

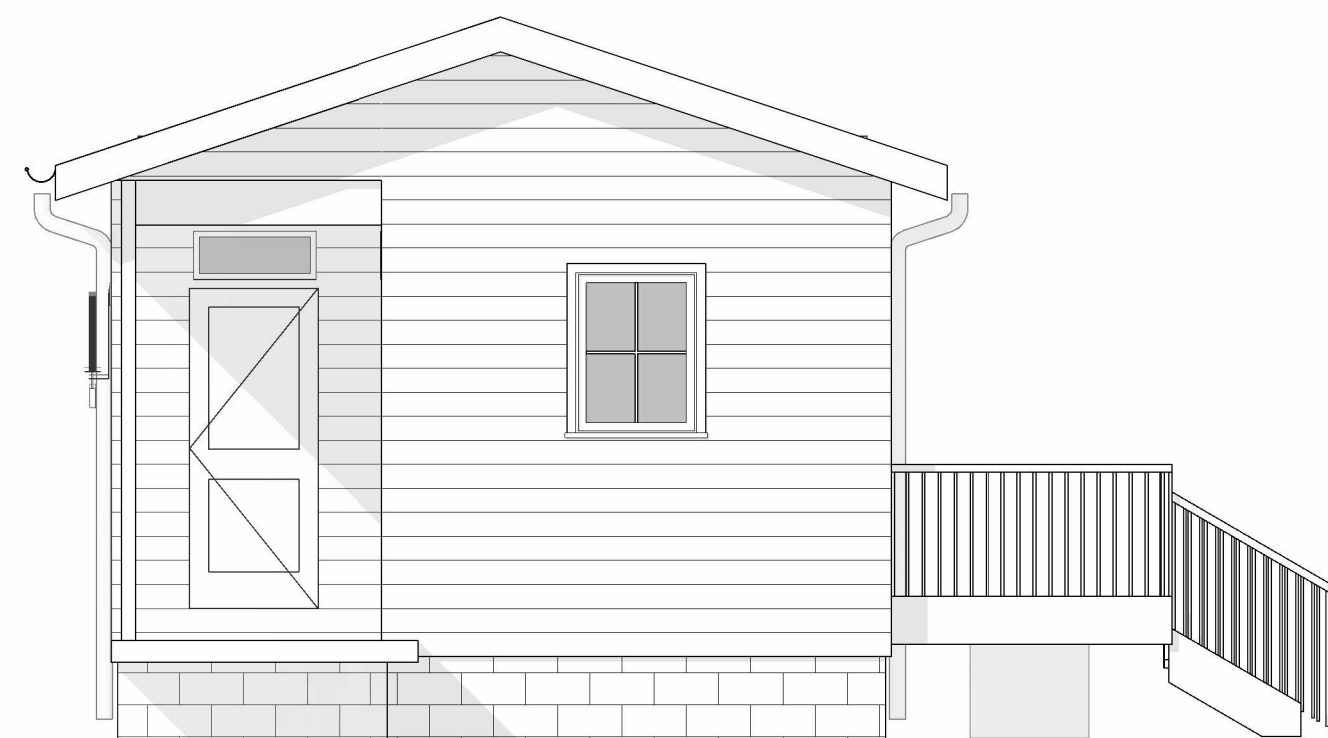
1b EXIST. EXT. ELEVATION - EAST  
1/4" = 1'-0"
