## Meeting Agenda

### Design Review Committee

1. Discussion Of Alterations (Loading Dock) At 252 5th Ave. N.; Sam Johnson, Applicant.
2. Discussion Of Fencing (Rear Yard) And Vehicular Gate At 112 Lewisburg Ave.; Jennifer Lombard, Applicant.
3. Discussion Of Signage And Alterations (Refuse Enclosure) At 94-98 E. Main St.; Mark Kozevski, Applicant.

4. Discussion Of Alterations (Courtyard) At 159 1st Avenue N.; Brandon Priddy, Applicant.
5. Discussion Of Site Alterations At 328 Franklin Rd.; Linda Childs, Applicant.
6. Discussion Of Alterations (Site Alterations) And Additions (Principal And Accessory) At 720 W. Main St.; Amanda McCreary, Applicant.
7. Discussion Of An Addition (Accessory Structure) And Site Alterations At 1303 Adams St.; Zachary Correa, Applicant.
8. Discussion of Preliminary Historic Zoning Commission Recommendation For A Proposed Hotel, Parking Structure, And Partial Demolition At 230 Franklin Rd. (The Factory); Greg Gamble, Applicant.

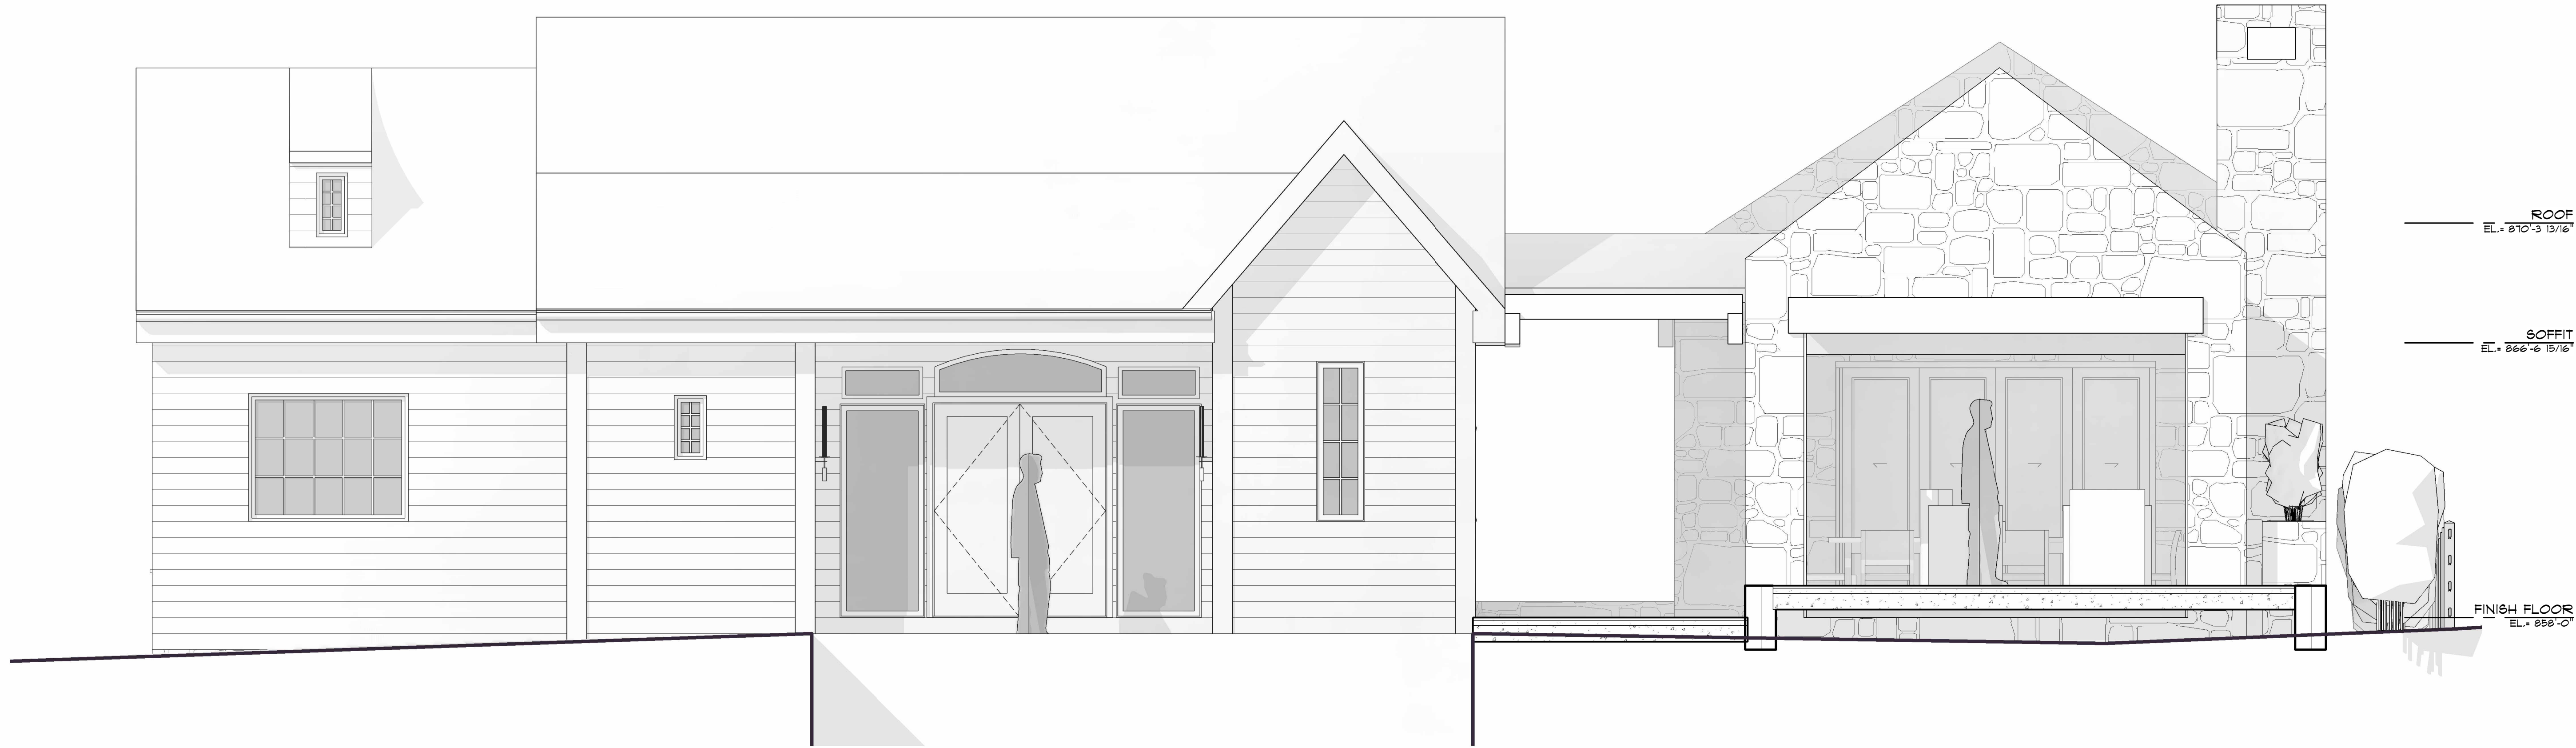
2 WEST EXTERIOR ELEVATION  
3/8" = 1'-0"

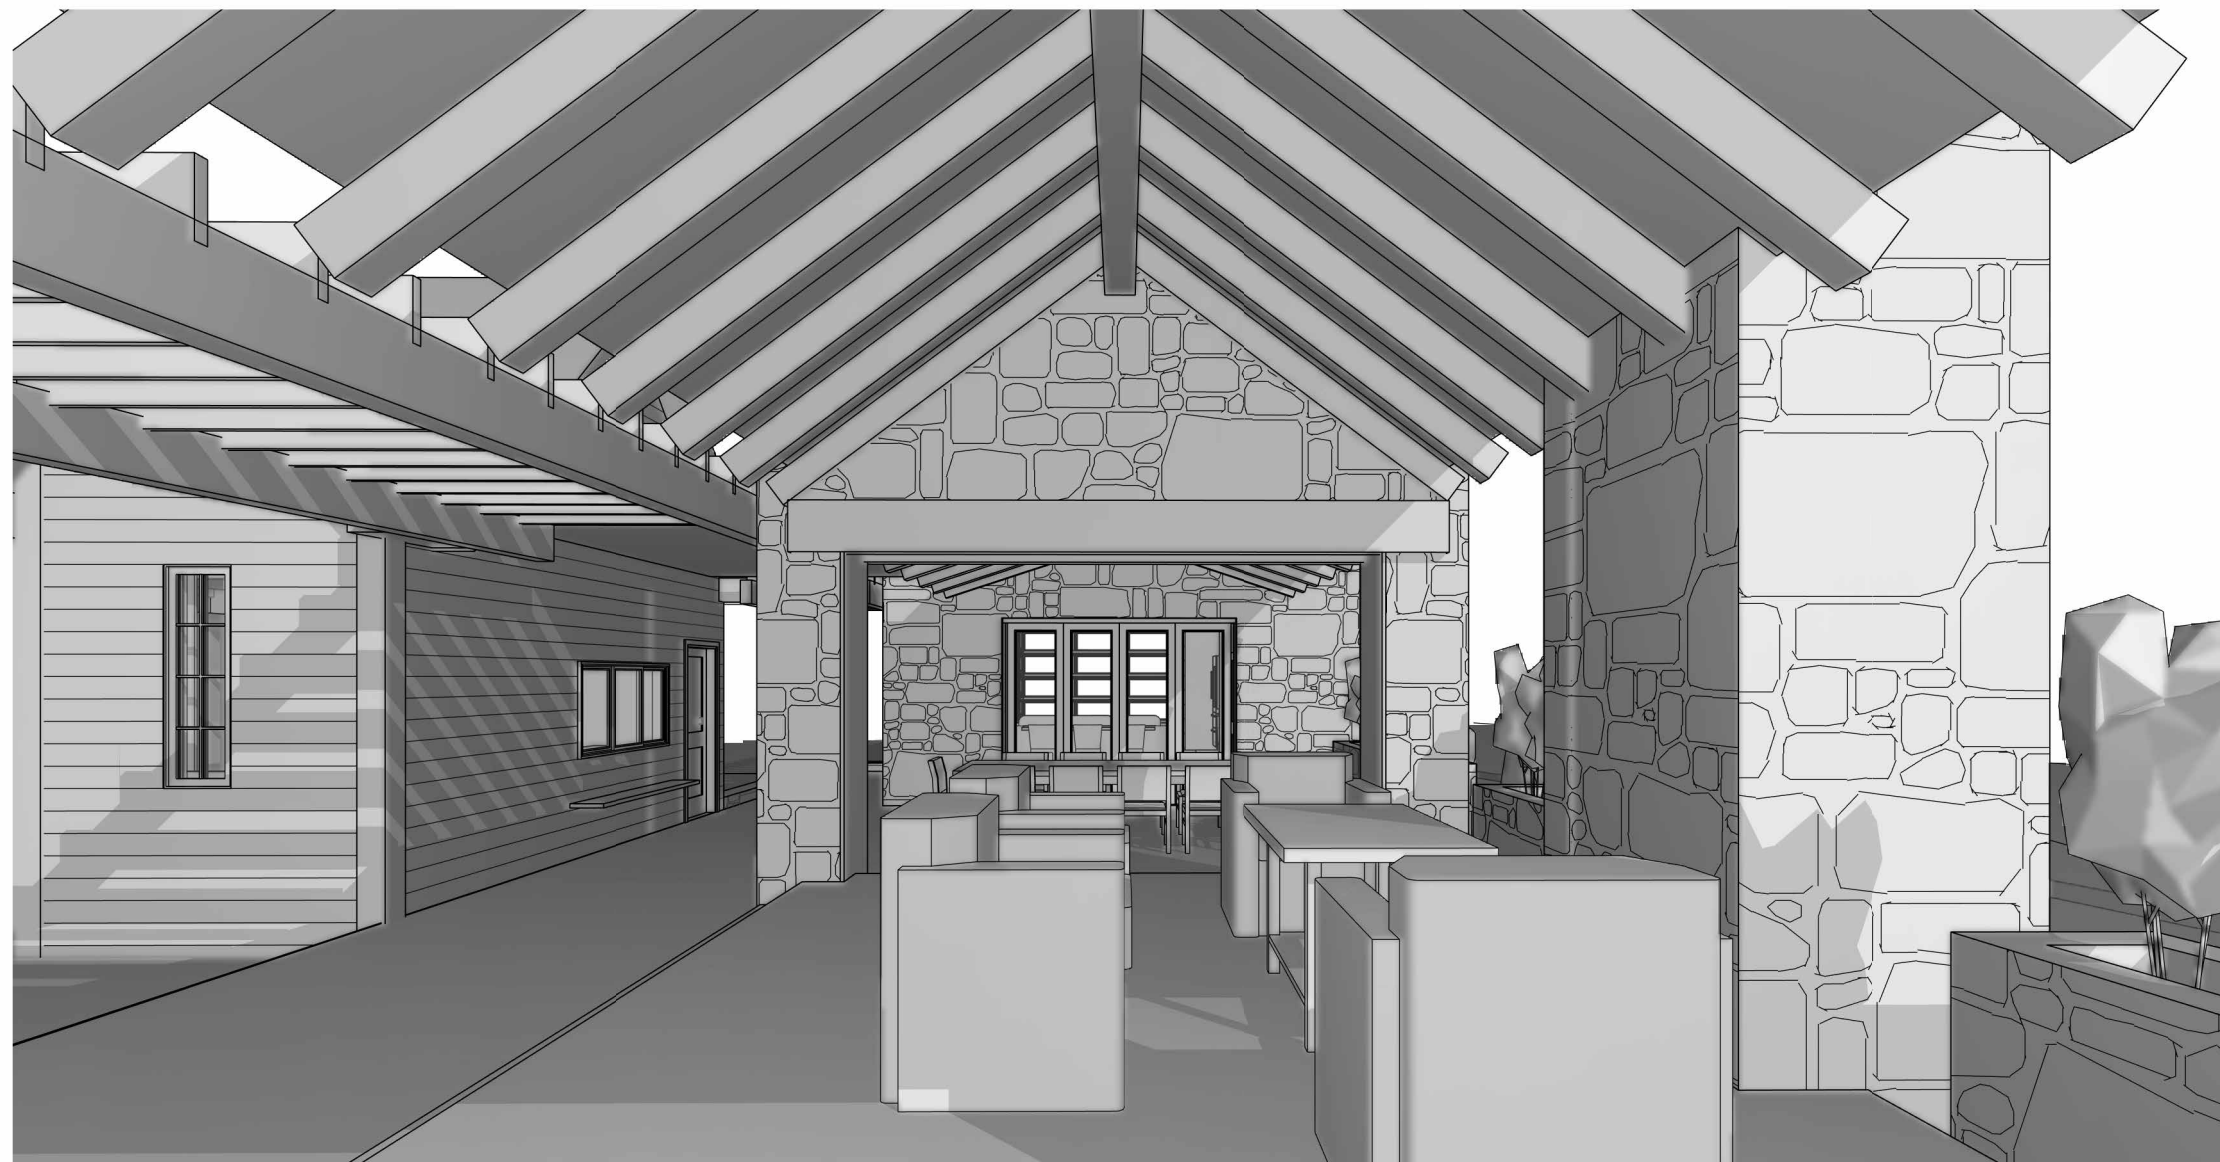
5 PAVILION INTER PERSPECTIVE

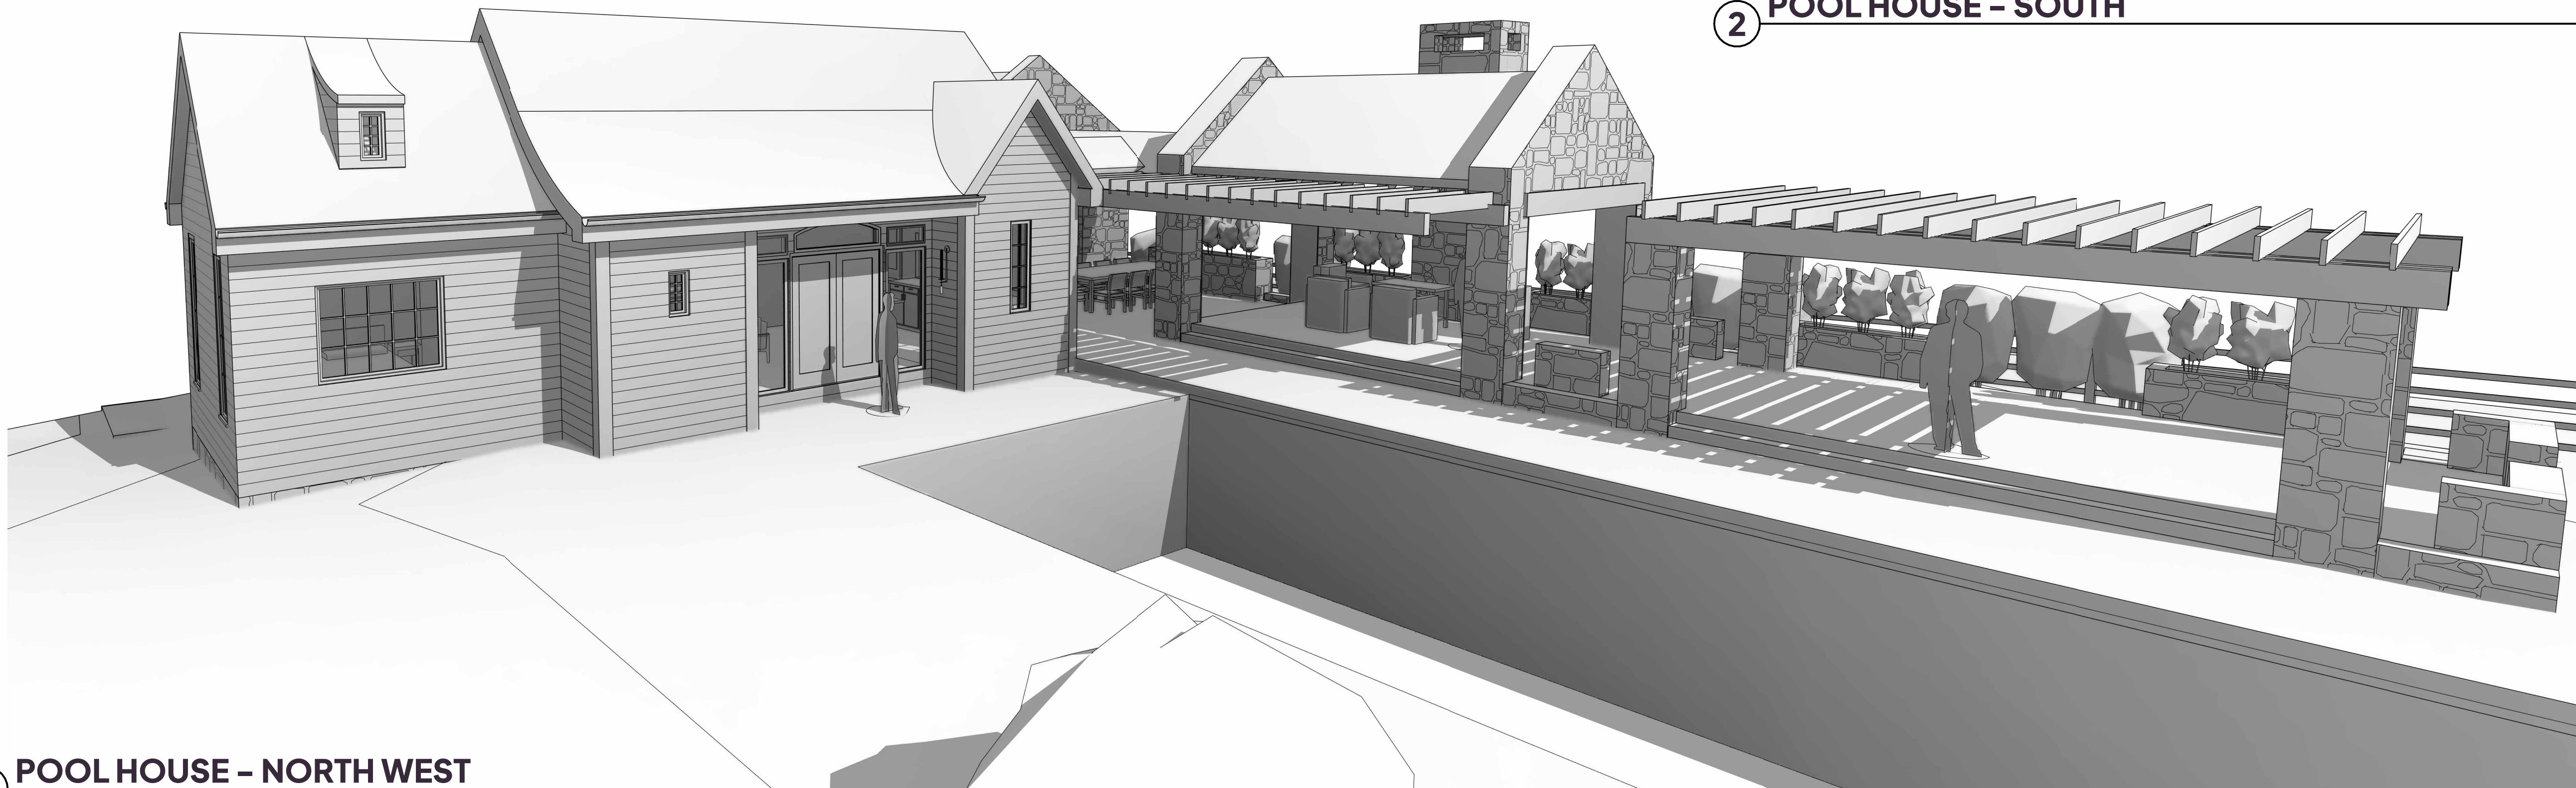
1 POOL HOUSE - NORTH WEST

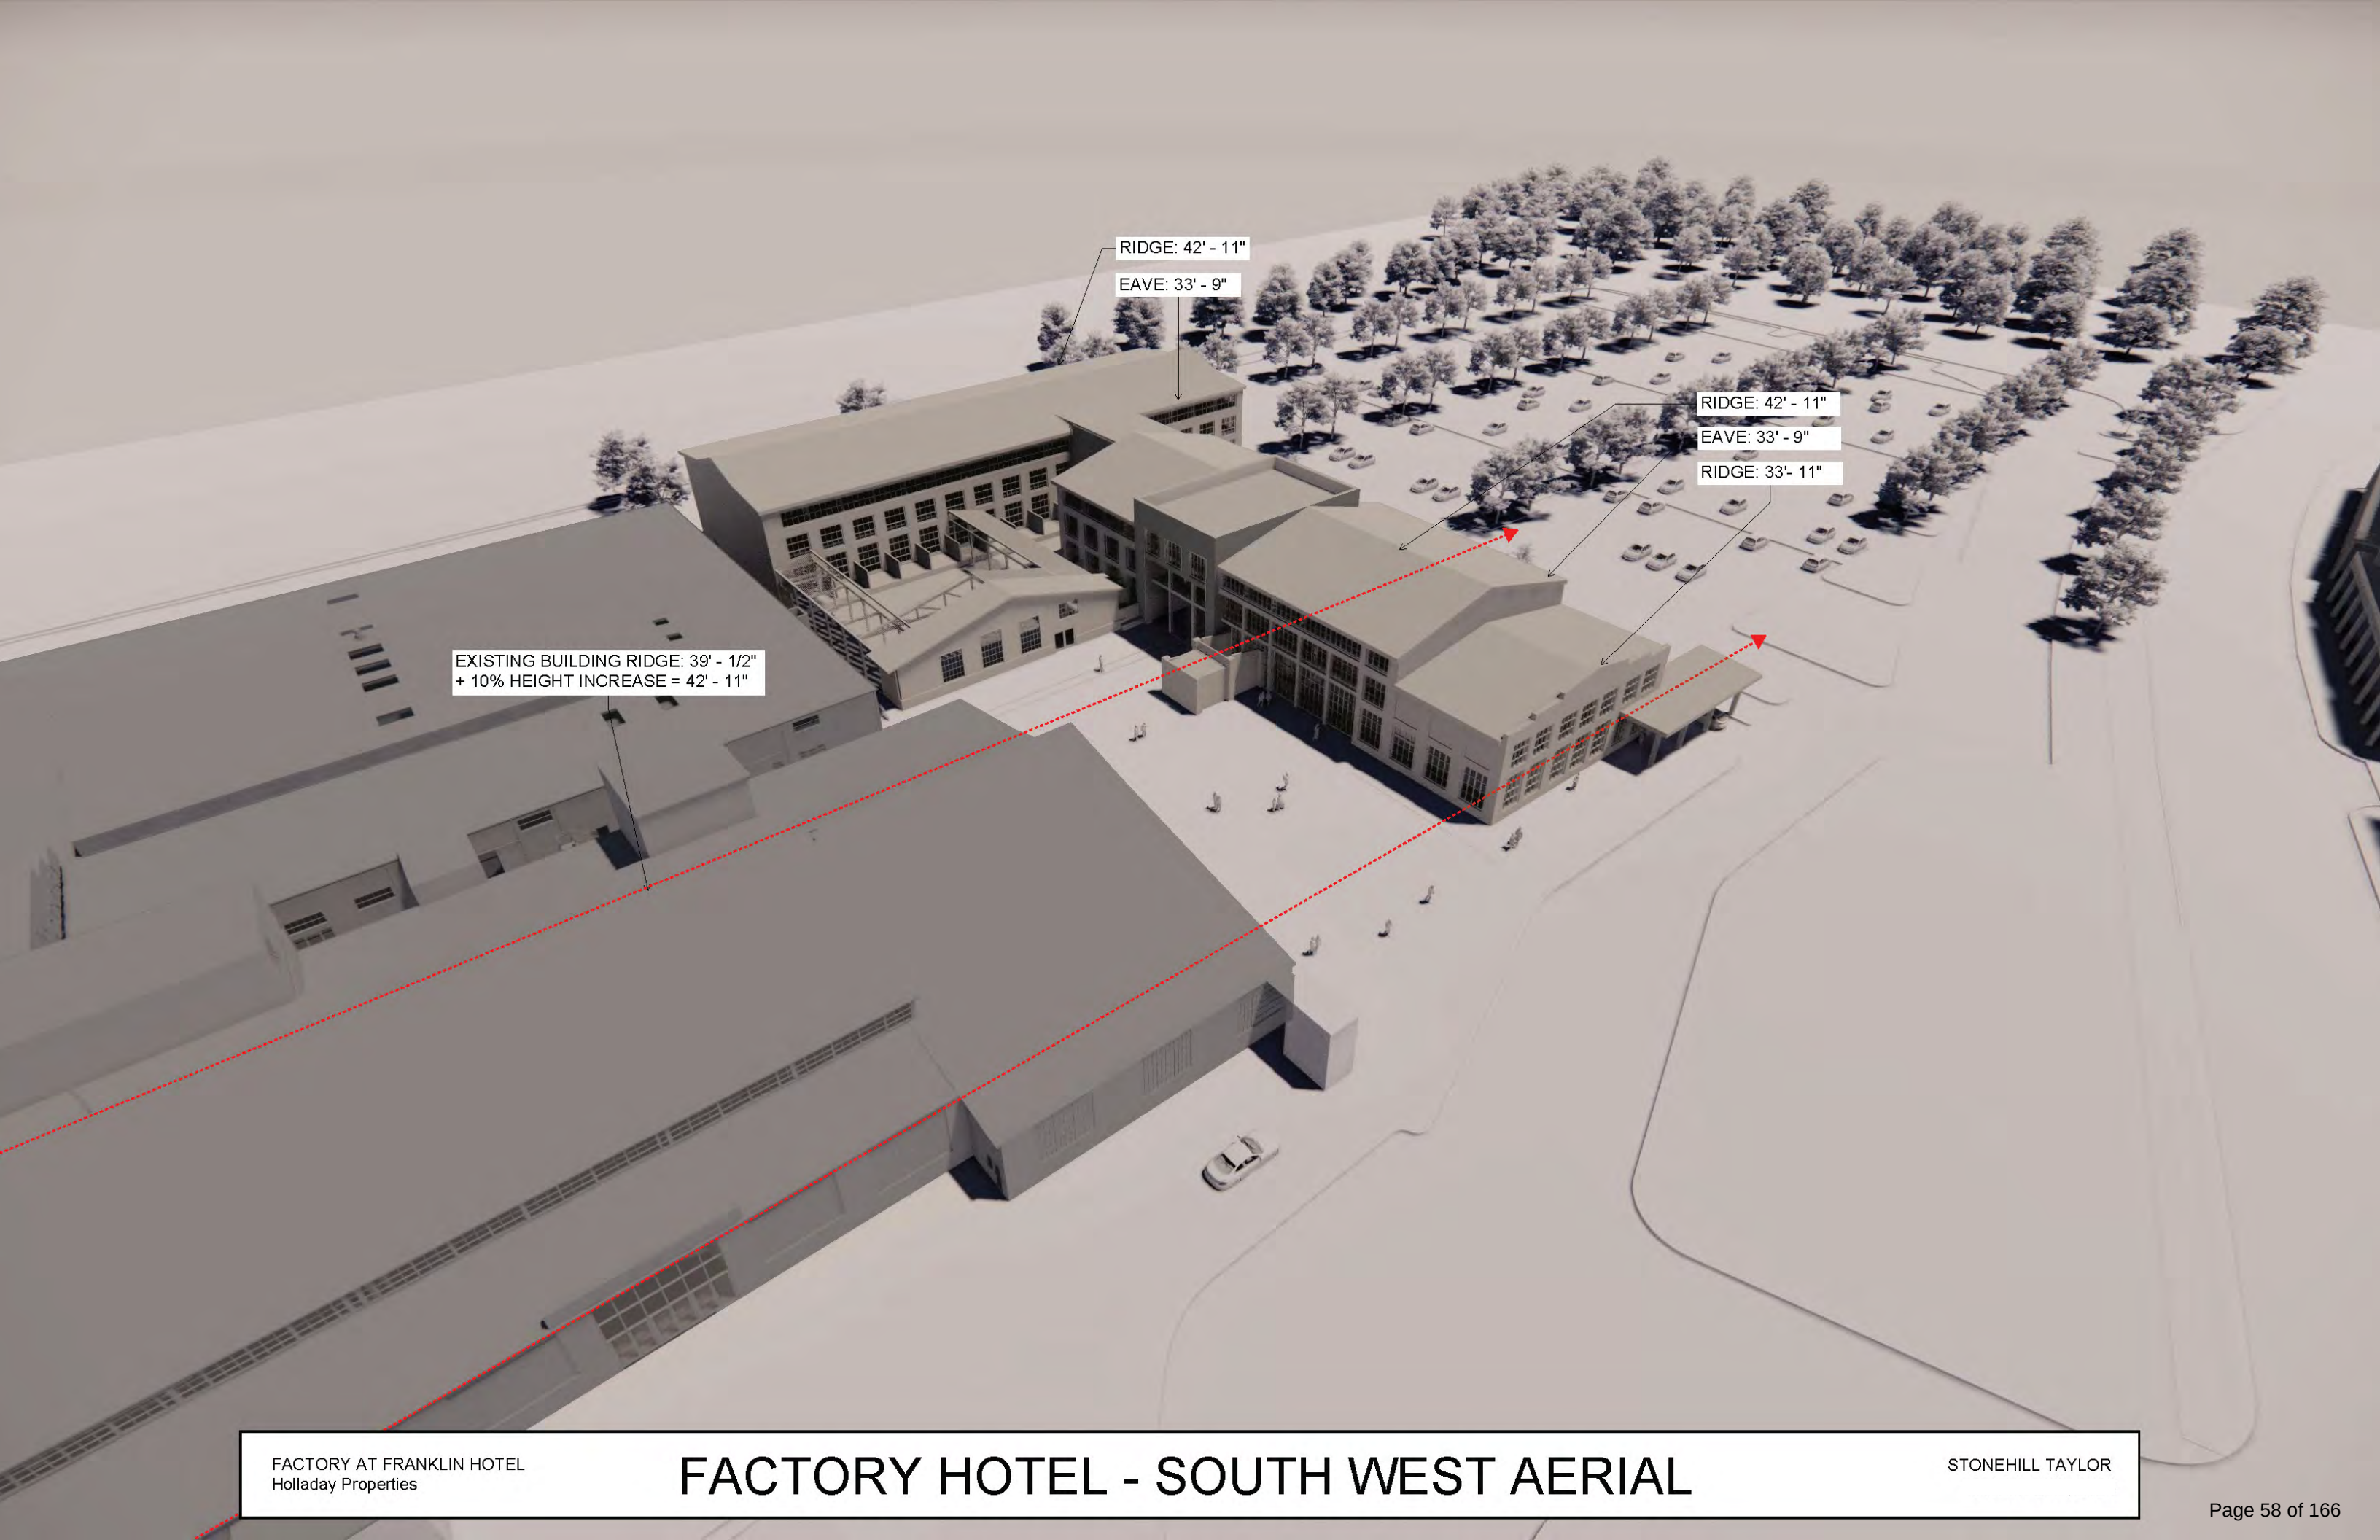
RIDGE: 42' - 11"

EAVE: 33' - 9"

RIDGE: 33' - 11"

EXISTING BUILDING RIDGE: 39' - 1/2"  
+ 10% HEIGHT INCREASE = 42' - 11"

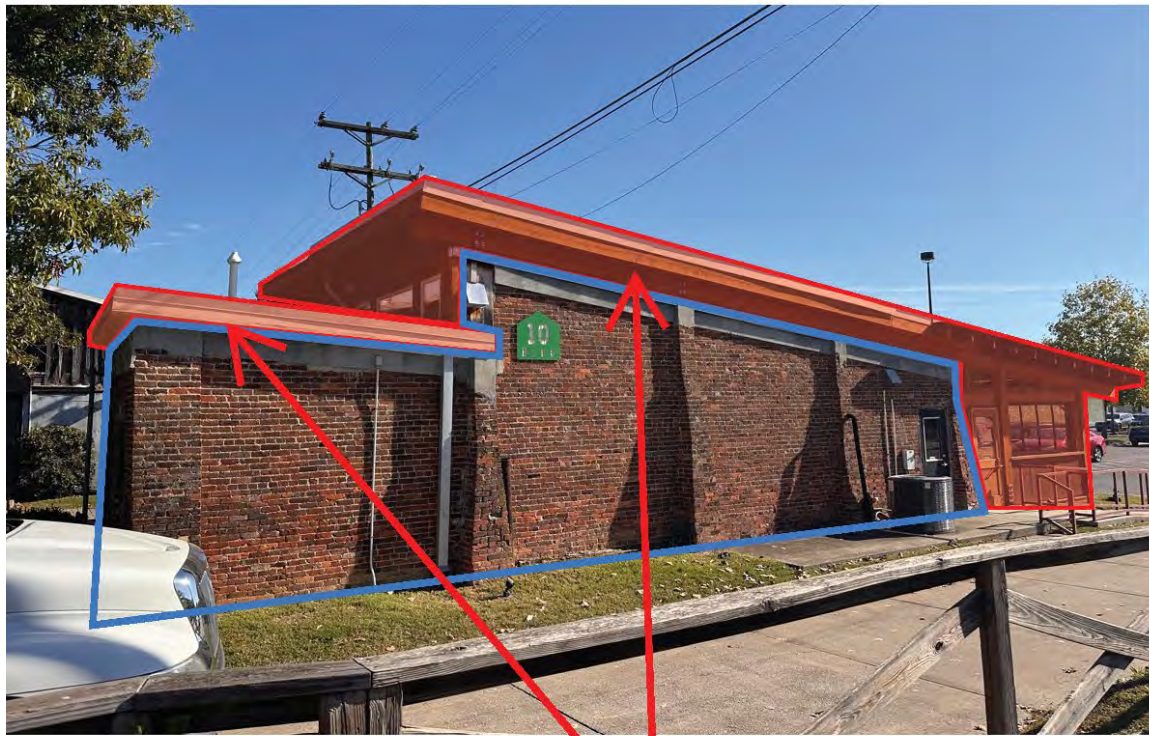
Current roof is contemporary & will be removed/replaced.

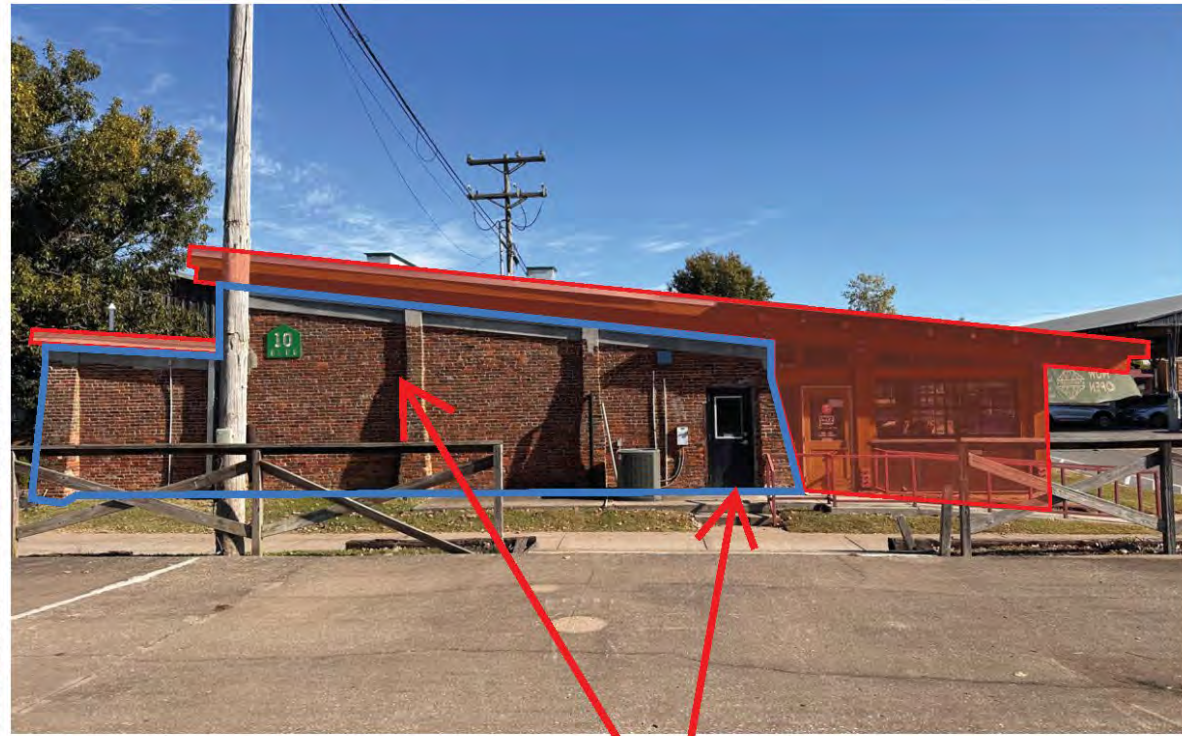
Brick & concrete wall/column coping to remain exposed/visible from within hotel lobby and courtyard. Existing door opening to remain.

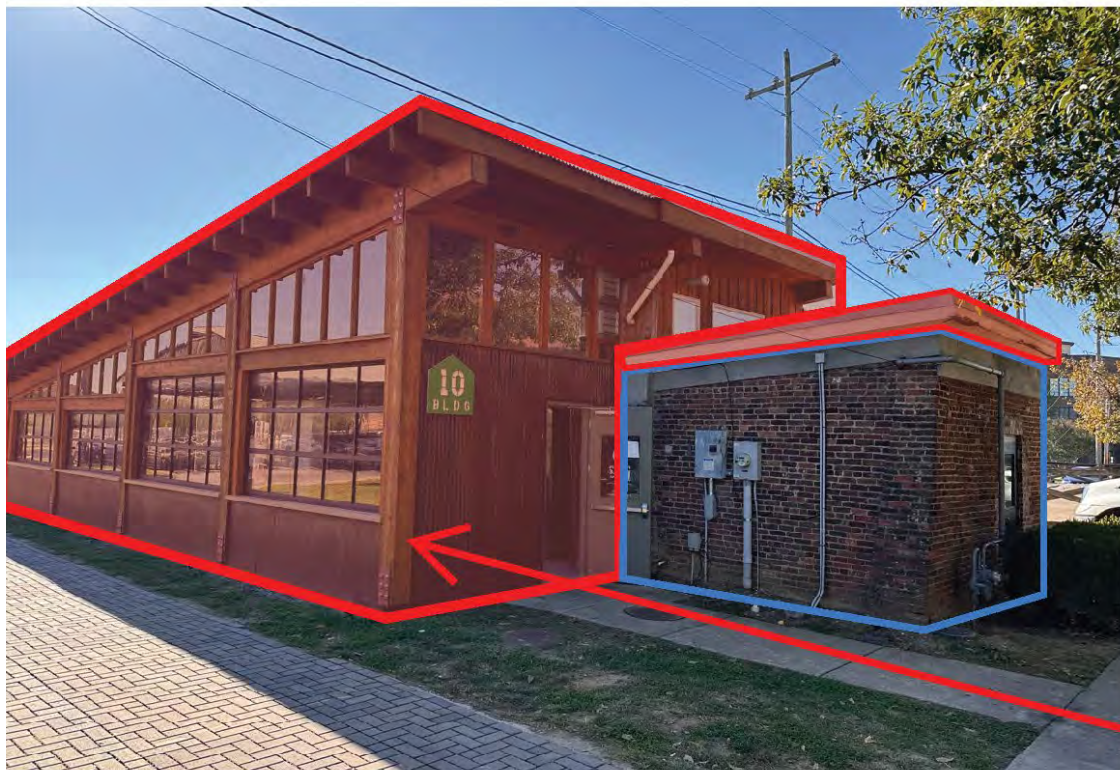
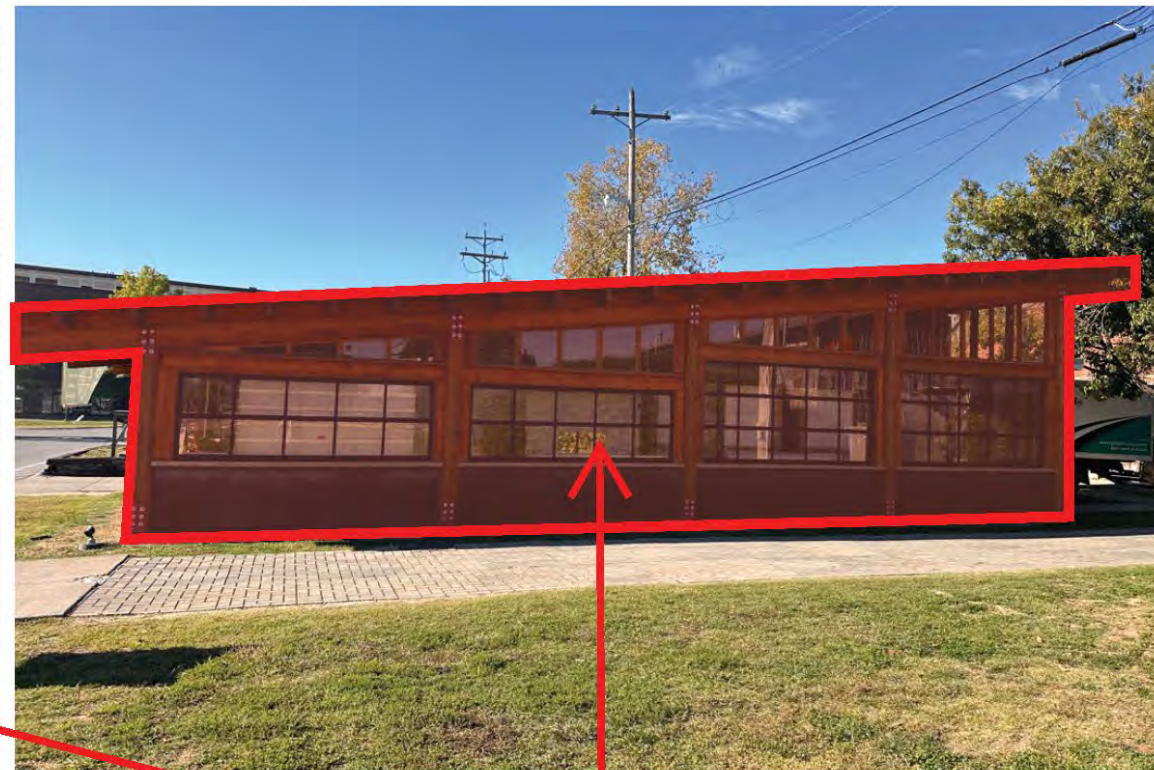
Historic building is not currently visible from the North, East, and West. Contemporary addition to be demolished.

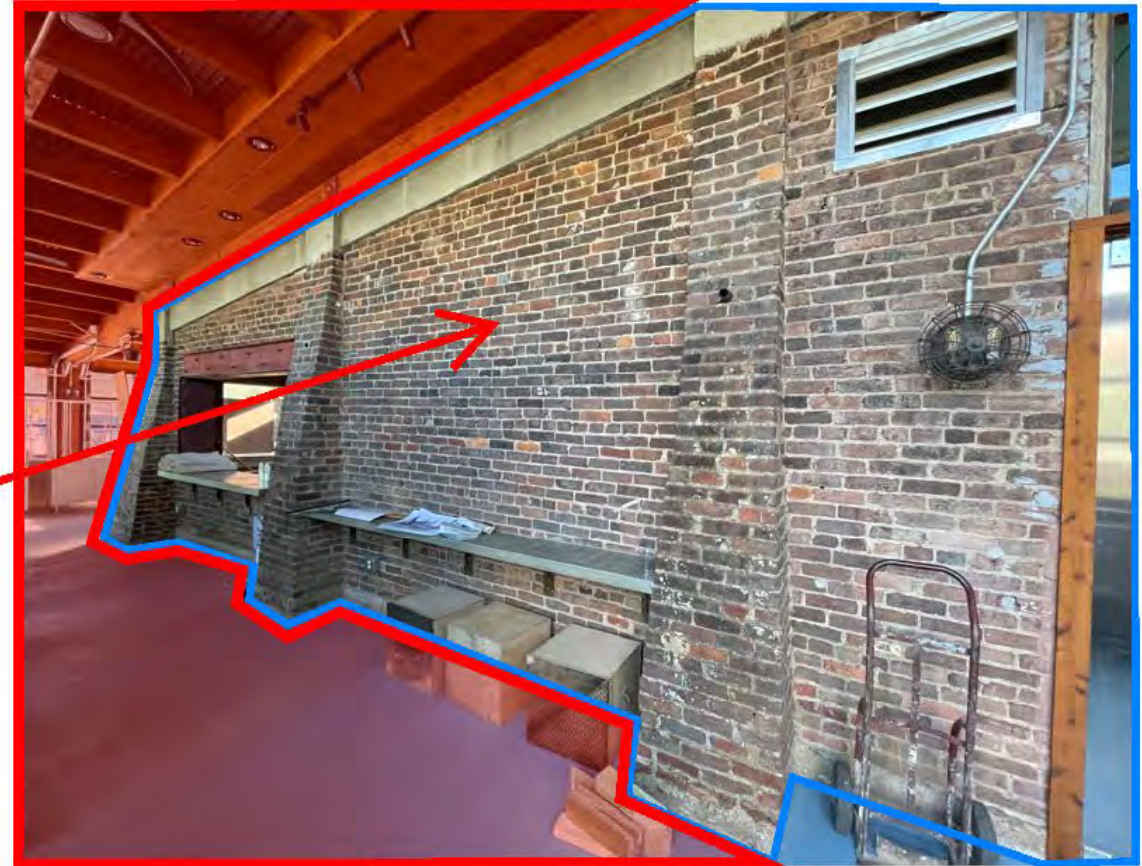
North & East facades are currently enclosed & hidden from public view. Contemporary addition will be removed to expose historic structure to pedestrian alley.

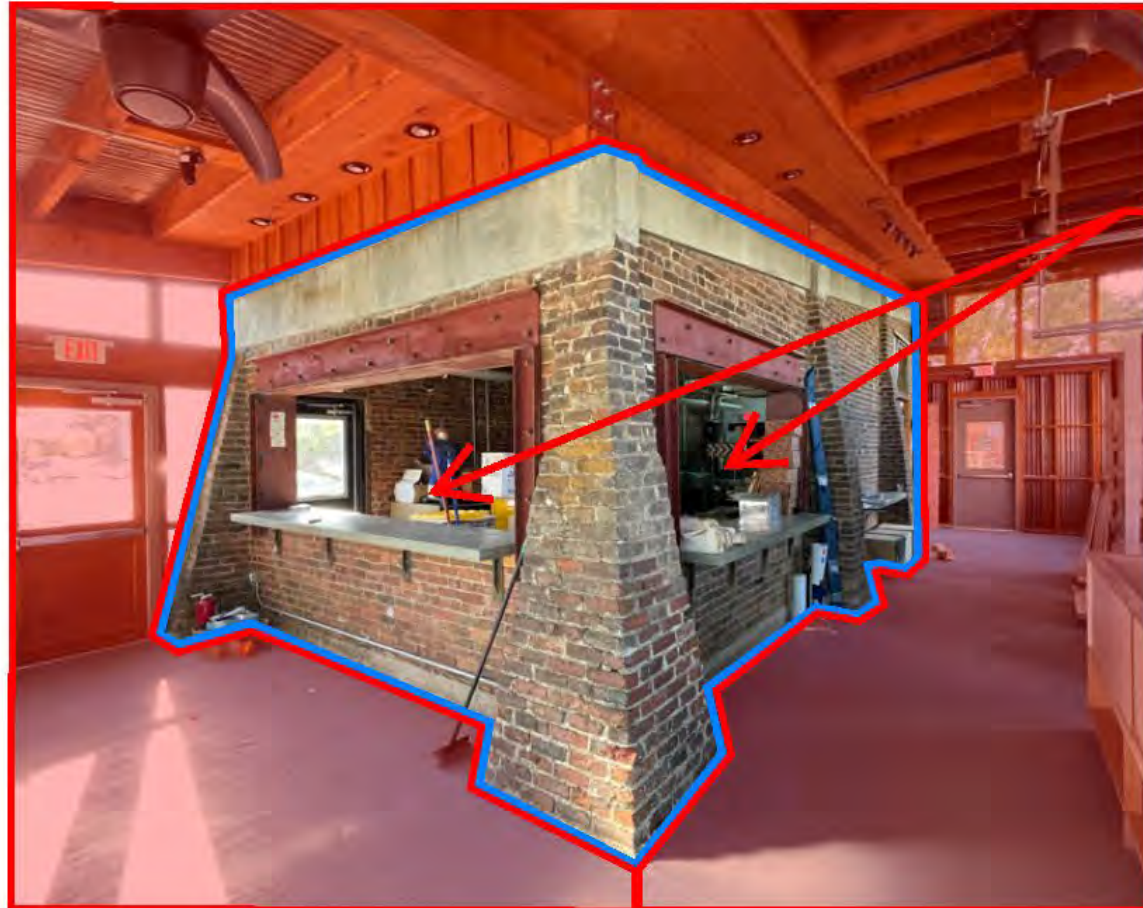
Existing guest counter openings will continue functioning as guest counters for hotel + general factory guests.

Pass-thru door to be replaced with exterior door.

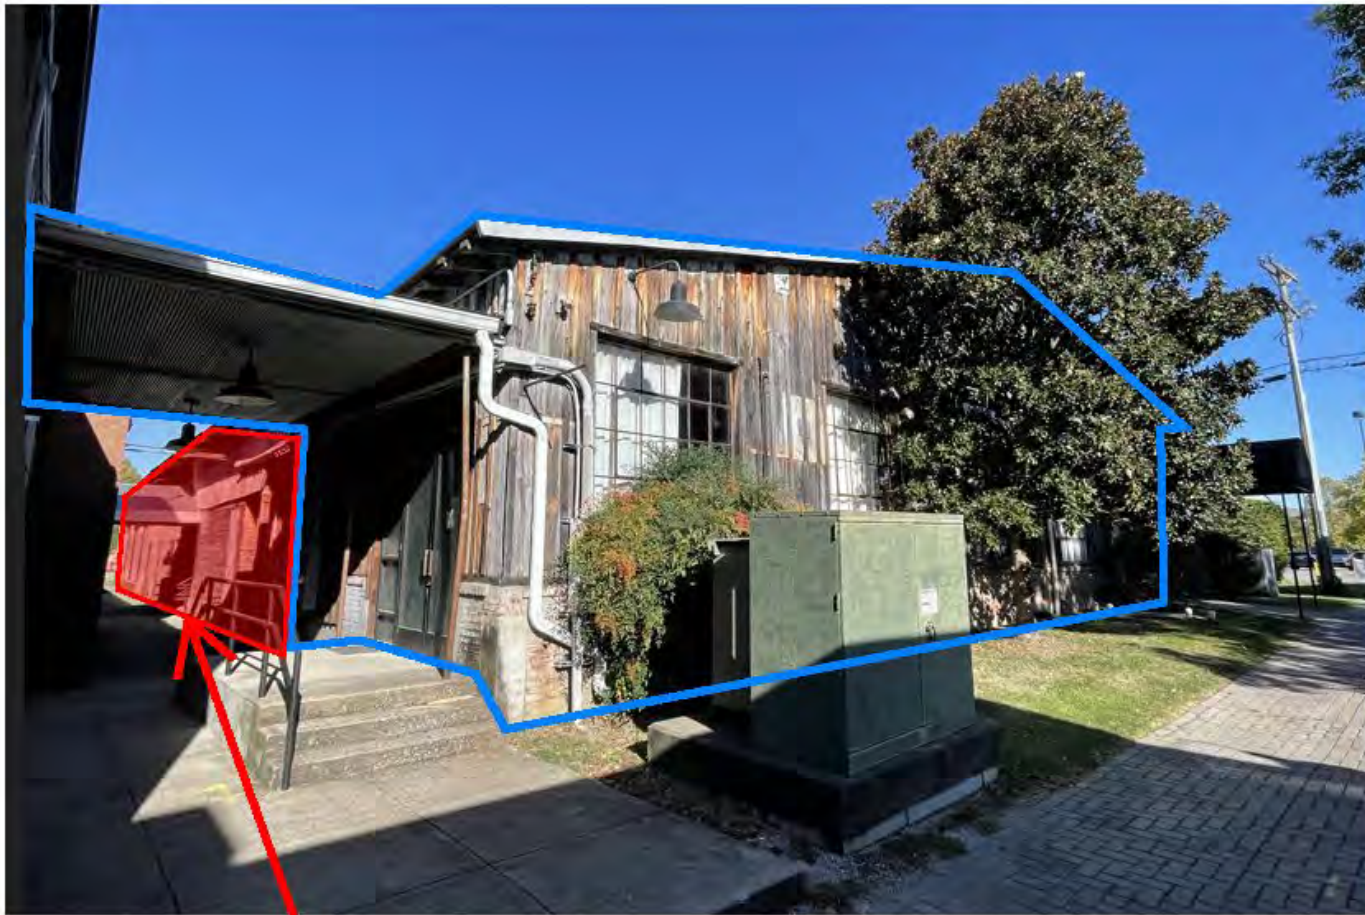
New, wood screening for courtyard.

Front elevation, first structural bay & roof will be re-rehabilitated. (Note: this facade was previously rebuilt ~20 years ago).

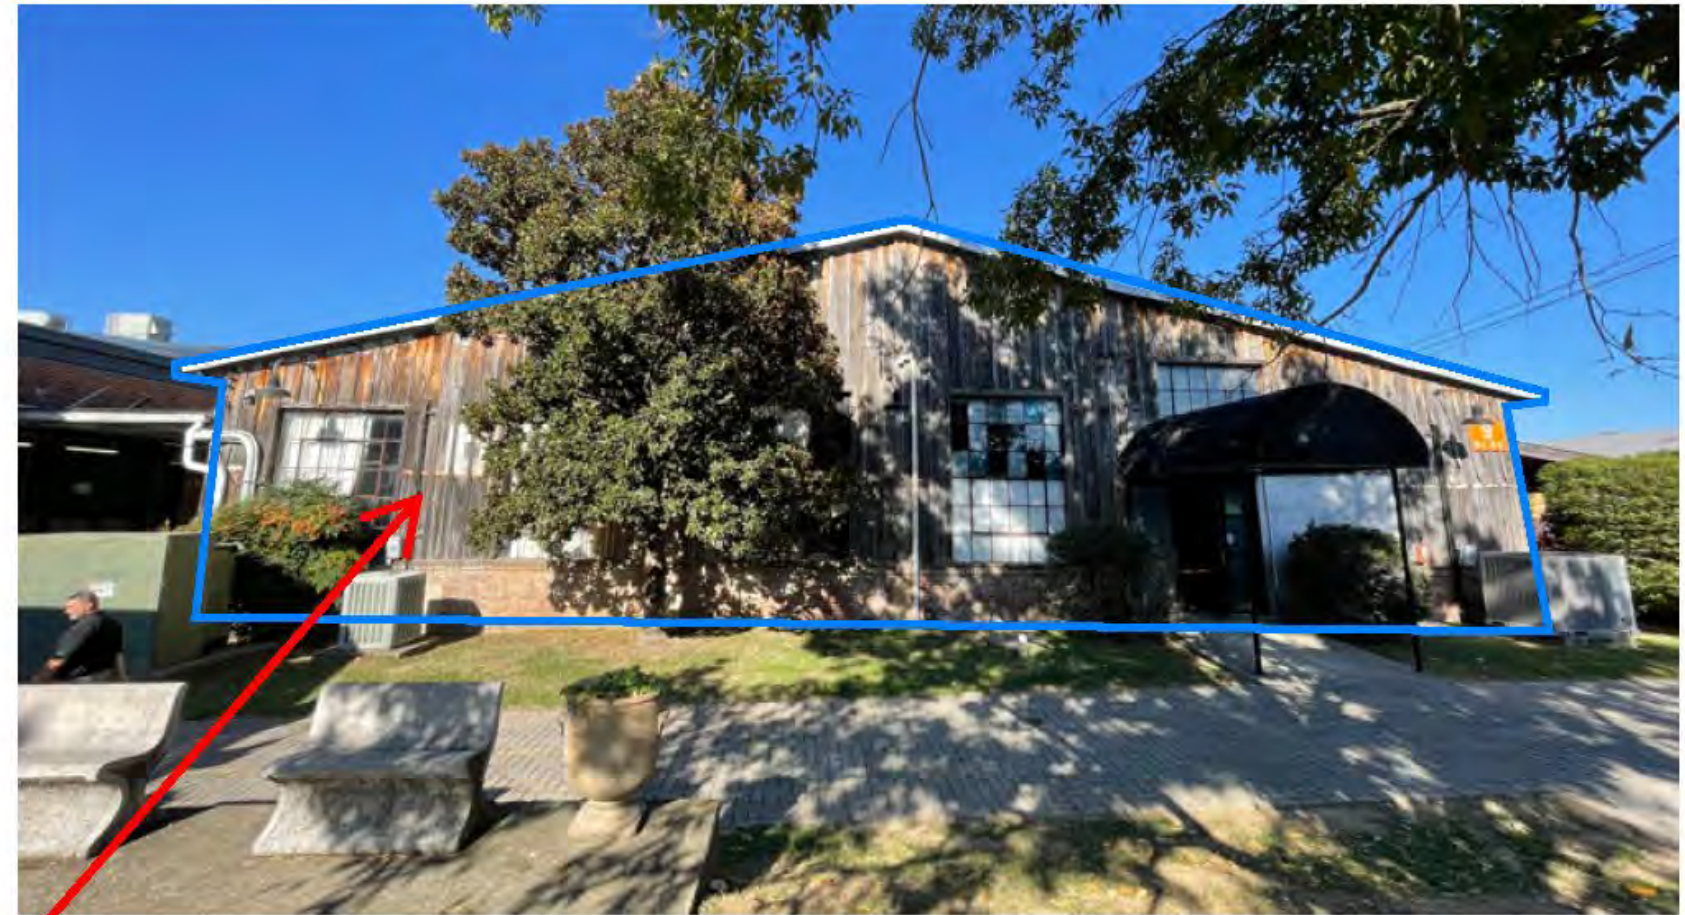
Inferior views from eastern parking lot. Front bay & ~50% of the footprint to remain. Courtyard design will utilize the existing column grid, and any historic heavy timber will be incorporated into the new courtyard (non-structurally) as allowed by code.

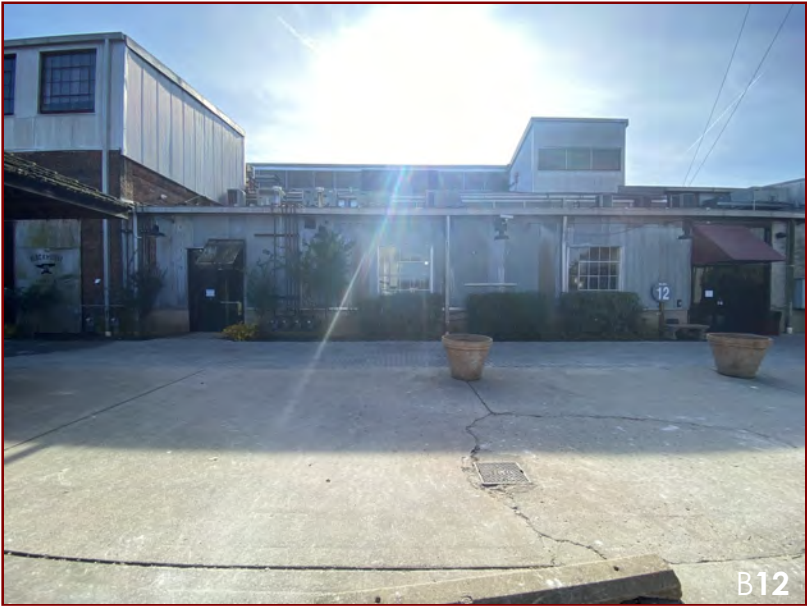
**OPENING RHYTHM**  
STACKED / LARGE ON LOWER LEVEL + SMALL ON UPPER LEVEL

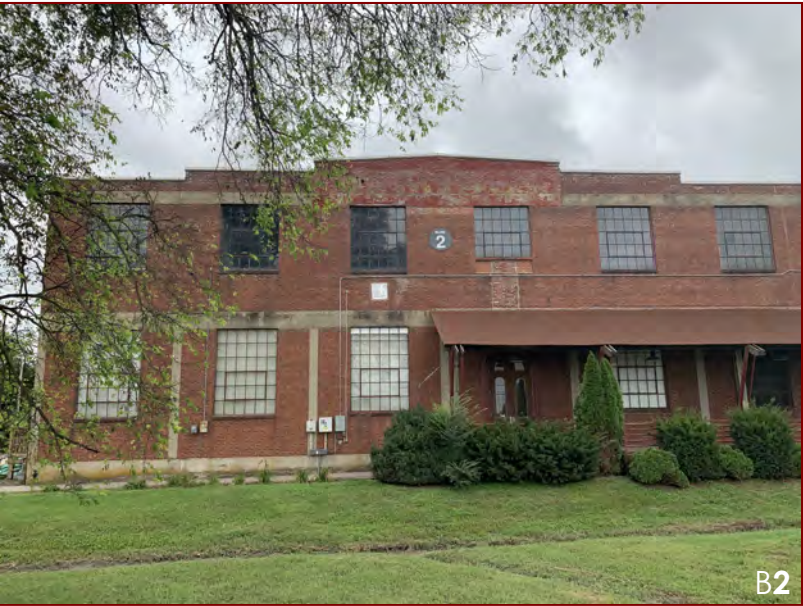
**OPENING RHYTHM**  
RIBBON WINDOWS

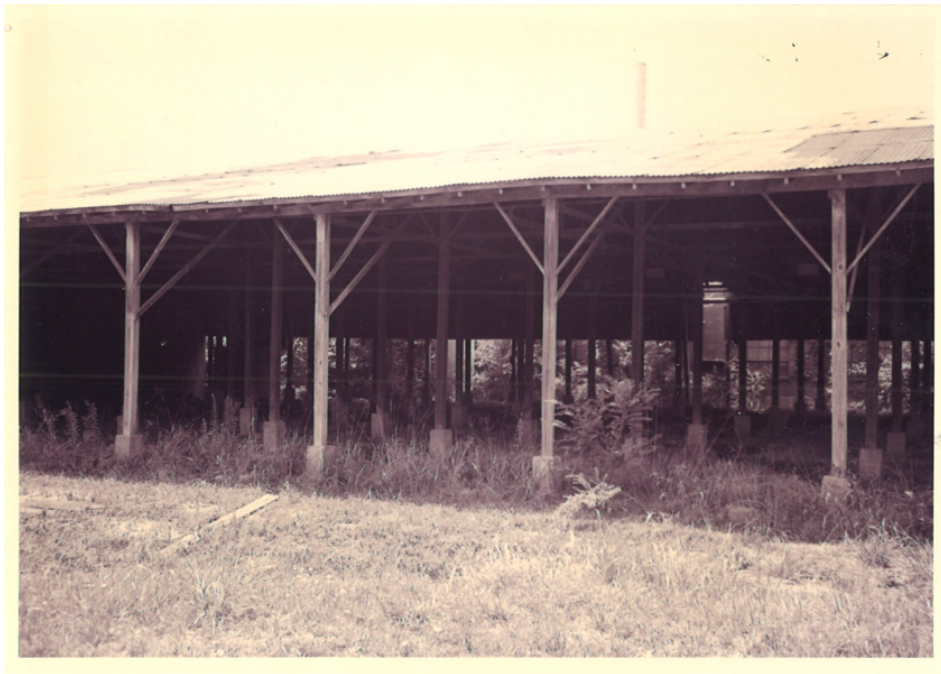
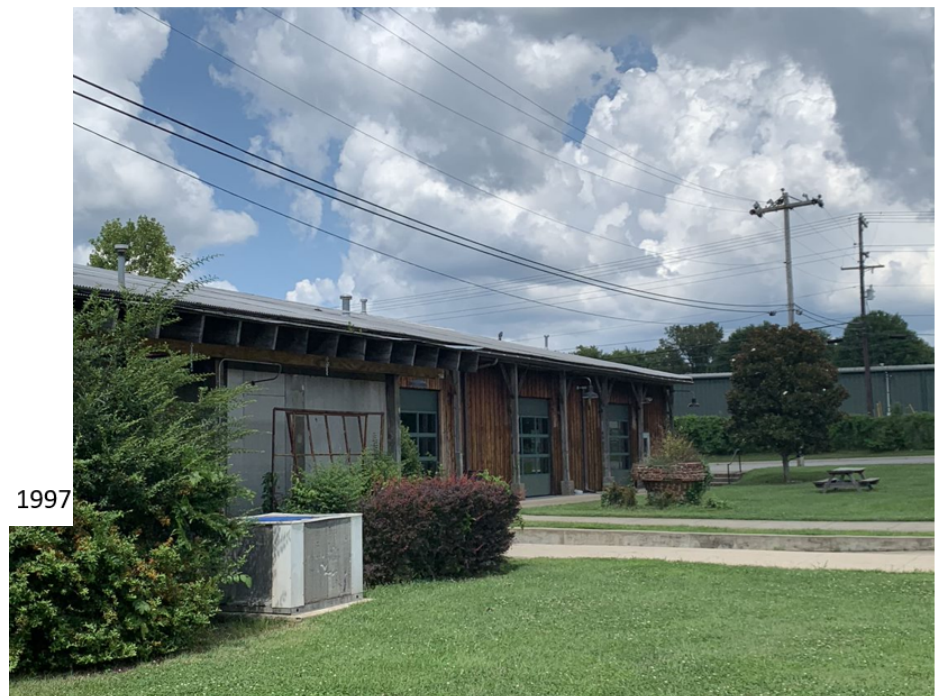
1997

2019

Also note the 2002 rehabilitation of the building included a substantial reconstruction, substantially altering the pole barn into a building.

- Reconstruction of the south elevation
- Reconstruction and repair of historic timber building structure using conventional wood components
- Reconstruction of the historic metal roof
- Installation of an interior slab on grade (previously dirt floor)
- Construction of exterior walls to enclose the historically open air structure with modern overhead doors

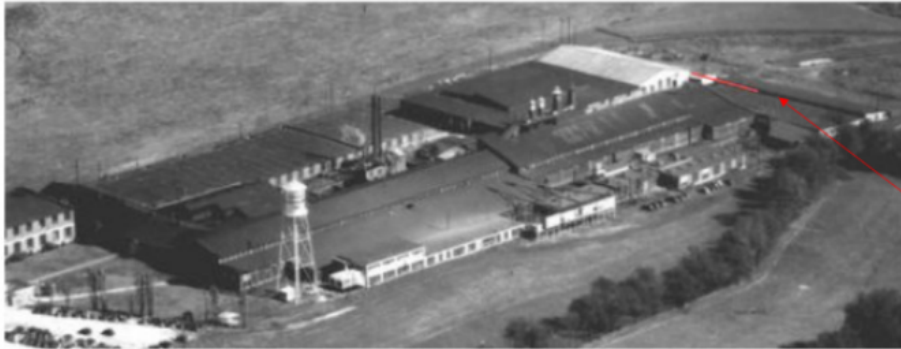
1947  
Dortch Stove  
Works

Angle of roofline at  
higher elevation  
lines up to the  
same corner of  
Building 9.

During the period of significance, Building 10 was clearly a room located inside a since demolished building that was attached to the east elevation of Building 12.

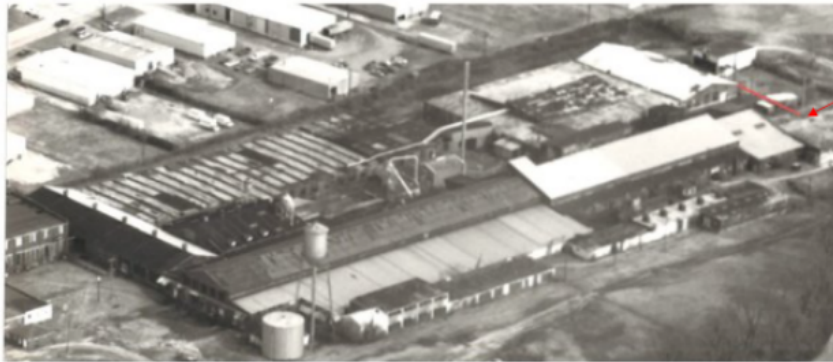
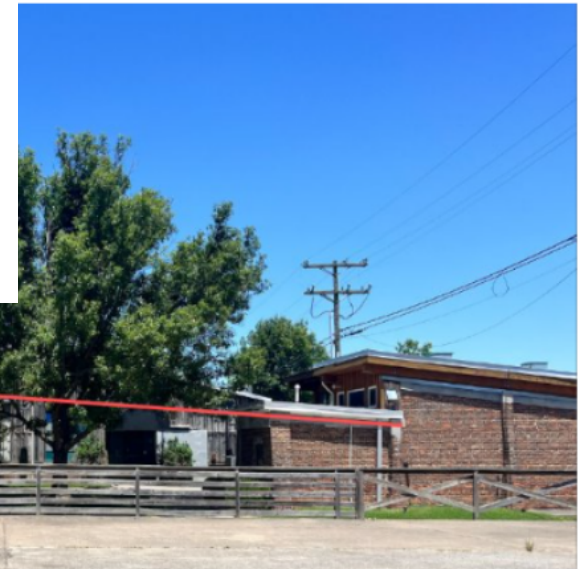
1996  
Calvin LeHew

Estimated roofline lines up with color and brick change on Building 12. It's believed that the change is the difference between exterior and interior brick. The darker bricks on Building 12 are more uniform and smooth, while the bricks on the lower portion of Building 12 and on Building 10 are rougher, lighter, and less uniform, indicating an interior origin.

Building 10 is presently located inside a contemporary building addition per previous HZC COA allowing for construction of a heavy timber structure enclosing the historic 'building' on three elevations.

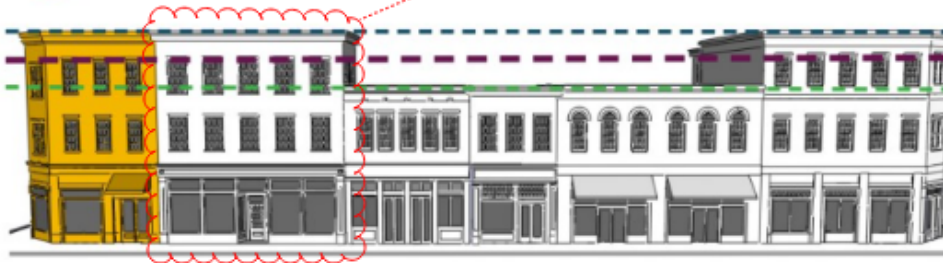
The visibility of the side elevation of this historic building is blocked by the newly constructed building

The below exhibit is from the Historic Guidelines regarding new buildings on established block faces. The visibility of the side elevation of the historic building is blocked by the new building.
