## Meeting Agenda

### Design Review Committee

1. Discussion Of Alterations (Loading Dock) At 252 5th Ave. N.; Sam Johnson, Applicant.
2. Discussion Of Fencing (Rear Yard) And Vehicular Gate At 112 Lewisburg Ave.; Jennifer Lombard, Applicant.
3. Discussion Of Signage And Alterations (Refuse Enclosure) At 94-98 E. Main St.; Mark Kozevski, Applicant.

4. Discussion Of Alterations (Courtyard) At 159 1st Avenue N.; Brandon Priddy, Applicant.
5. Discussion Of Site Alterations At 328 Franklin Rd.; Linda Childs, Applicant.
6. Discussion Of Alterations (Site Alterations) And Additions (Principal And Accessory) At 720 W. Main St.; Amanda McCreary, Applicant.
7. Discussion Of An Addition (Accessory Structure) And Site Alterations At 1303 Adams St.; Zachary Correa, Applicant.
8. Discussion of Preliminary Historic Zoning Commission Recommendation For A Proposed Hotel, Parking Structure, And Partial Demolition At 230 Franklin Rd. (The Factory); Greg Gamble, Applicant.

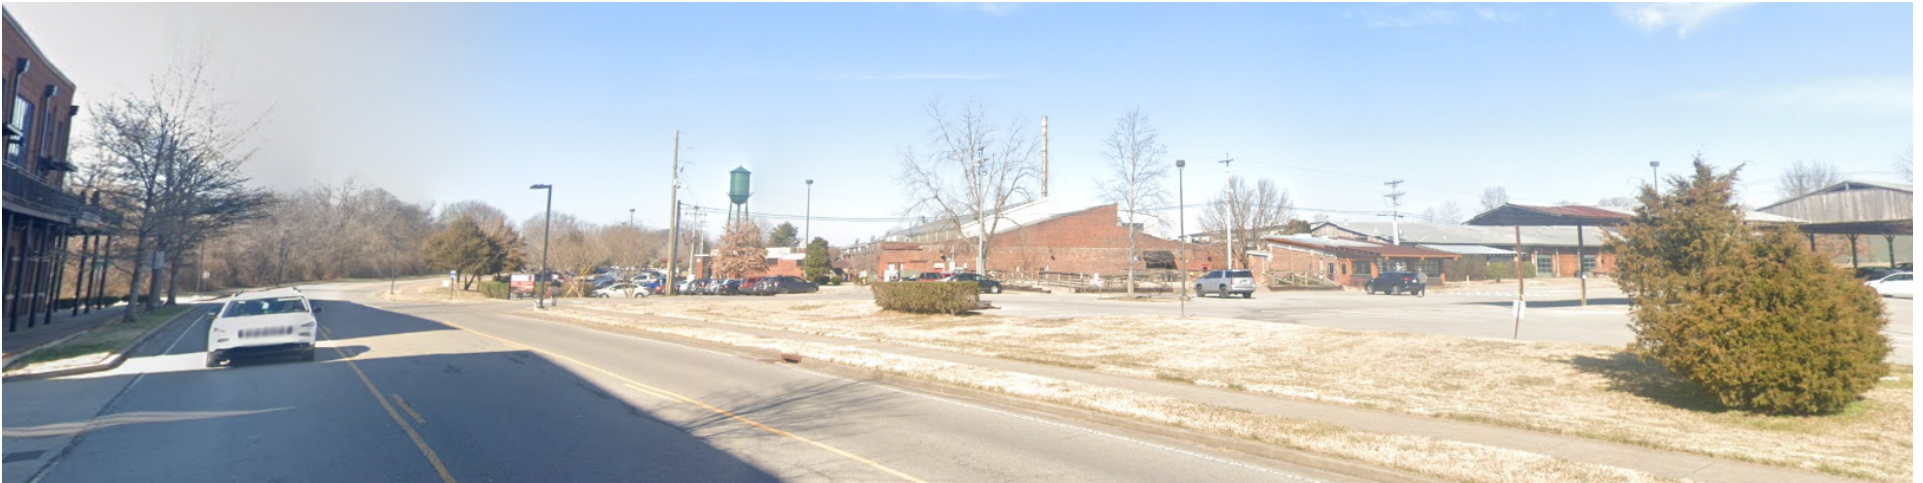
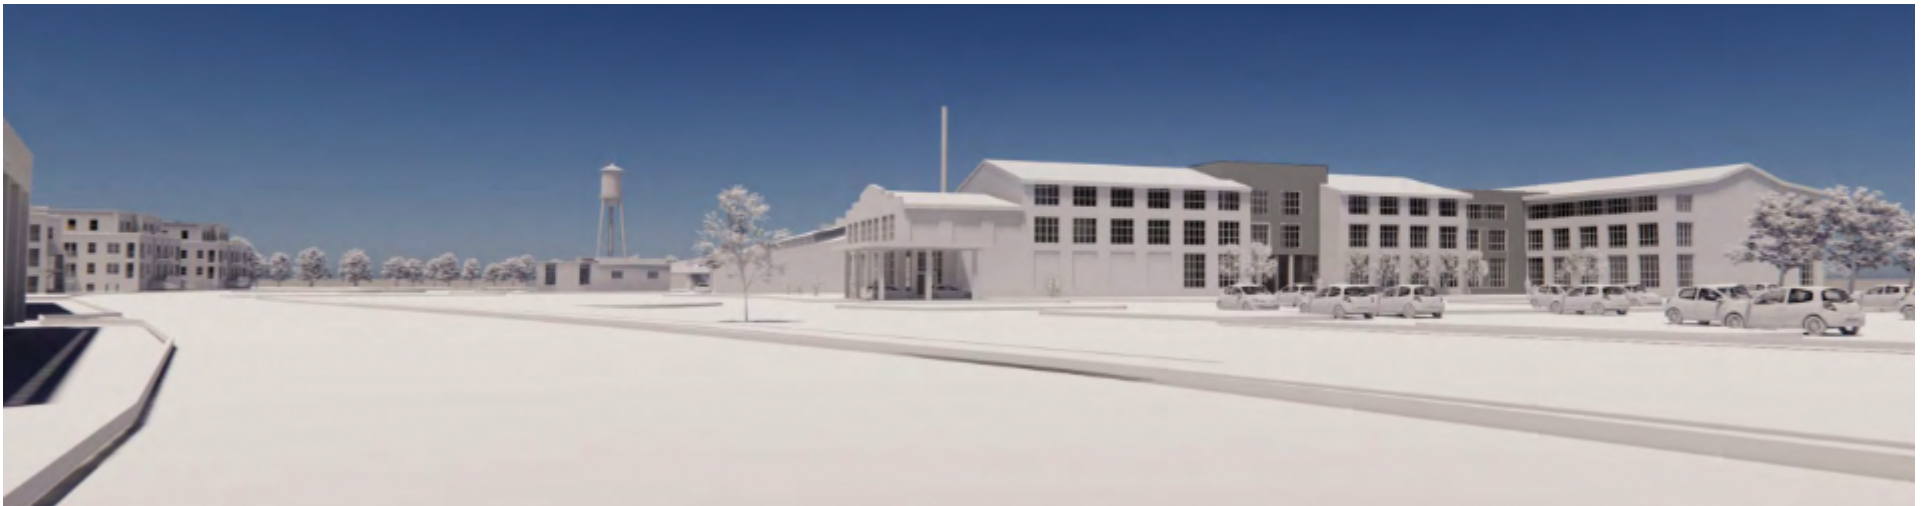
The proposed hotel building is in line with the established blockface; it is positioned behind and to the side of historic buildings and does not block the view of the historic buildings. The proposed parking garage is positioned behind the historic buildings and does not block the view of the historic buildings.

Views are looking westward on Liberty Pike (top image is existing, bottom rendering is proposed):

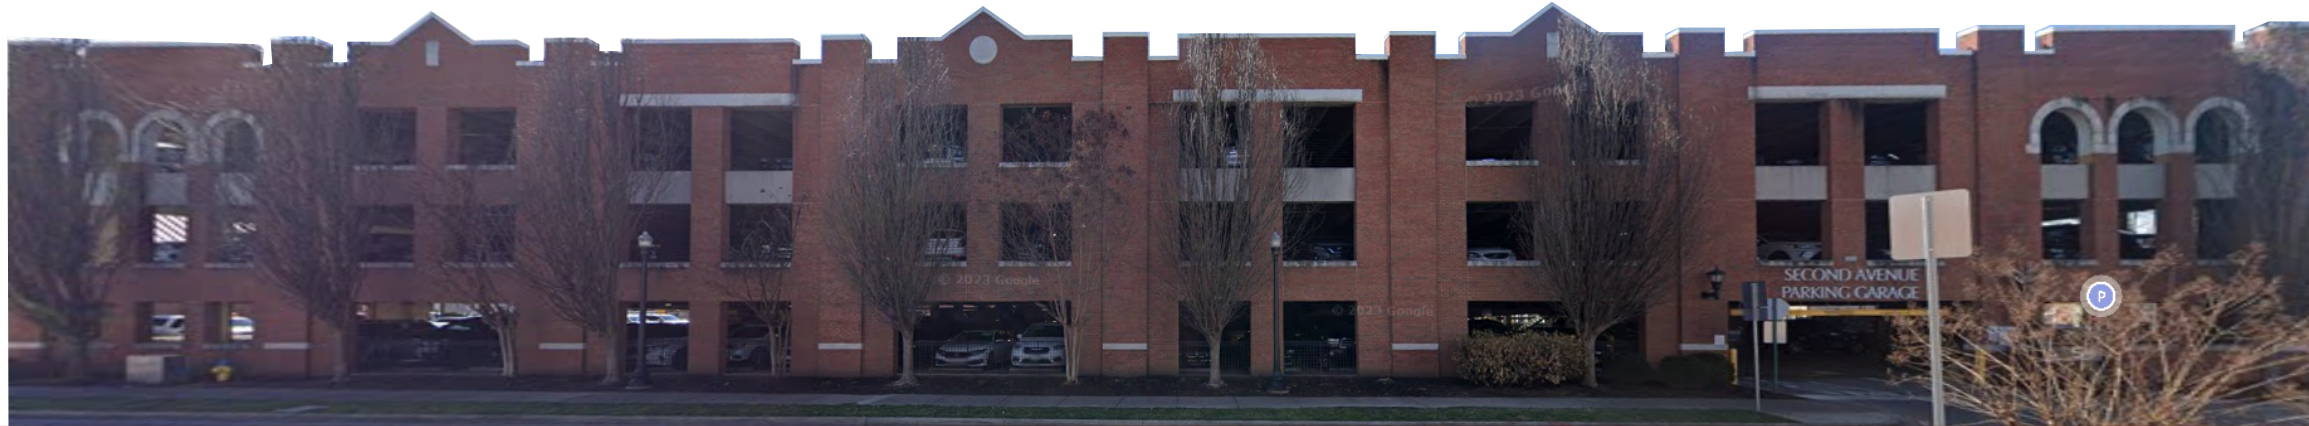
**2ND AVE GARAGE**  
4 STORIES  
~47'-0"

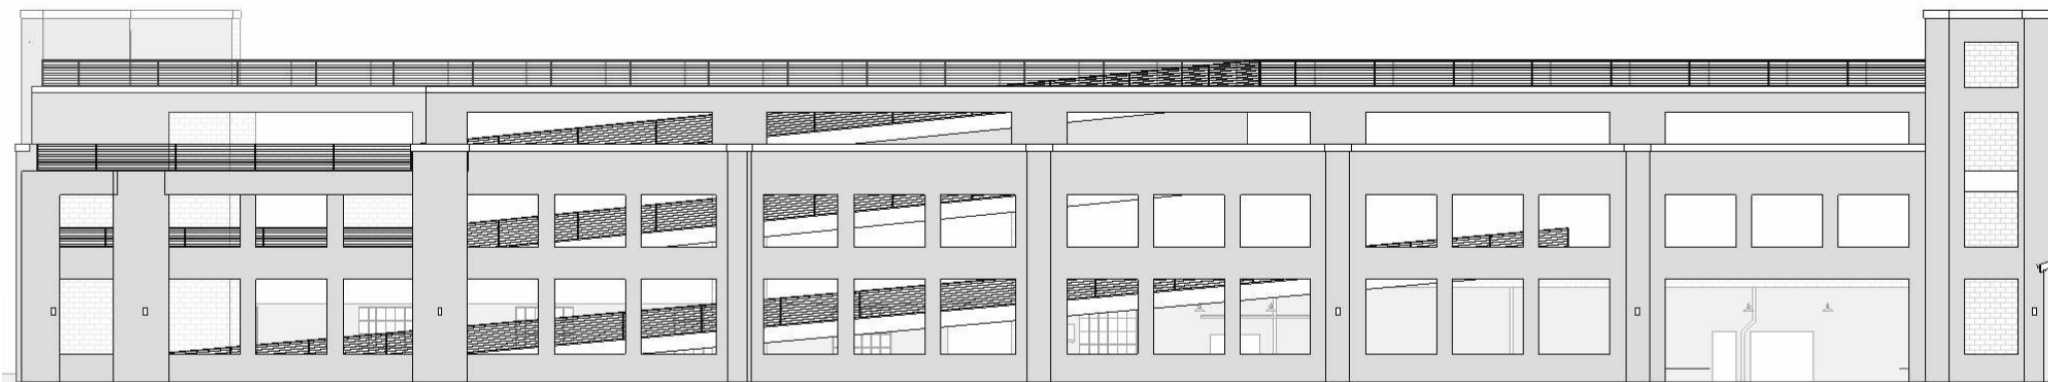
**FACTORY GARAGE**  
4 STORIES  
47'-0"

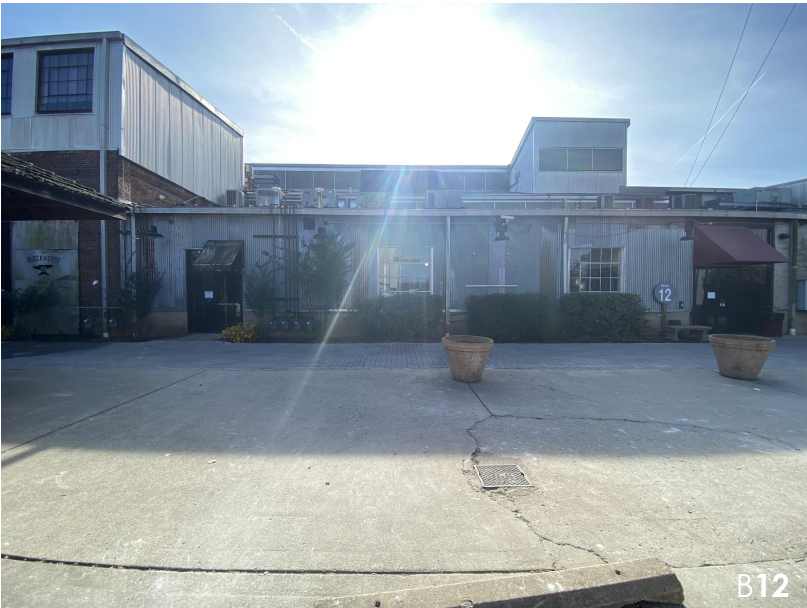
**MATERIALITY**  
BRICK BASE + METAL PANEL TOP

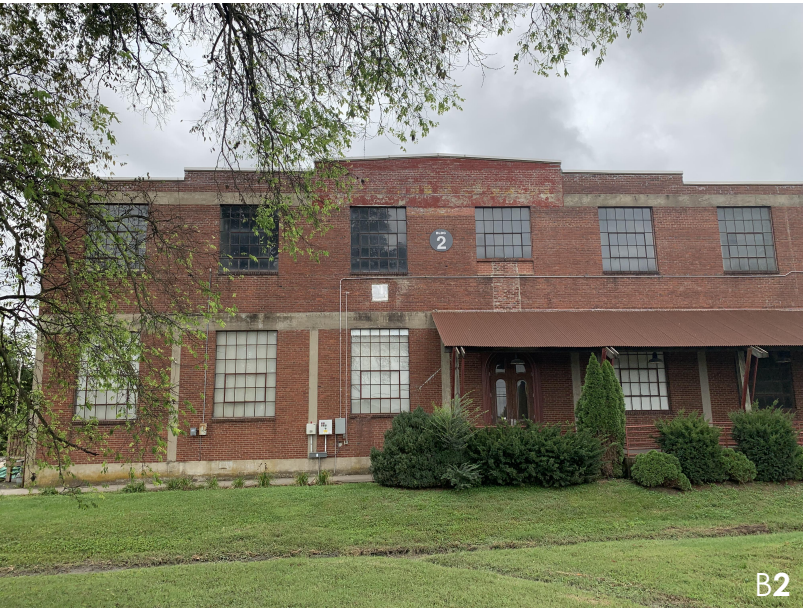
**OPENING RHYTHM**  
STACKED / LARGE ON LOWER LEVEL + SMALL ON UPPER LEVEL

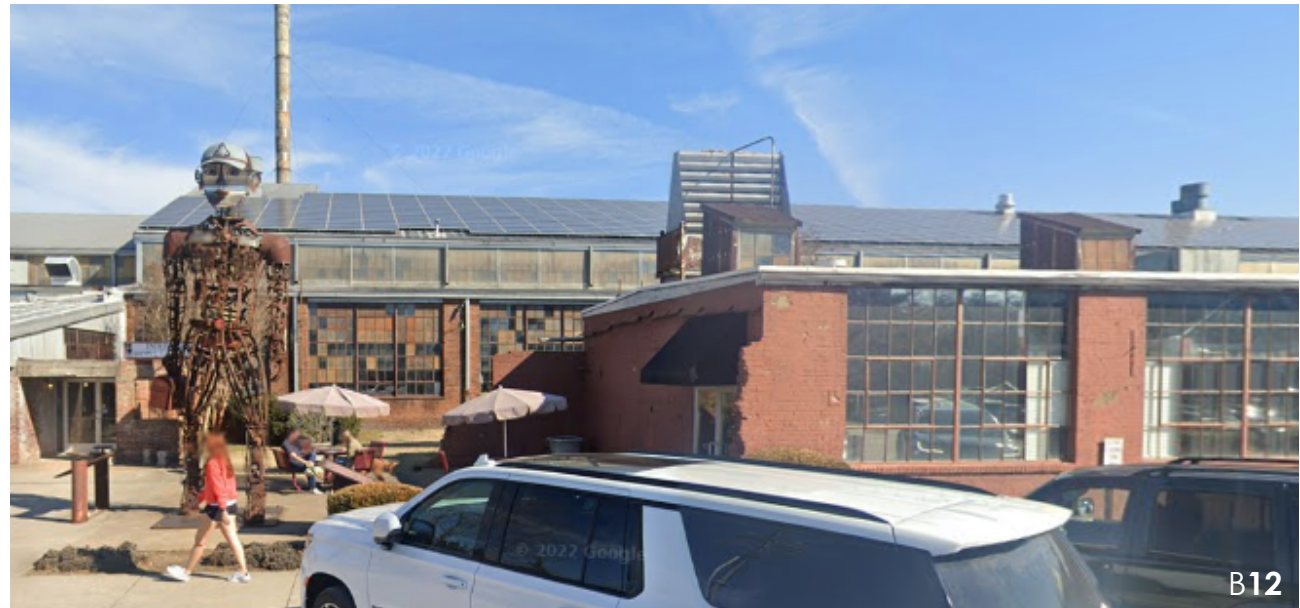
**OPENING RHYTHM**  
RIBBON WINDOWS

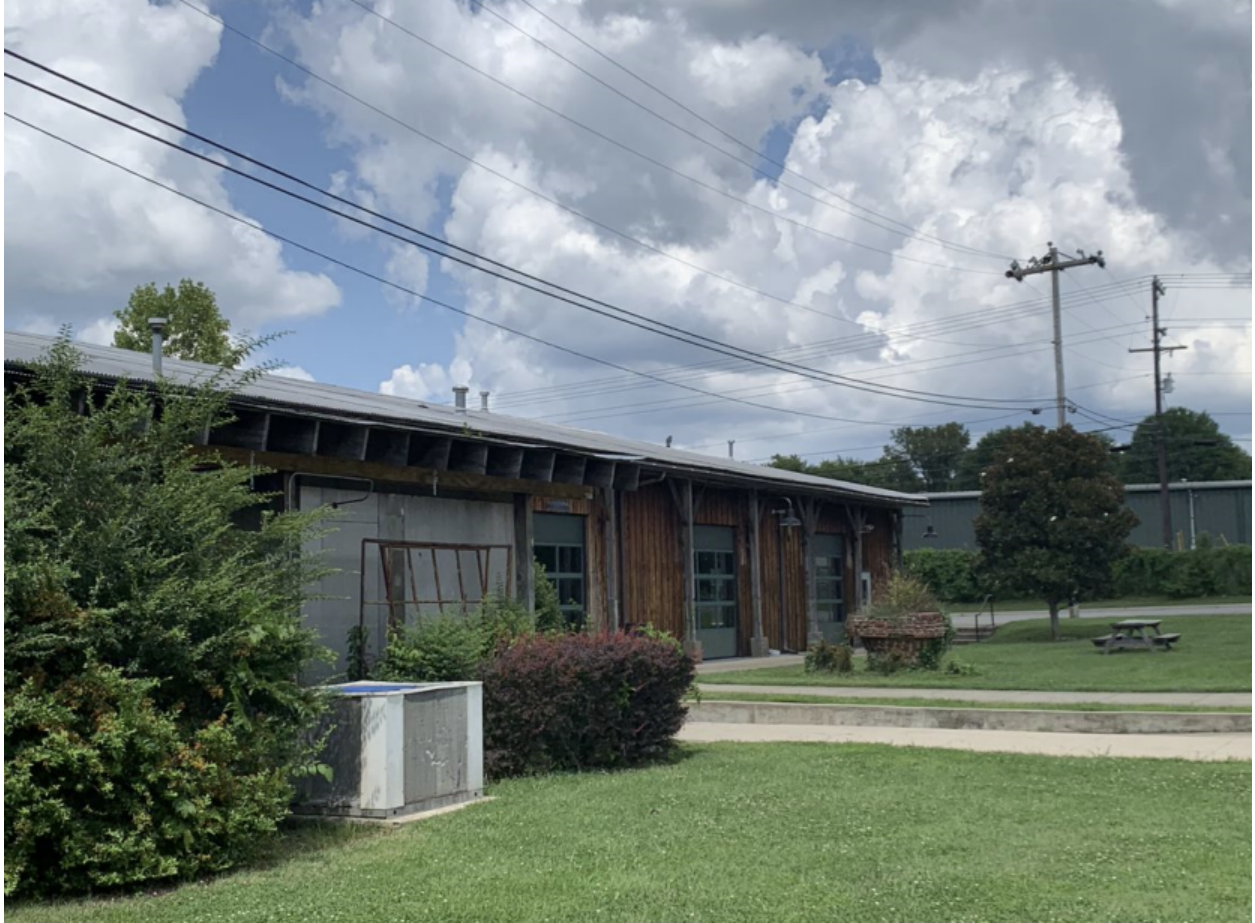
View from southeast side of site

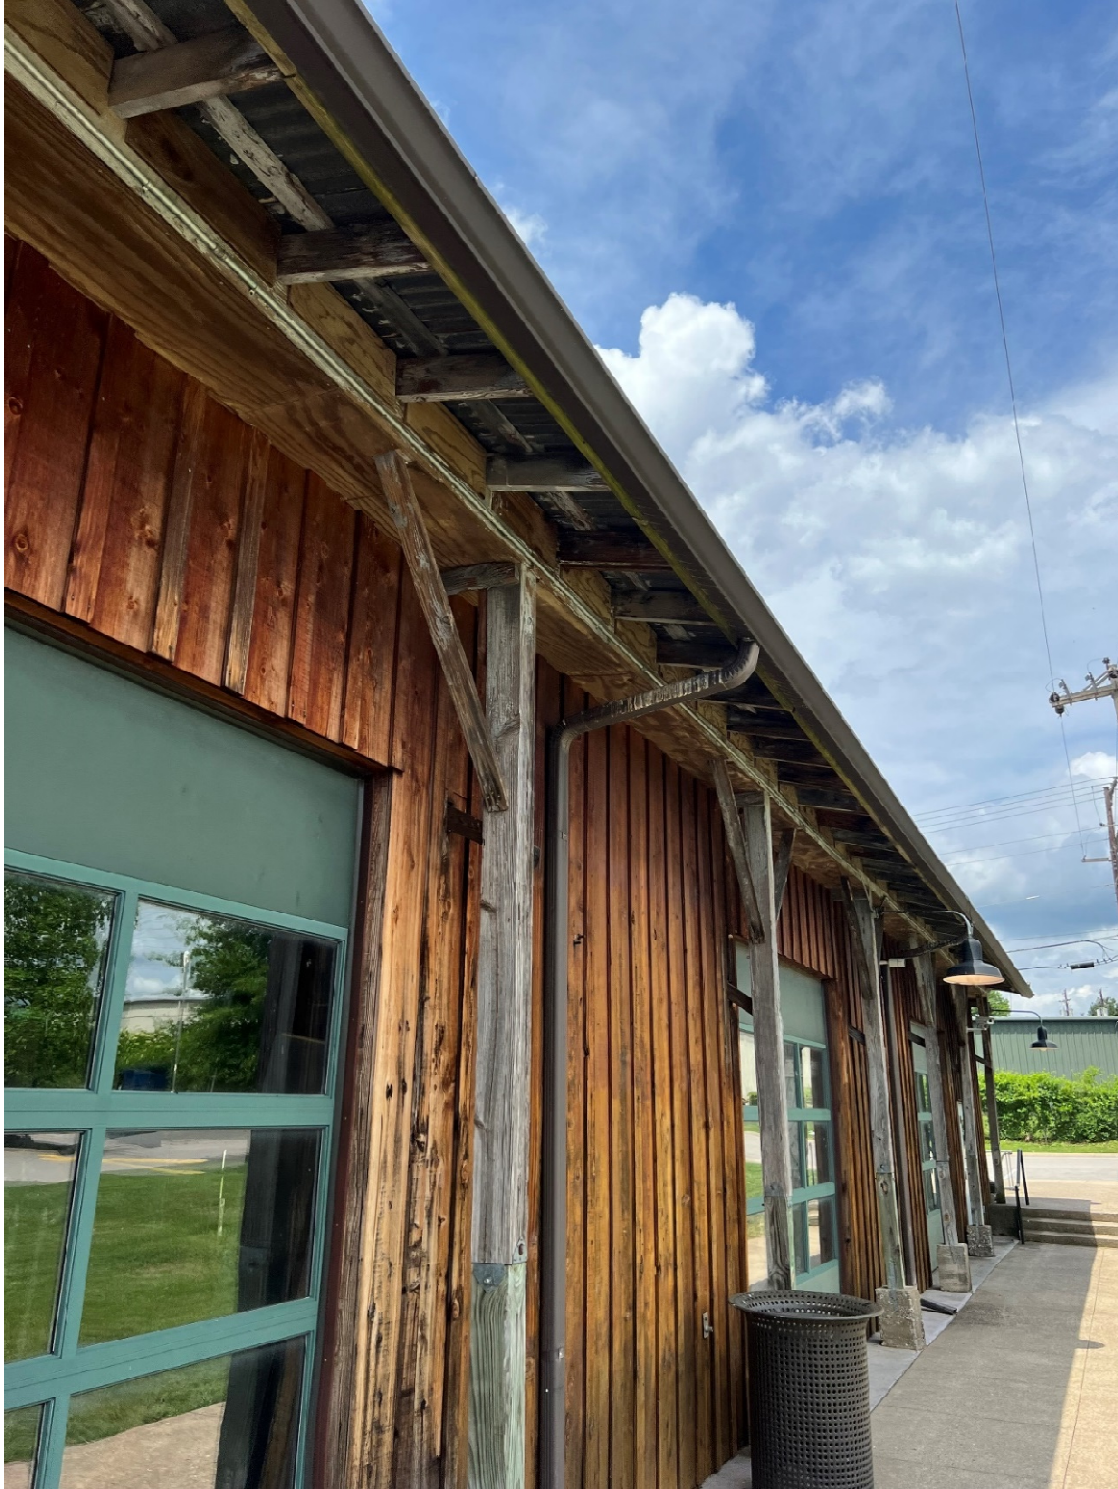
View at southeast eaves and column line

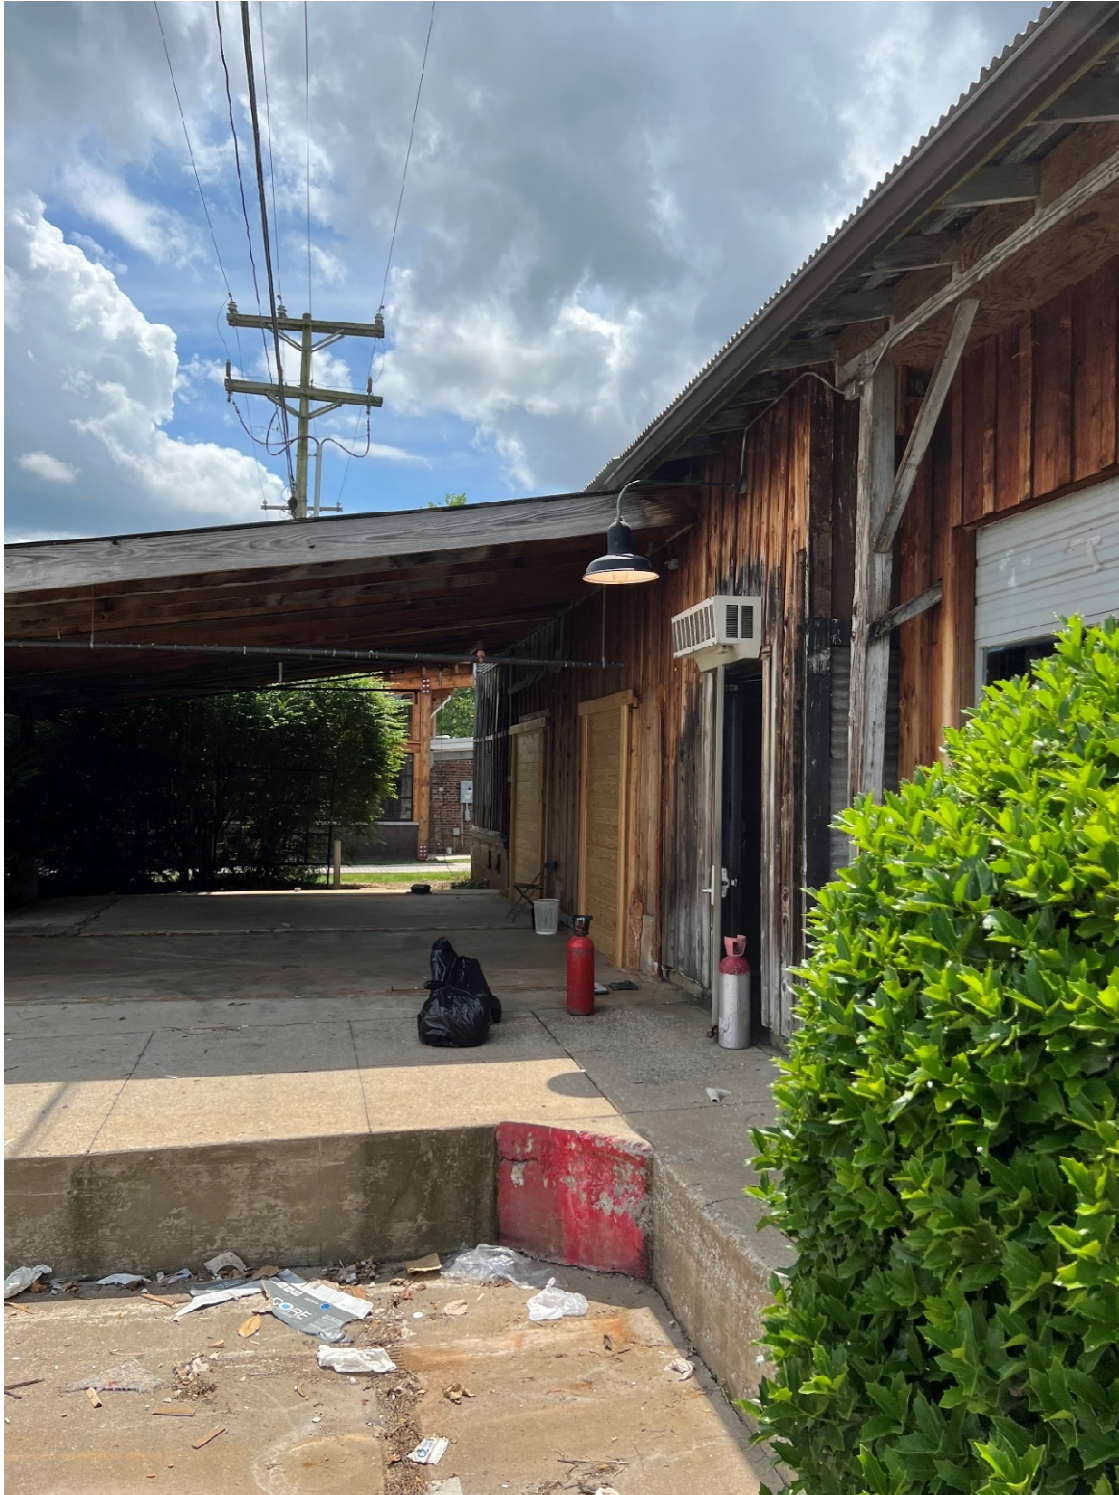
East elevation looking south

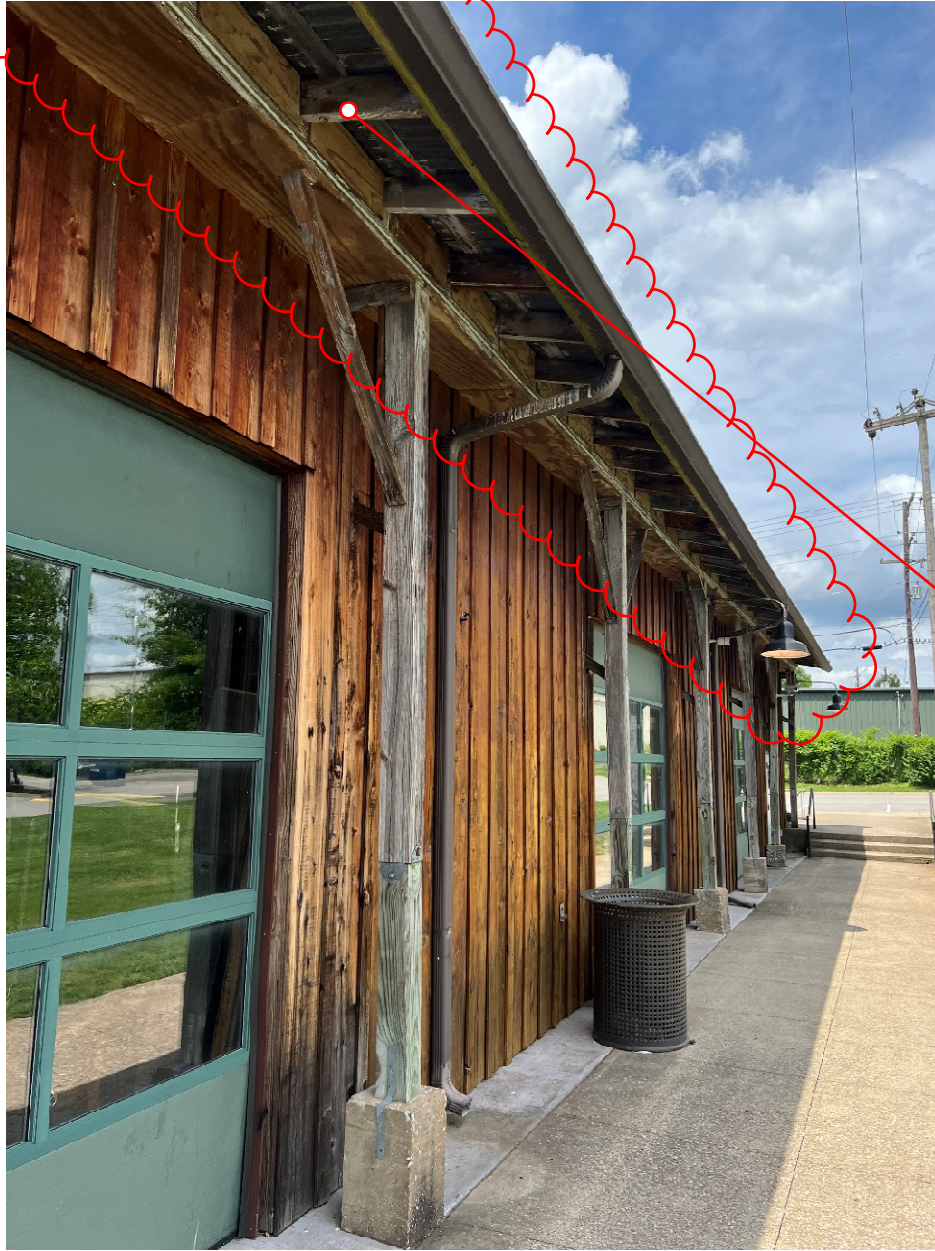
WATER DAMAGE AT ALL  
ROOF COMPONENTS  
INCLUDING RAFTERS  
AND ROOF SHEATHING.

Condition: Deterioration and moisture intrusion damage at all roof members at exterior.

Solution: Replace or repair sections of roof framing components around perimeter of building.

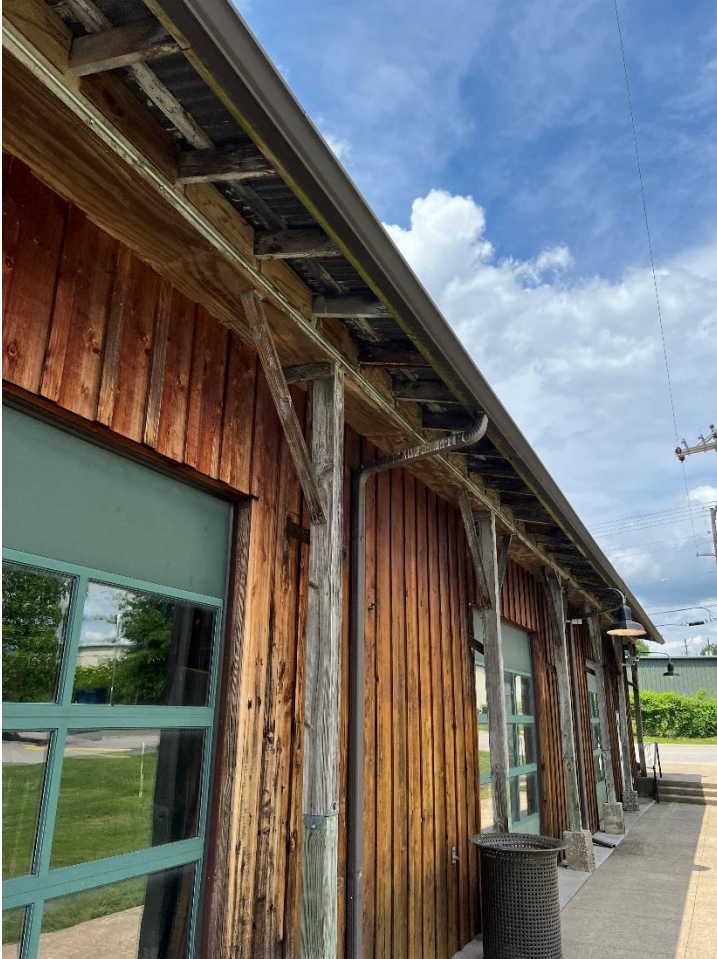
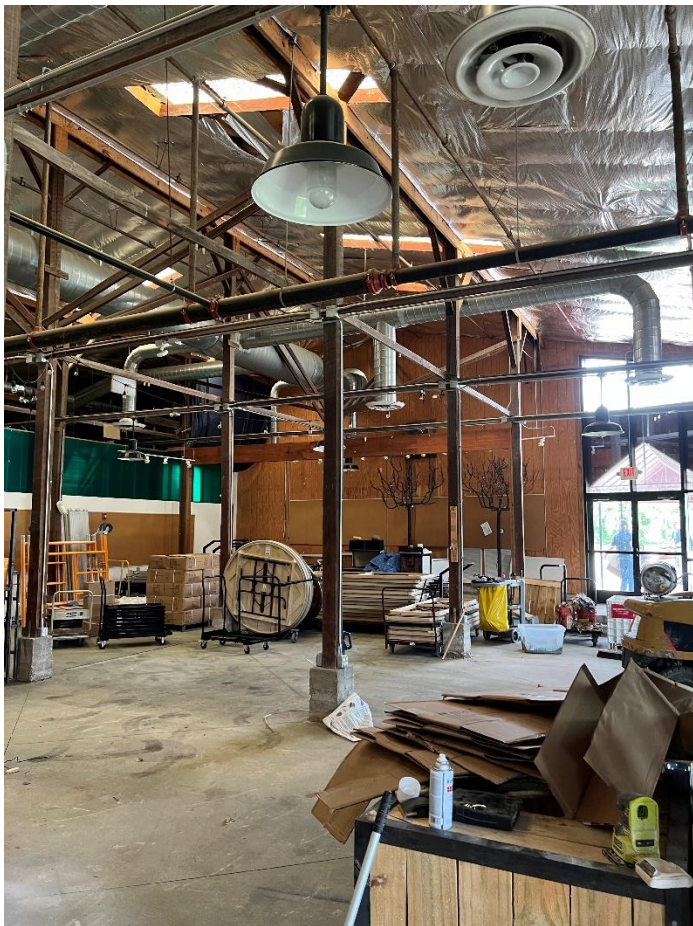
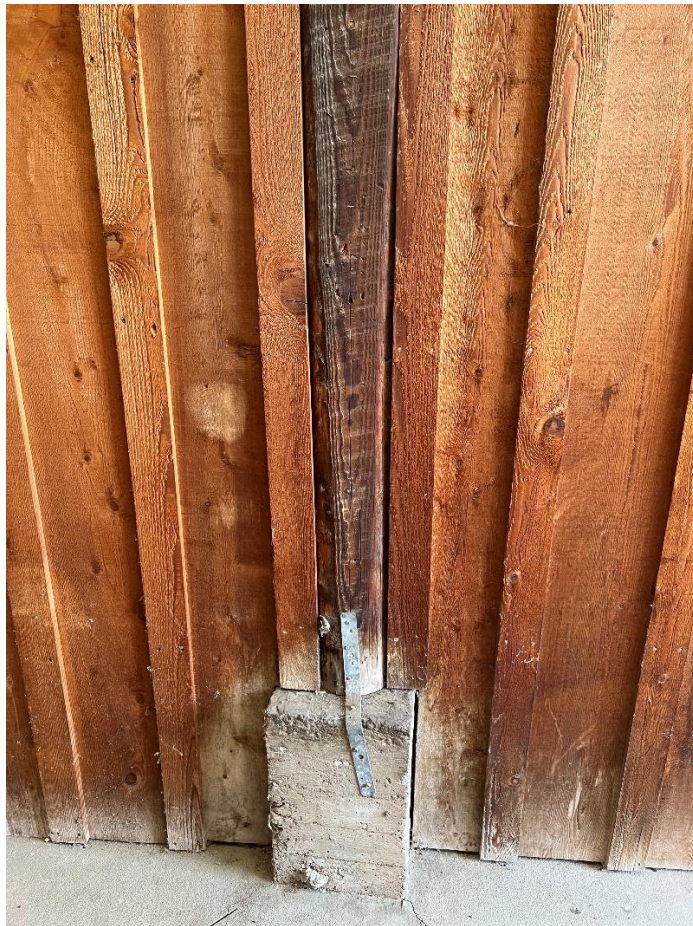
Below is a visual summary of observations noted above.

1. It did not appear any sort of sheathing or vapor barrier is present on the building. This is and will continue to create long term moisture issues.
2. The exterior siding is in poor condition and likely needs replacement. This has the potential for long term water intrusion issues.
3. It is unlikely consistent insulation is present in the wall cavities.
4. Sections of the exterior rafters and fascia boards are damaged.

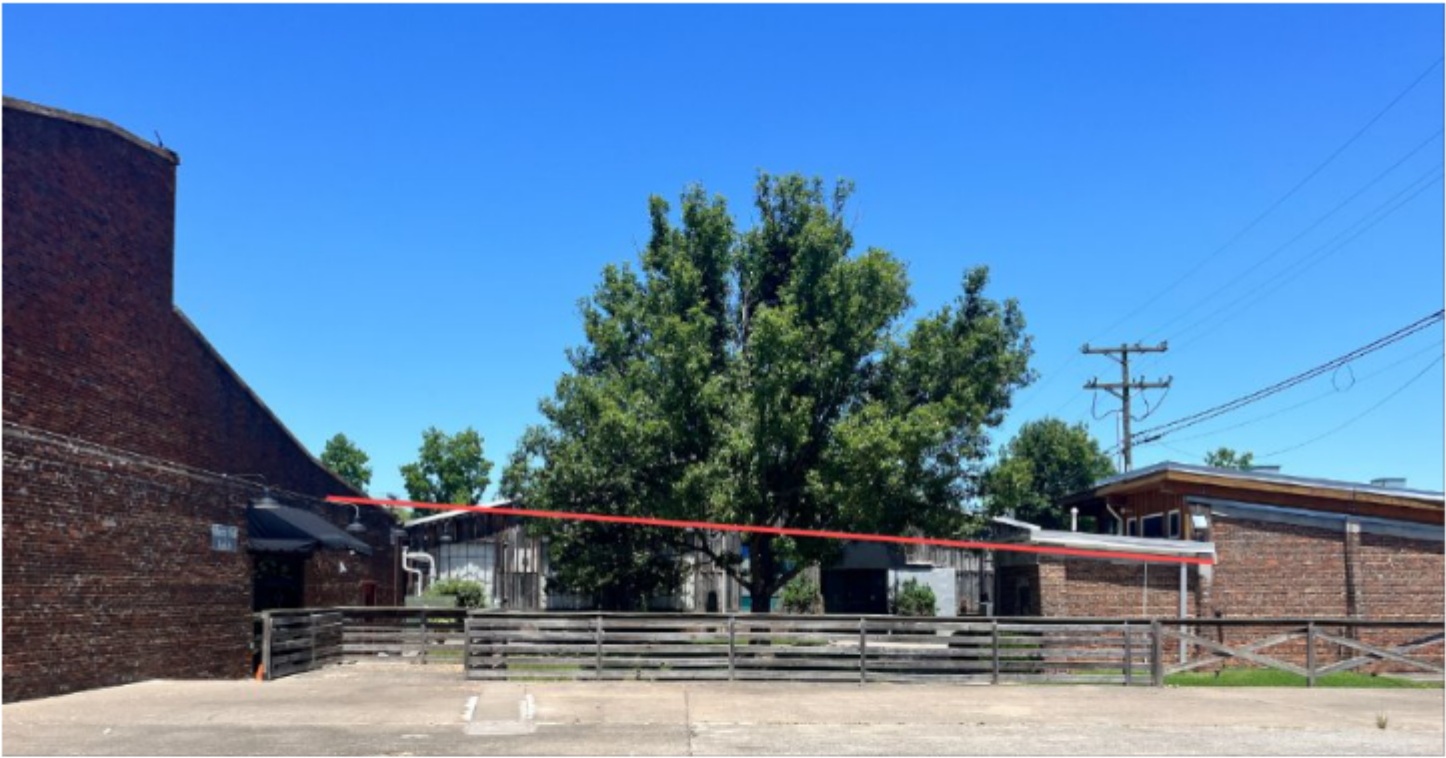
Estimated roofline lines up with color and brick change on Building 12. It's believed that the change is the difference between exterior and interior brick. The darker bricks on Building 12 are more uniform and smooth, while the bricks on the lower portion of Building 12 and on Building 10 are rougher, lighter, and less uniform, indicating an interior origin.

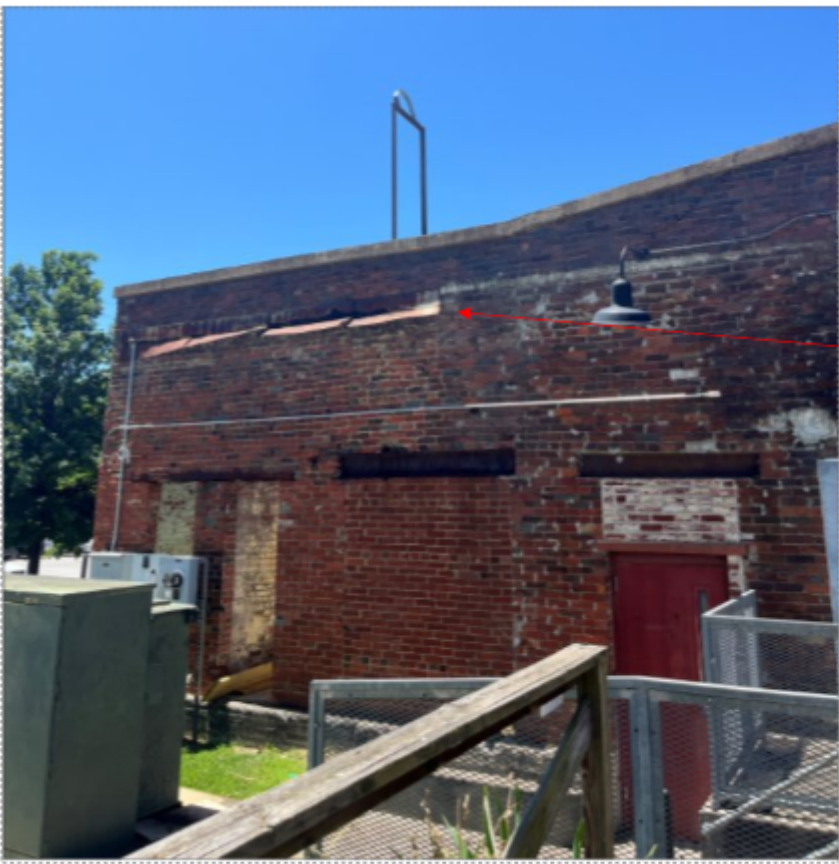
Leftover flashing from the conjunction of Building 12 and Building X.
