## City of Franklin

#### Design Review Committee

1. Discussion of Demolition At 119 Church St.; John Ligon, Applicant.
2. Discussion Of A Historic Zoning Commission Recommendation For Public Art At 1221 Columbia Ave.; Laurie McPeak, Applicant.
3. Discussion Of Awning Alterations At 900 Fair St.; Stephen Scott, Applicant.
4. Discussion Of Partial Demolition And An Addition (Principal) At 212 Lewisburg Ave.; Don Burke, Applicant.
5. Discussion Of An Addition (Principal) And Partial Demolition (Accessory Structure) At 305 3rd Ave. S.; Brandon Priddy, Applicant.
6. Discussion Of New Construction At 1845 William Campbell Ct. (Lot 7 At Magnolia Hall); Maria Ortiz, Applicant.
7. Discussion Of New Construction At 1855 William Campbell Ct. (Lot 11 At Magnolia Hall); Maria Ortiz, Applicant.

Preferred Builders and Associates – 119 Church St – Framing

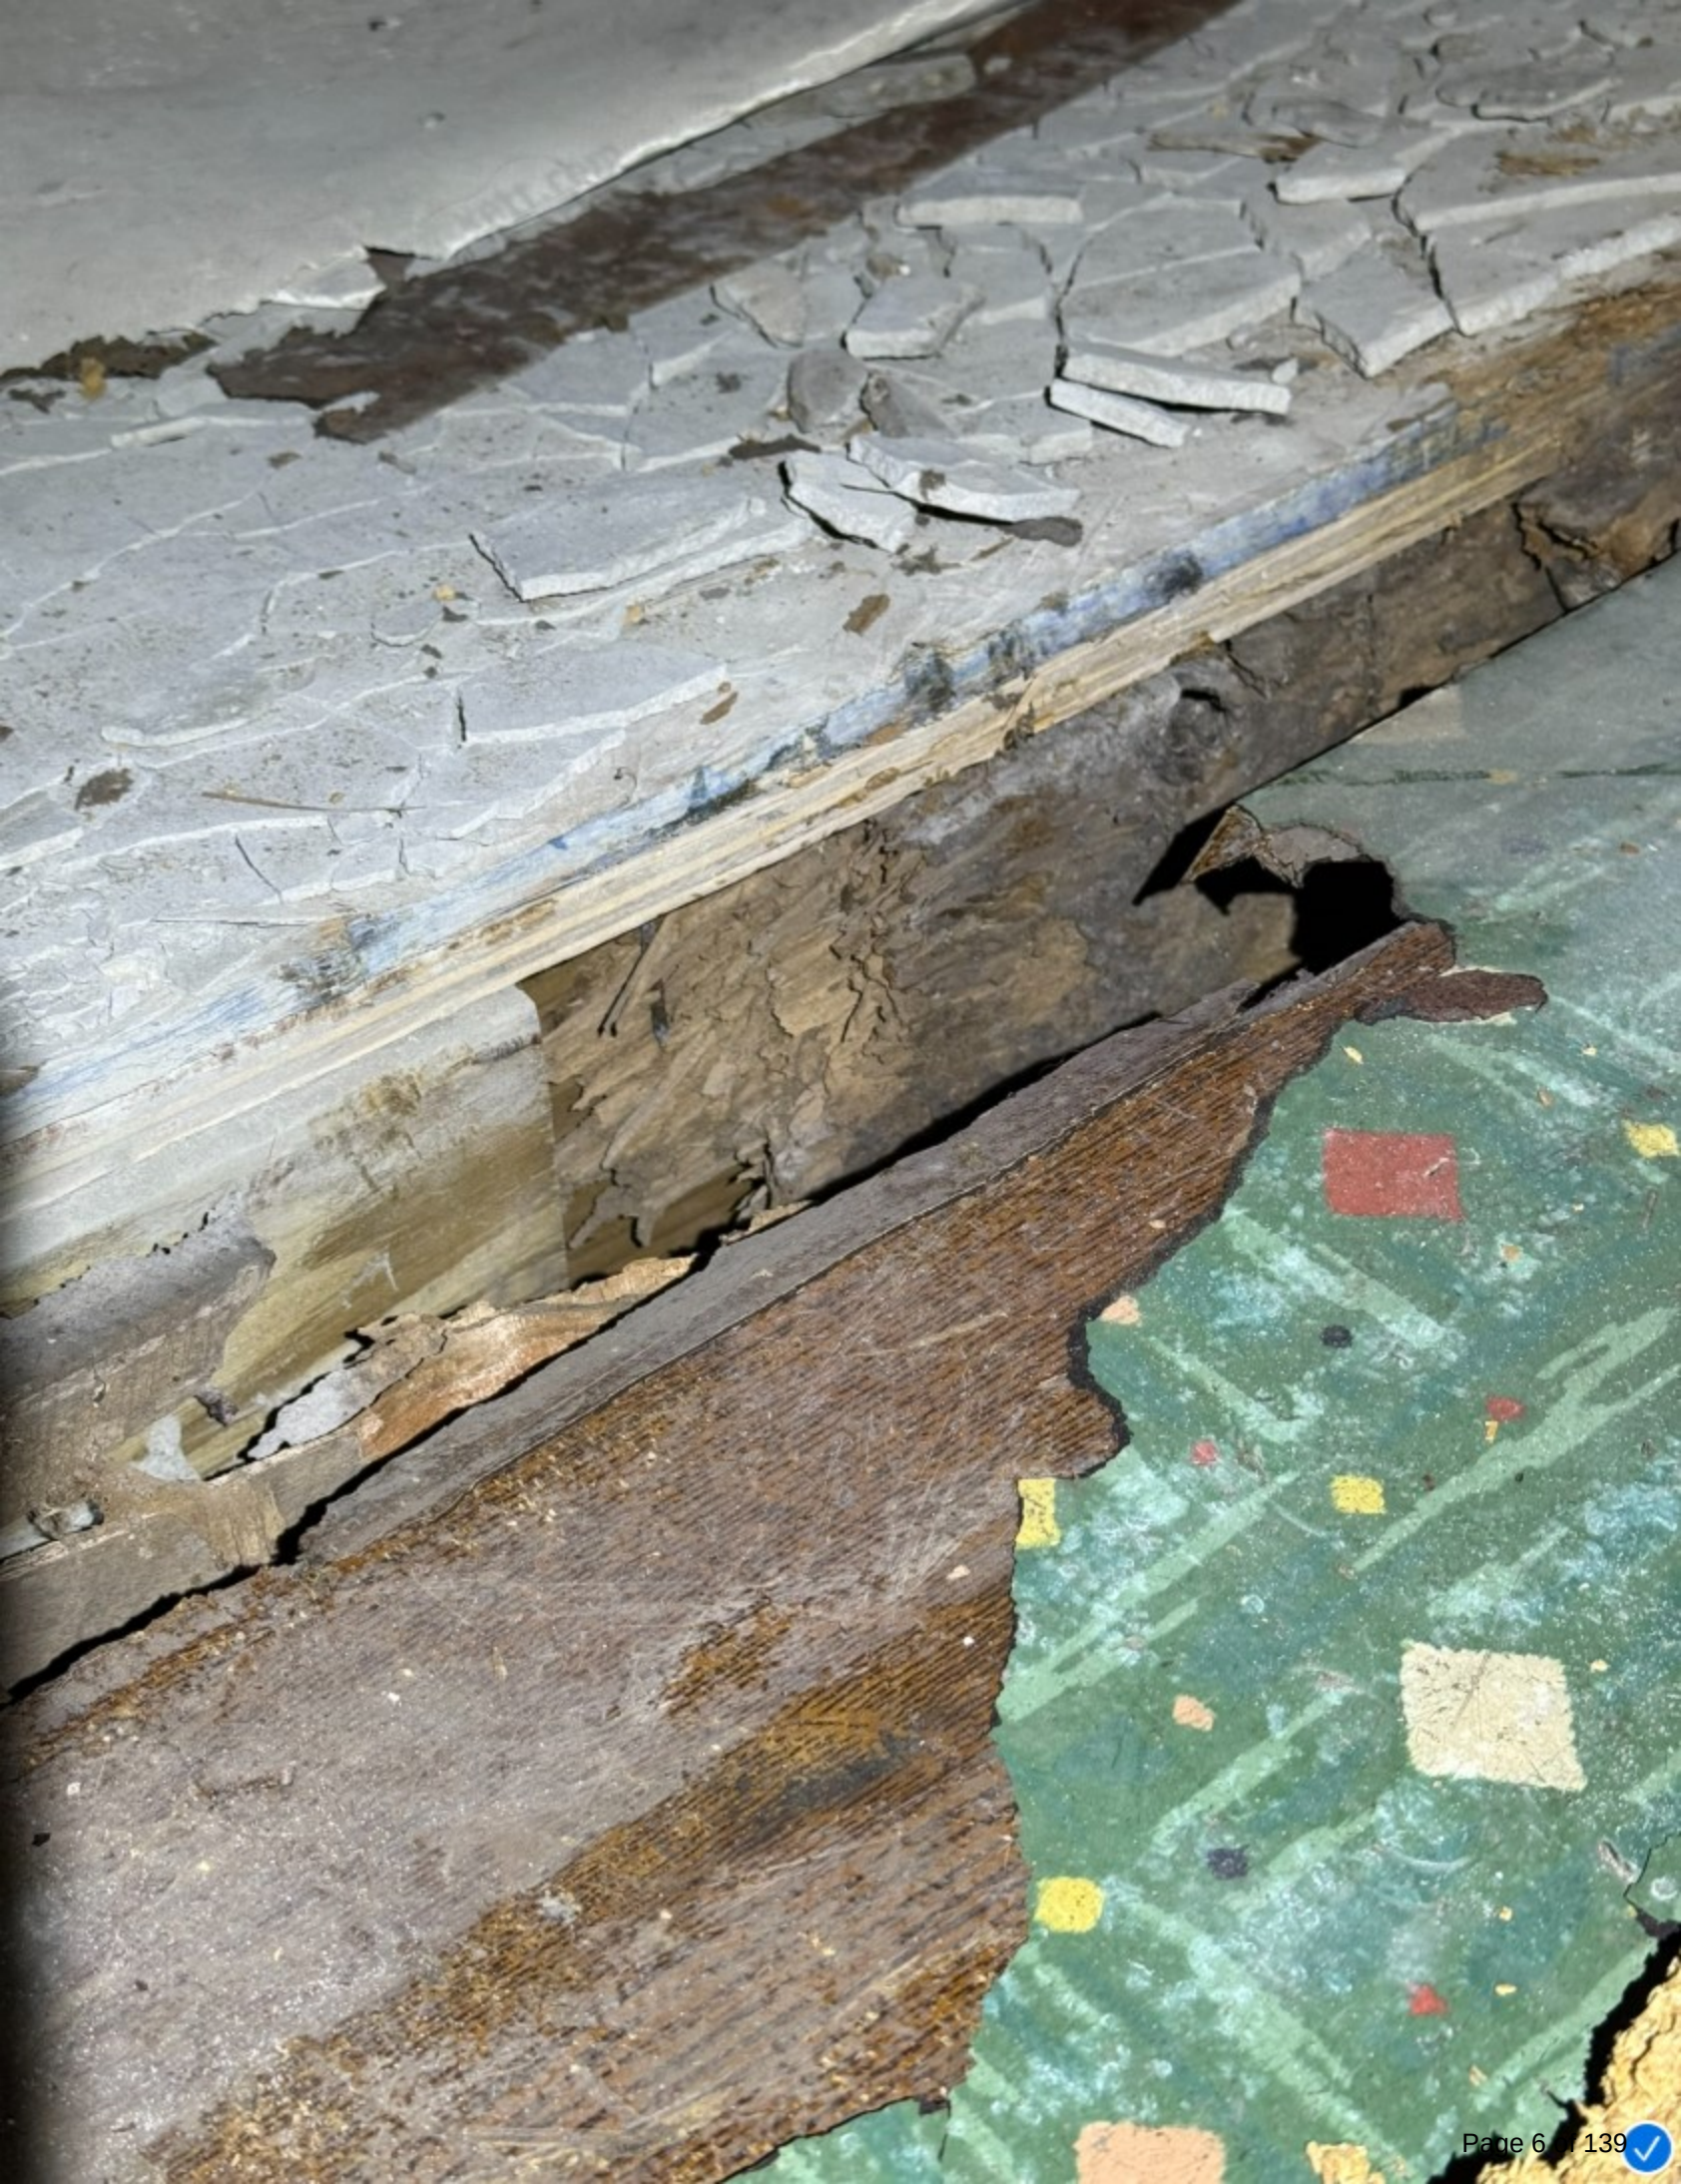
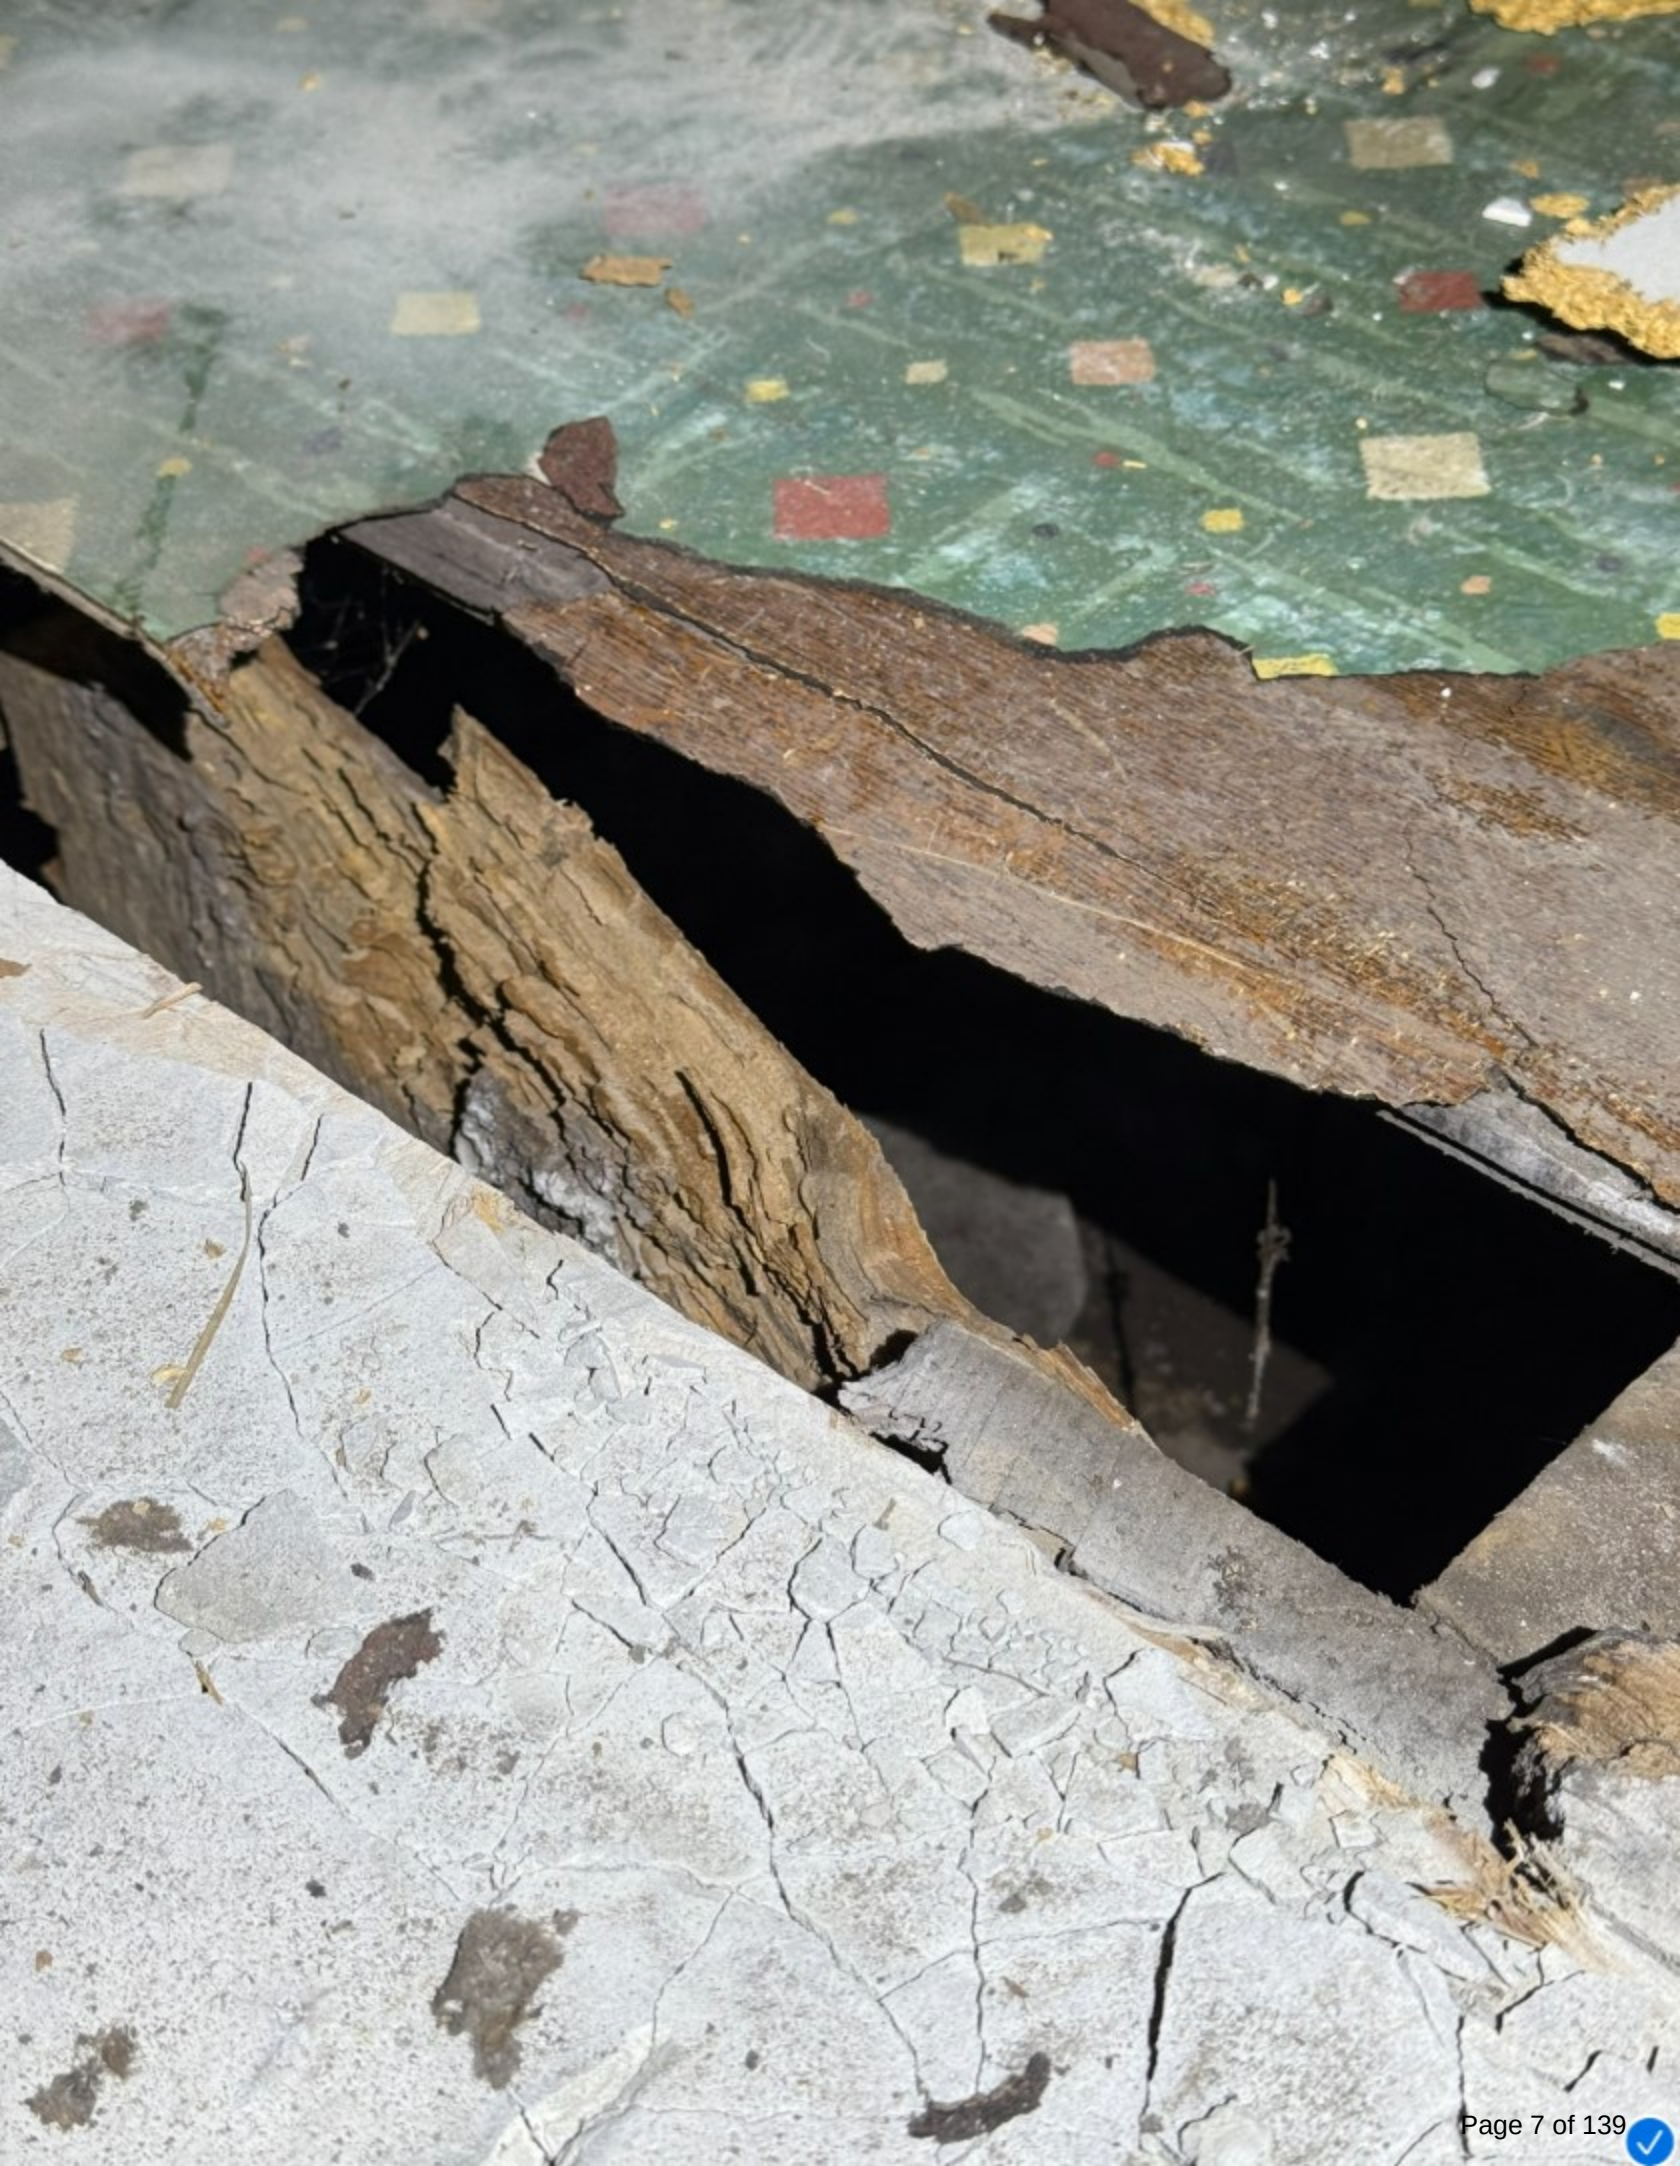
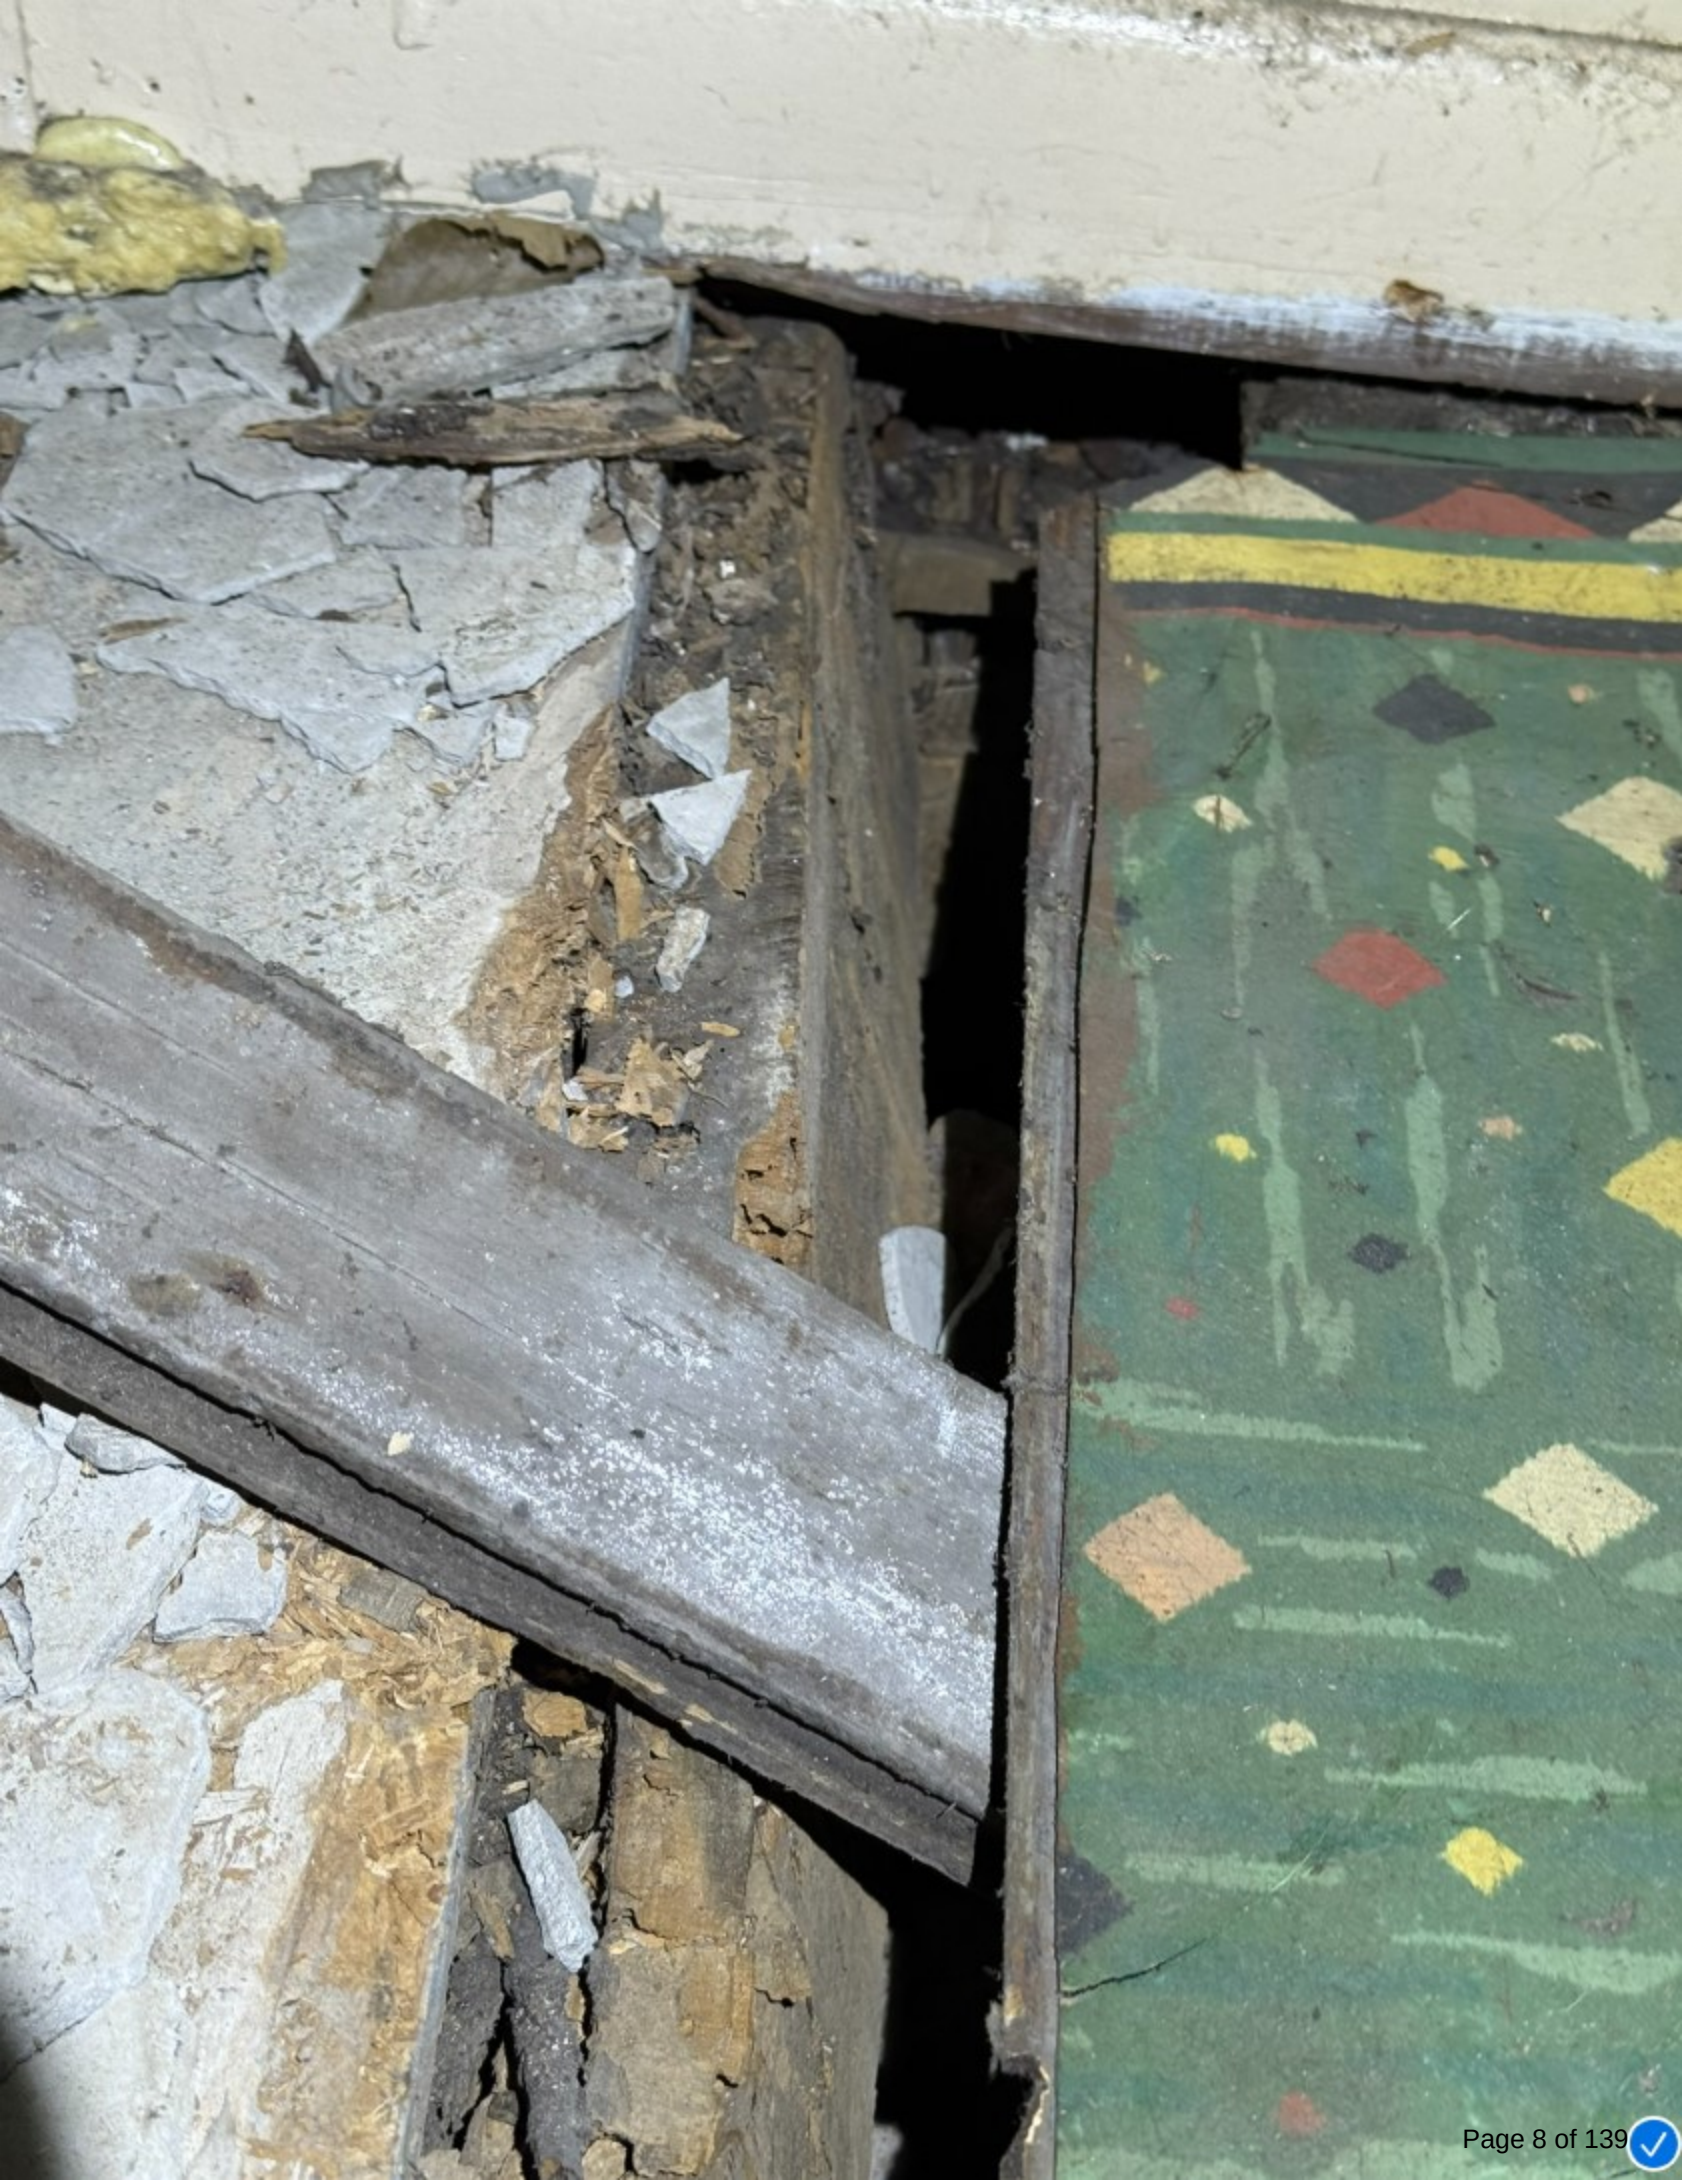
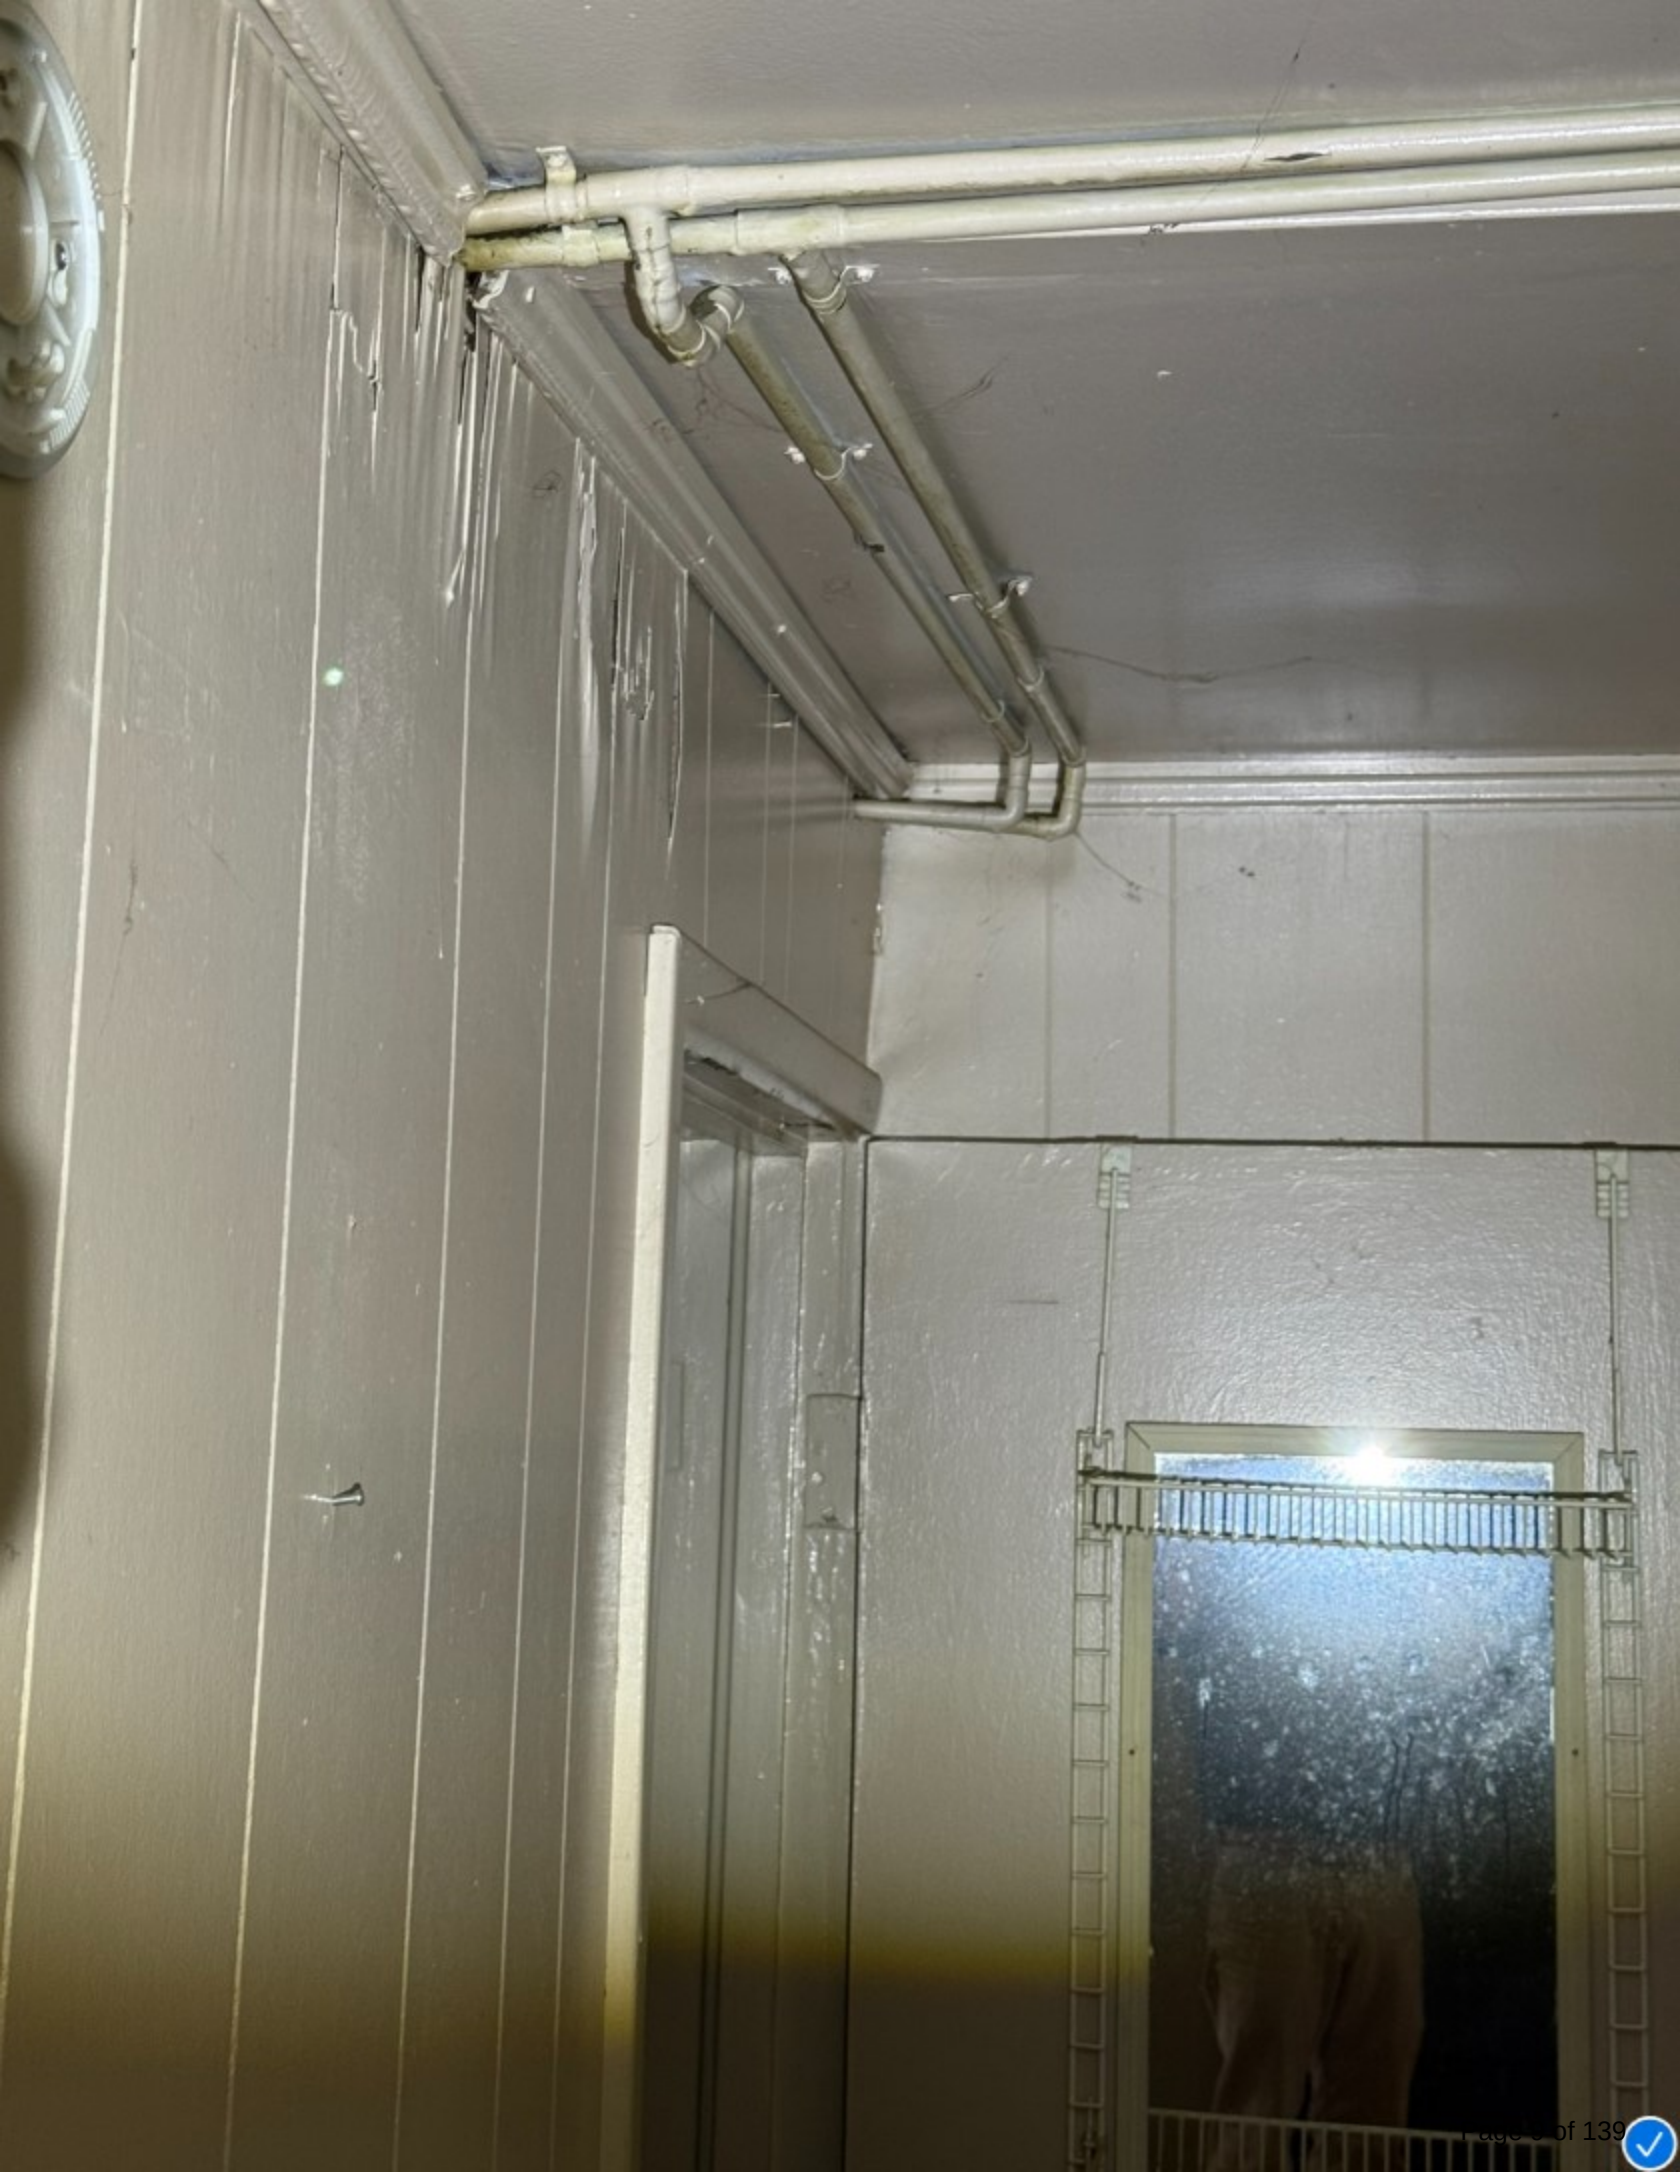
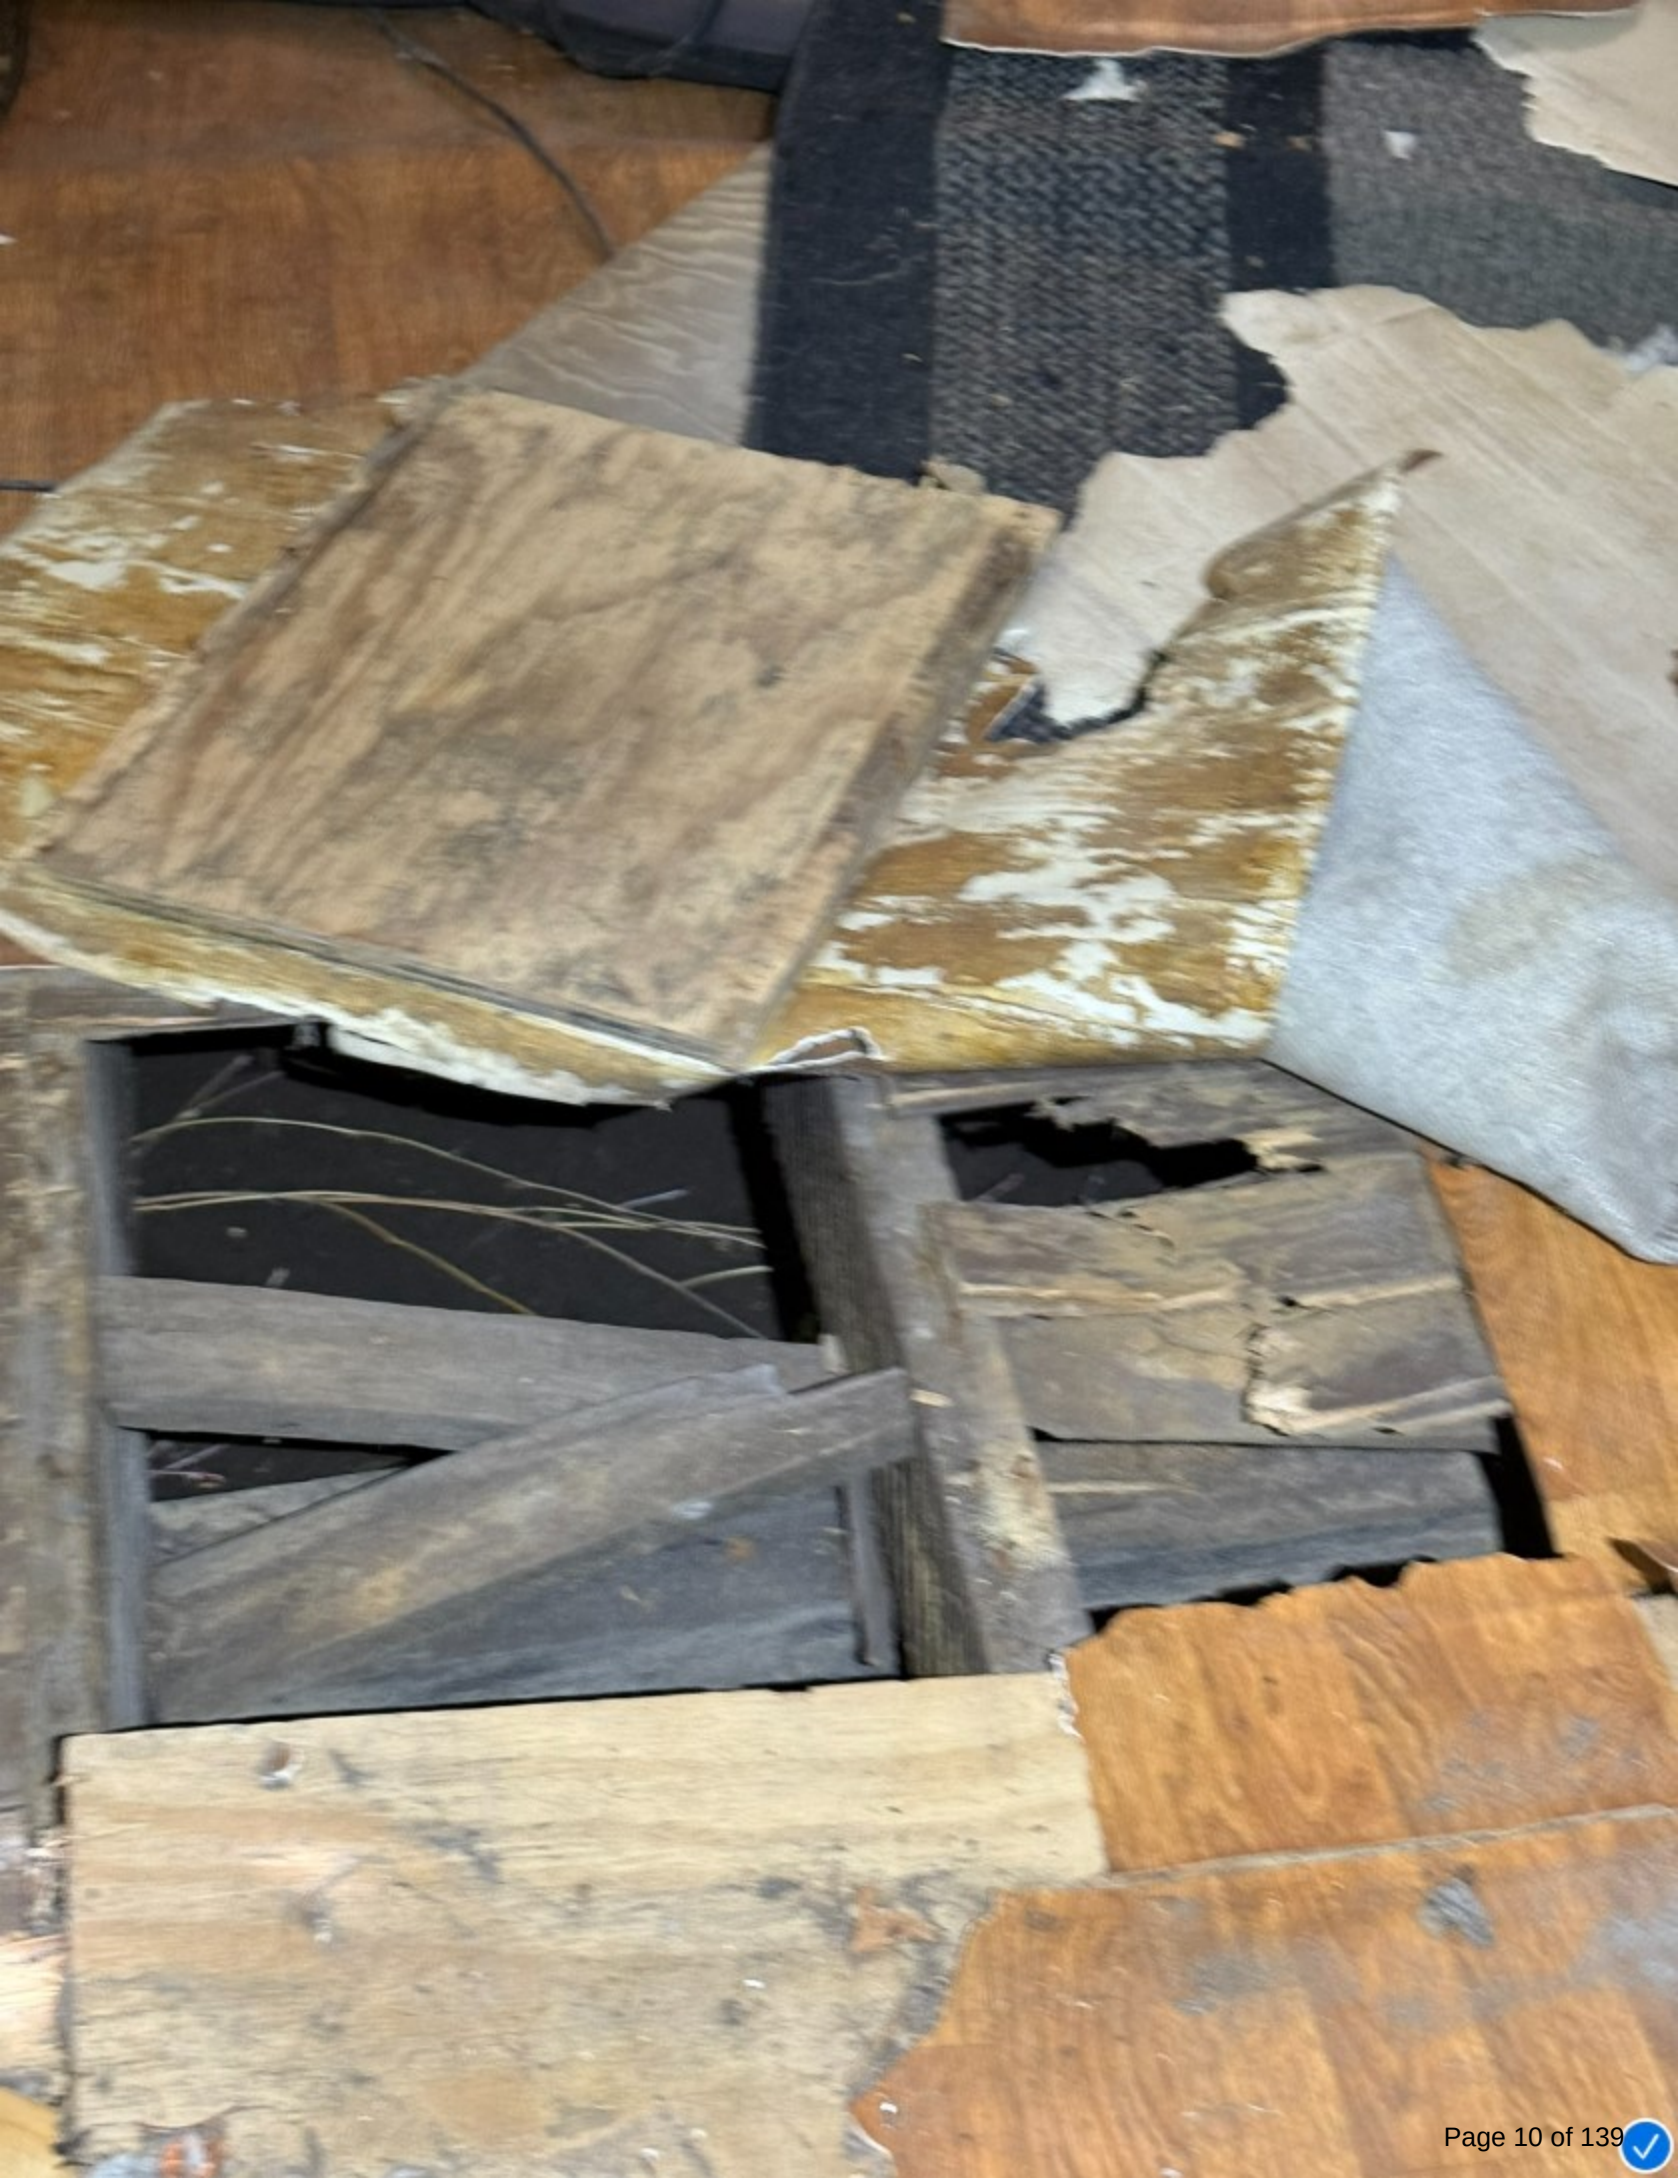
The house apparently has no foundation, and the floor system basically sets on the ground or, at best, on loose corner stones. Un-mortared masonry, rocks and concrete test cylinders form somewhat of a cover skirt around the perimeter, but they provide virtually no support for the structure. (See Photos 2-7.)
