## City of Franklin

#### Design Review Committee

1. Discussion of Demolition At 119 Church St.; John Ligon, Applicant.
2. Discussion Of A Historic Zoning Commission Recommendation For Public Art At 1221 Columbia Ave.; Laurie McPeak, Applicant.
3. Discussion Of Awning Alterations At 900 Fair St.; Stephen Scott, Applicant.
4. Discussion Of Partial Demolition And An Addition (Principal) At 212 Lewisburg Ave.; Don Burke, Applicant.
5. Discussion Of An Addition (Principal) And Partial Demolition (Accessory Structure) At 305 3rd Ave. S.; Brandon Priddy, Applicant.
6. Discussion Of New Construction At 1845 William Campbell Ct. (Lot 7 At Magnolia Hall); Maria Ortiz, Applicant.
7. Discussion Of New Construction At 1855 William Campbell Ct. (Lot 11 At Magnolia Hall); Maria Ortiz, Applicant.

Preferred Builders and Associates – 119 Church St – Framing

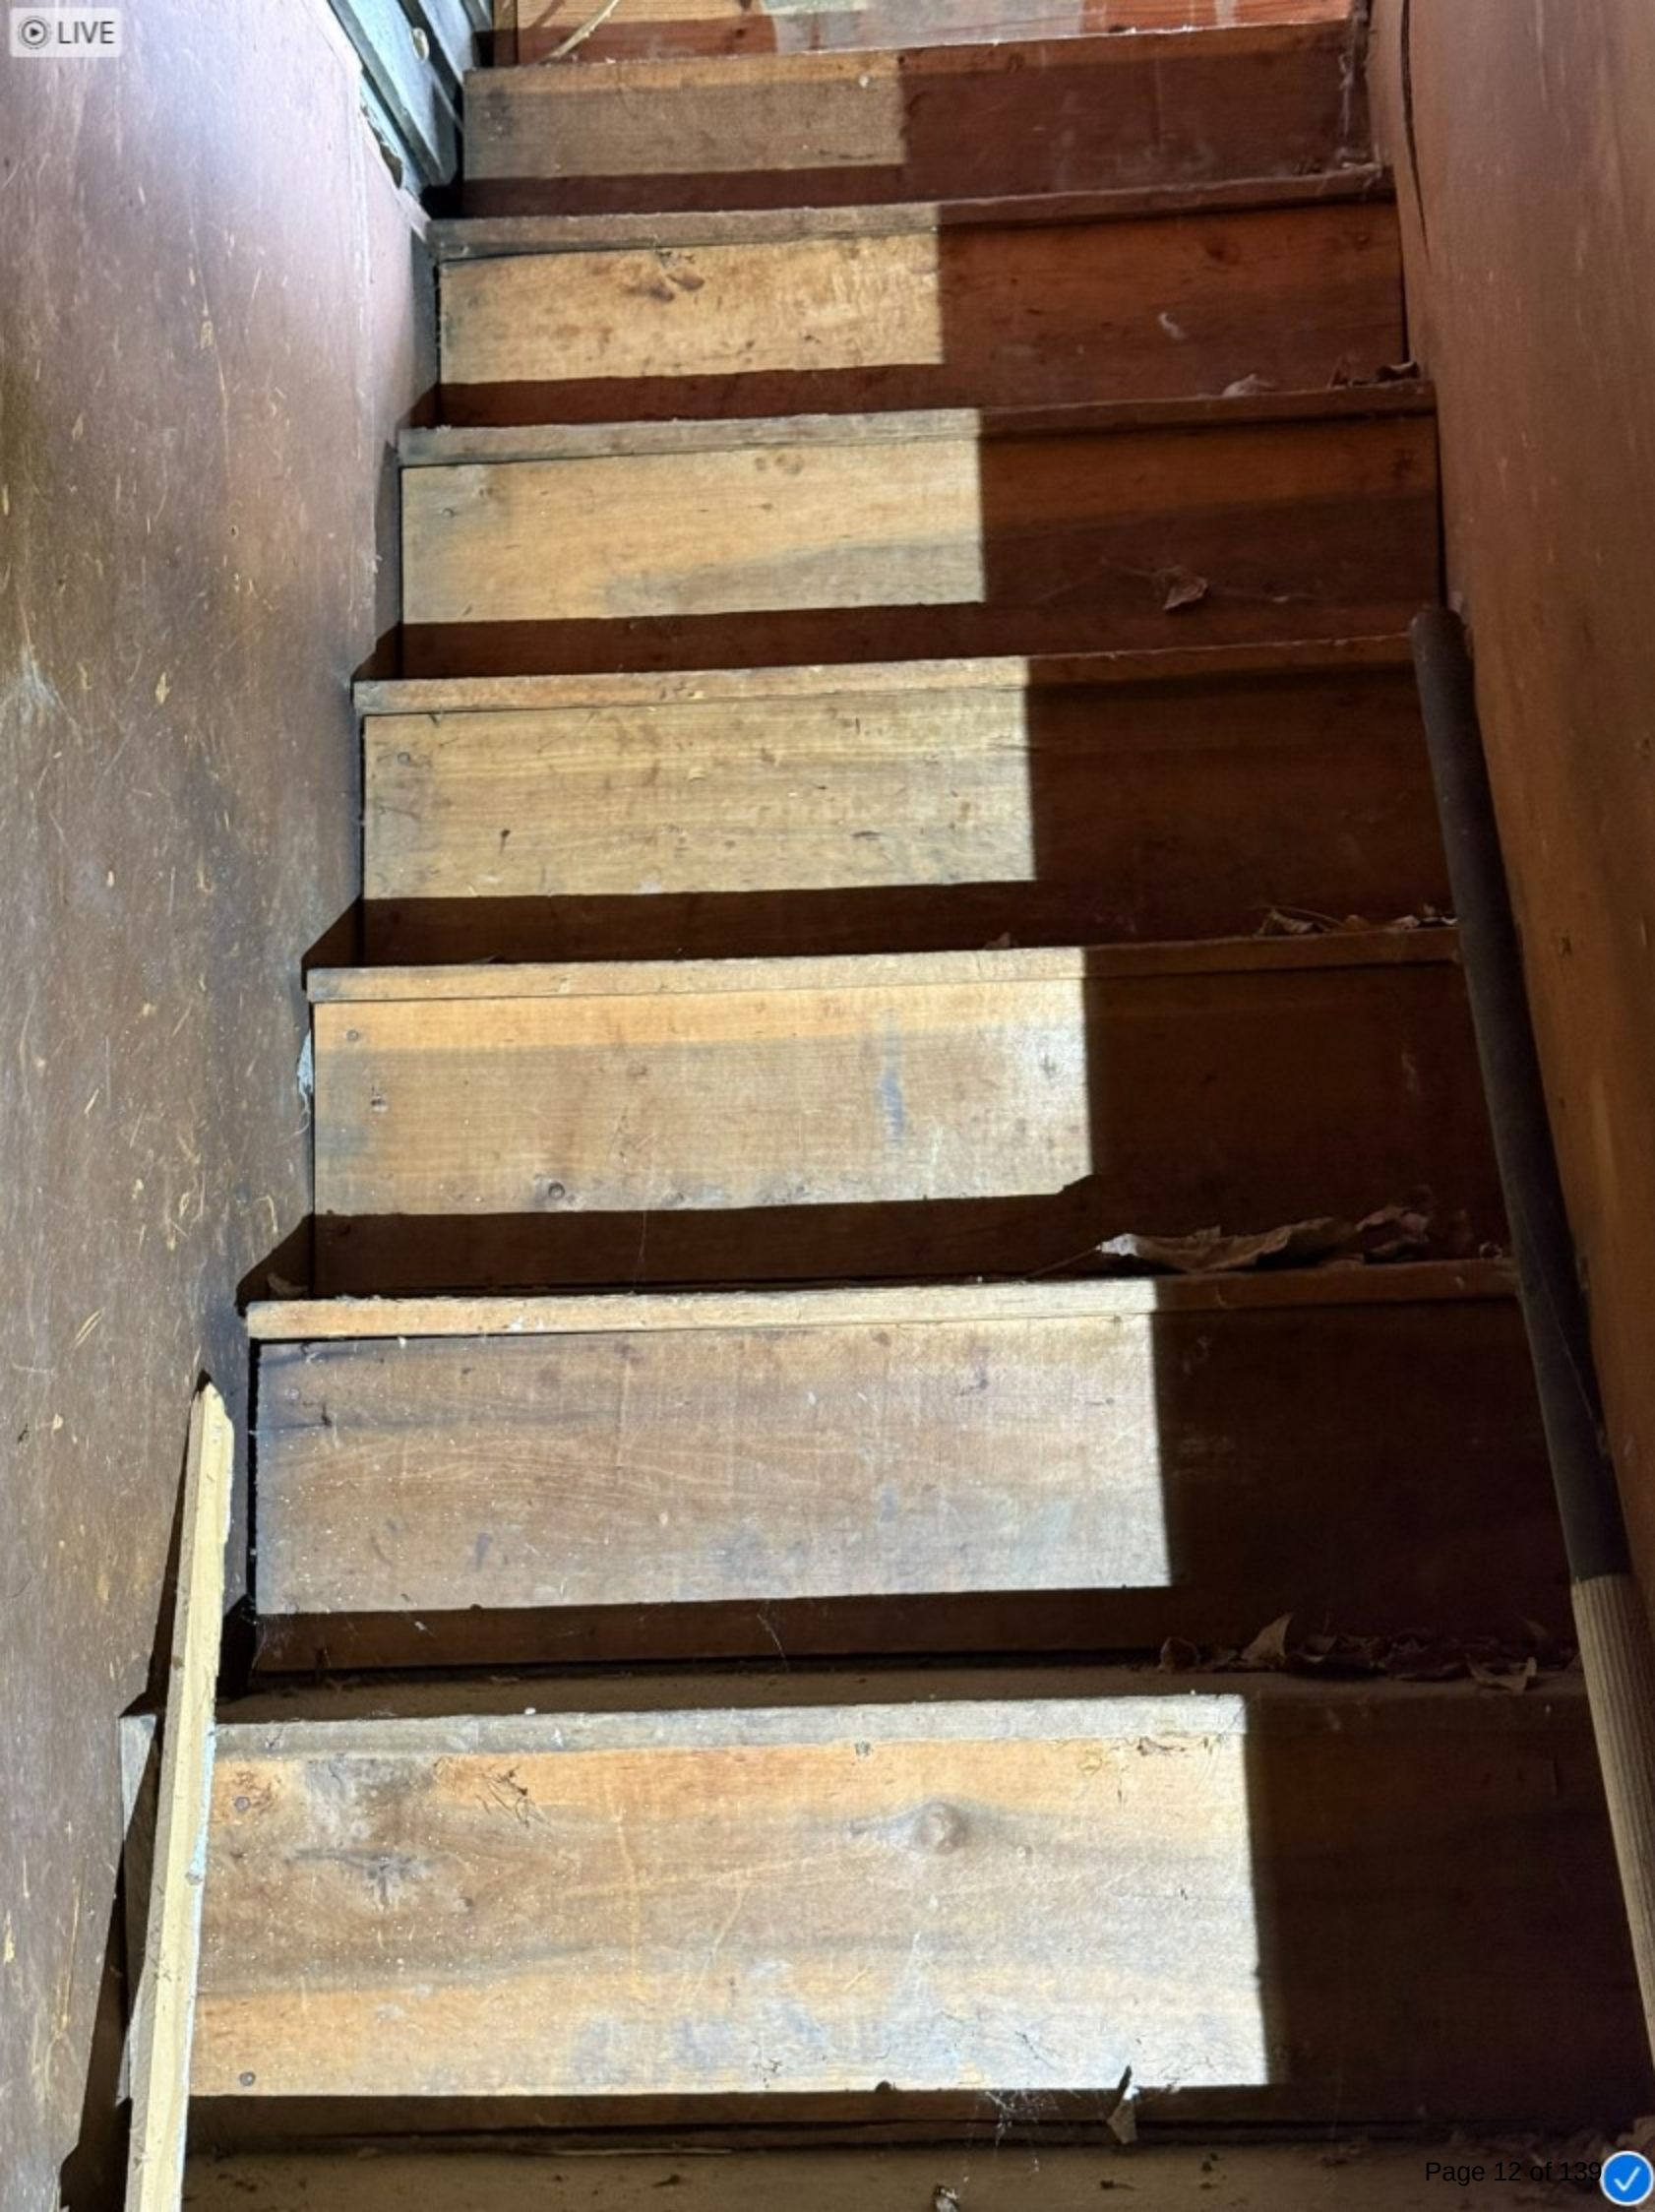
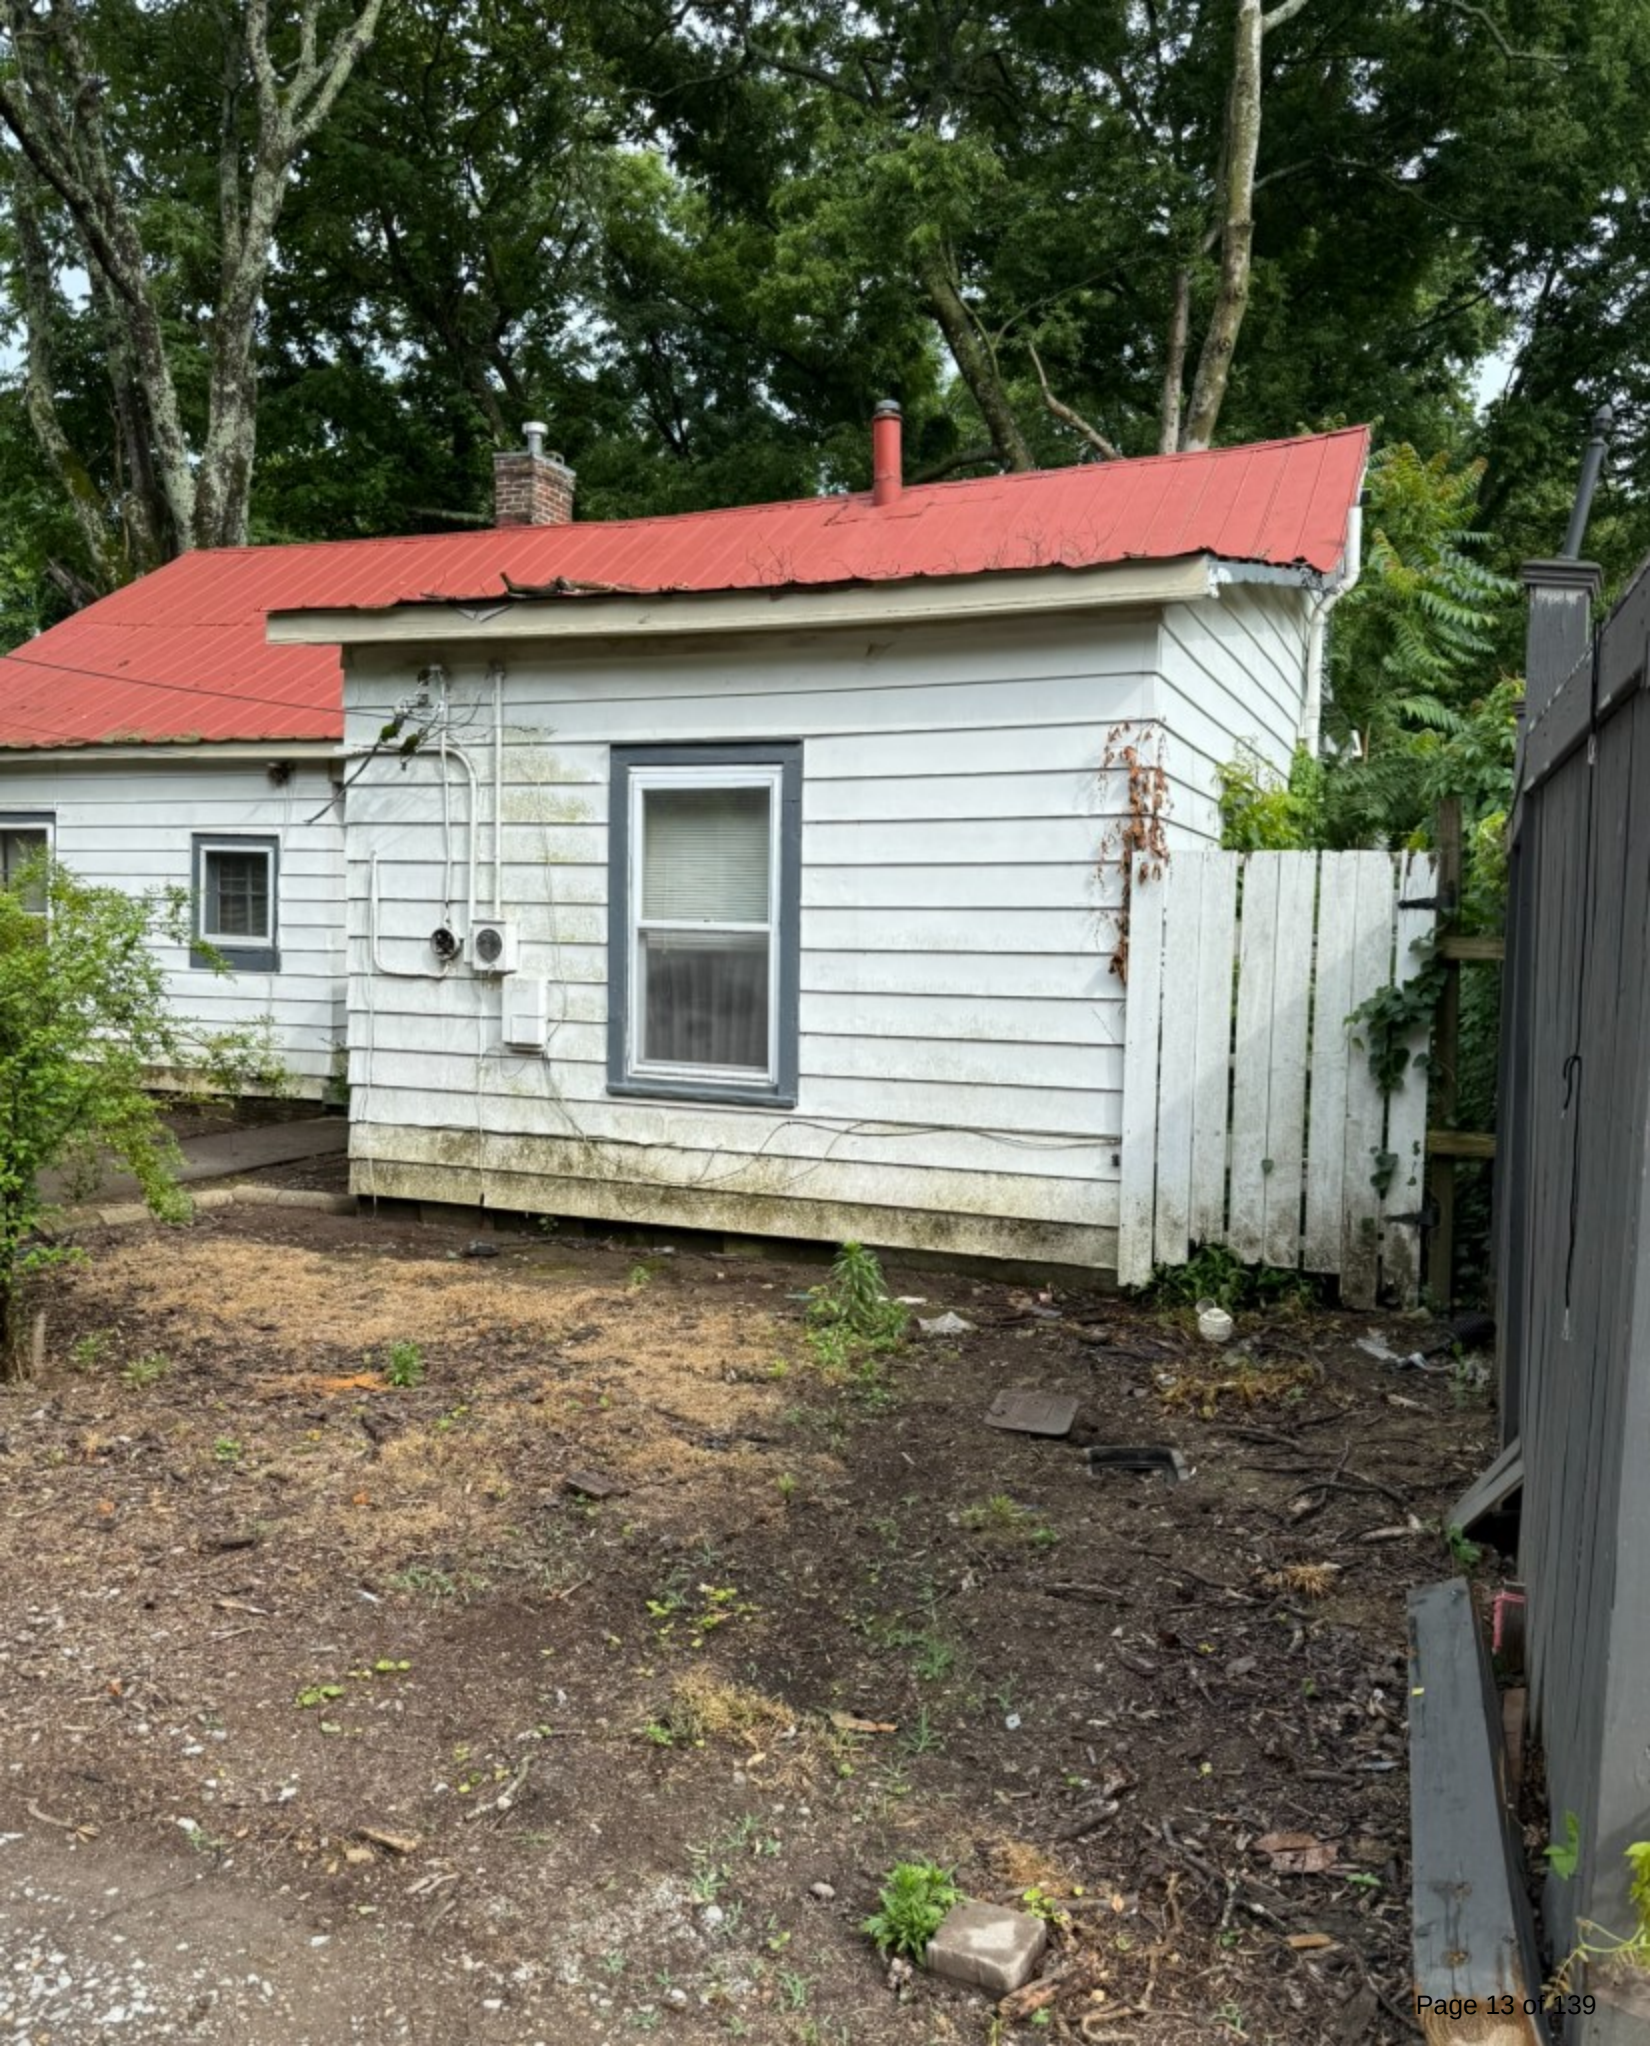
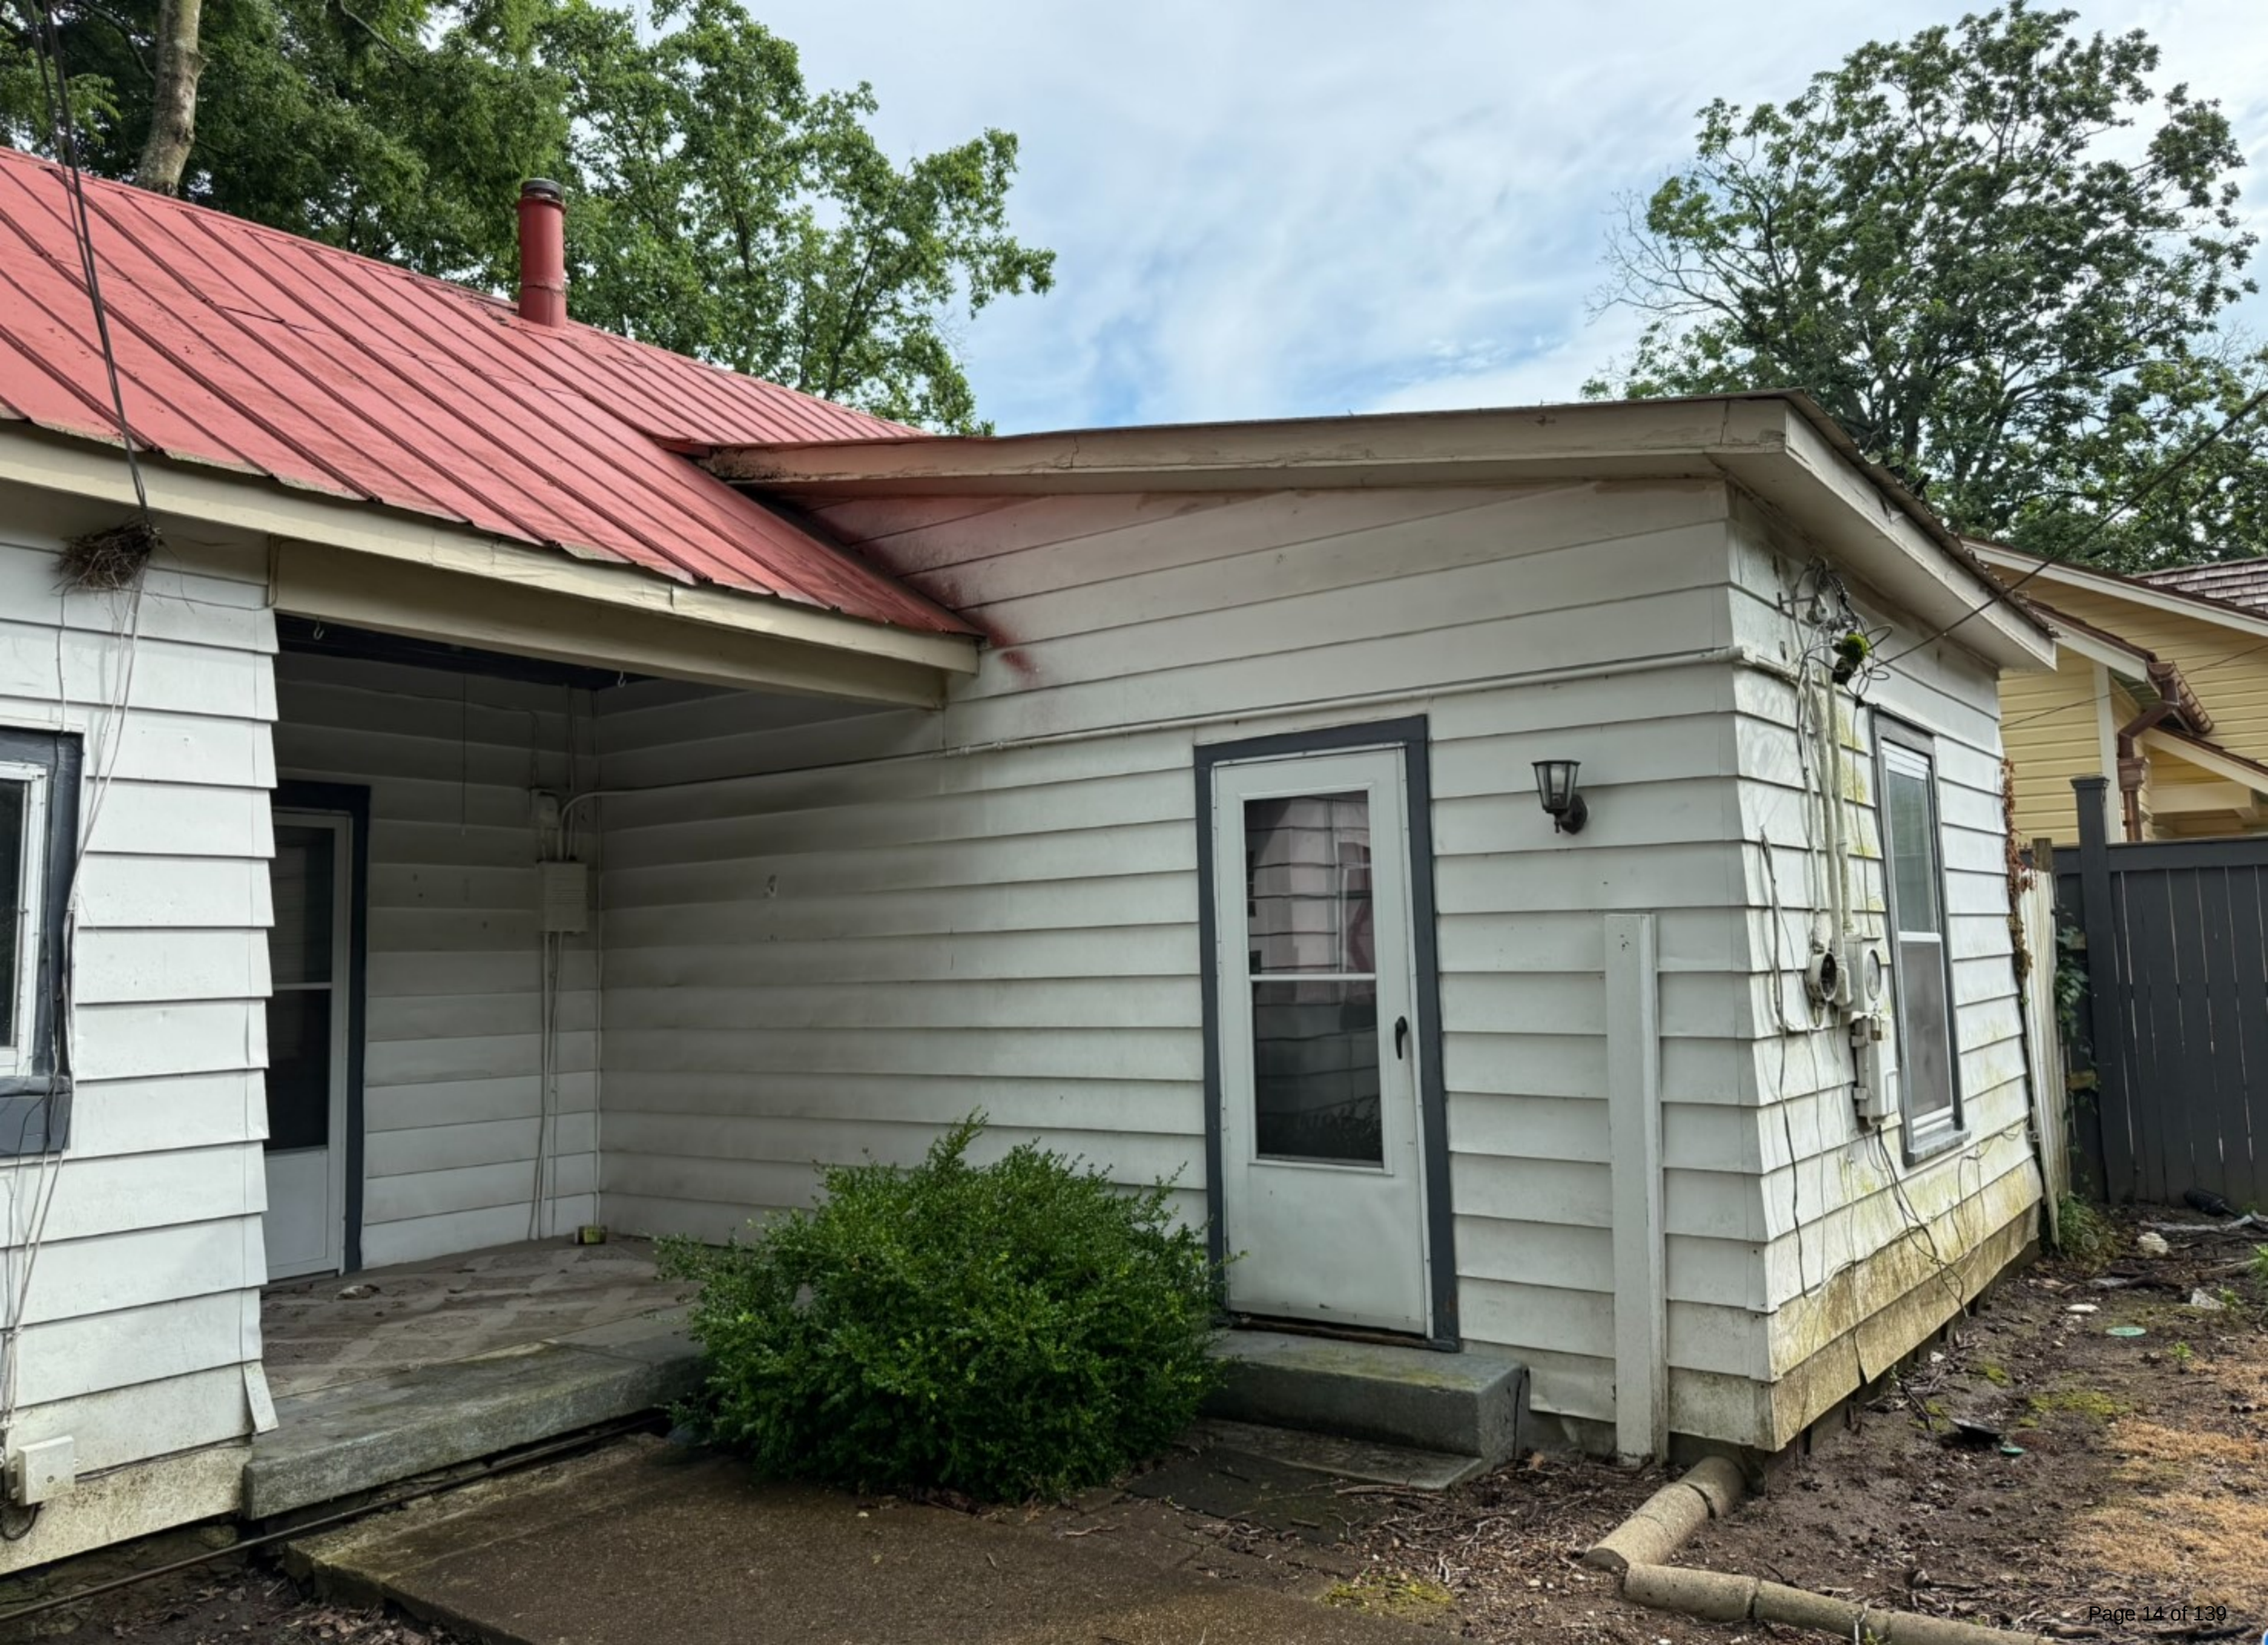
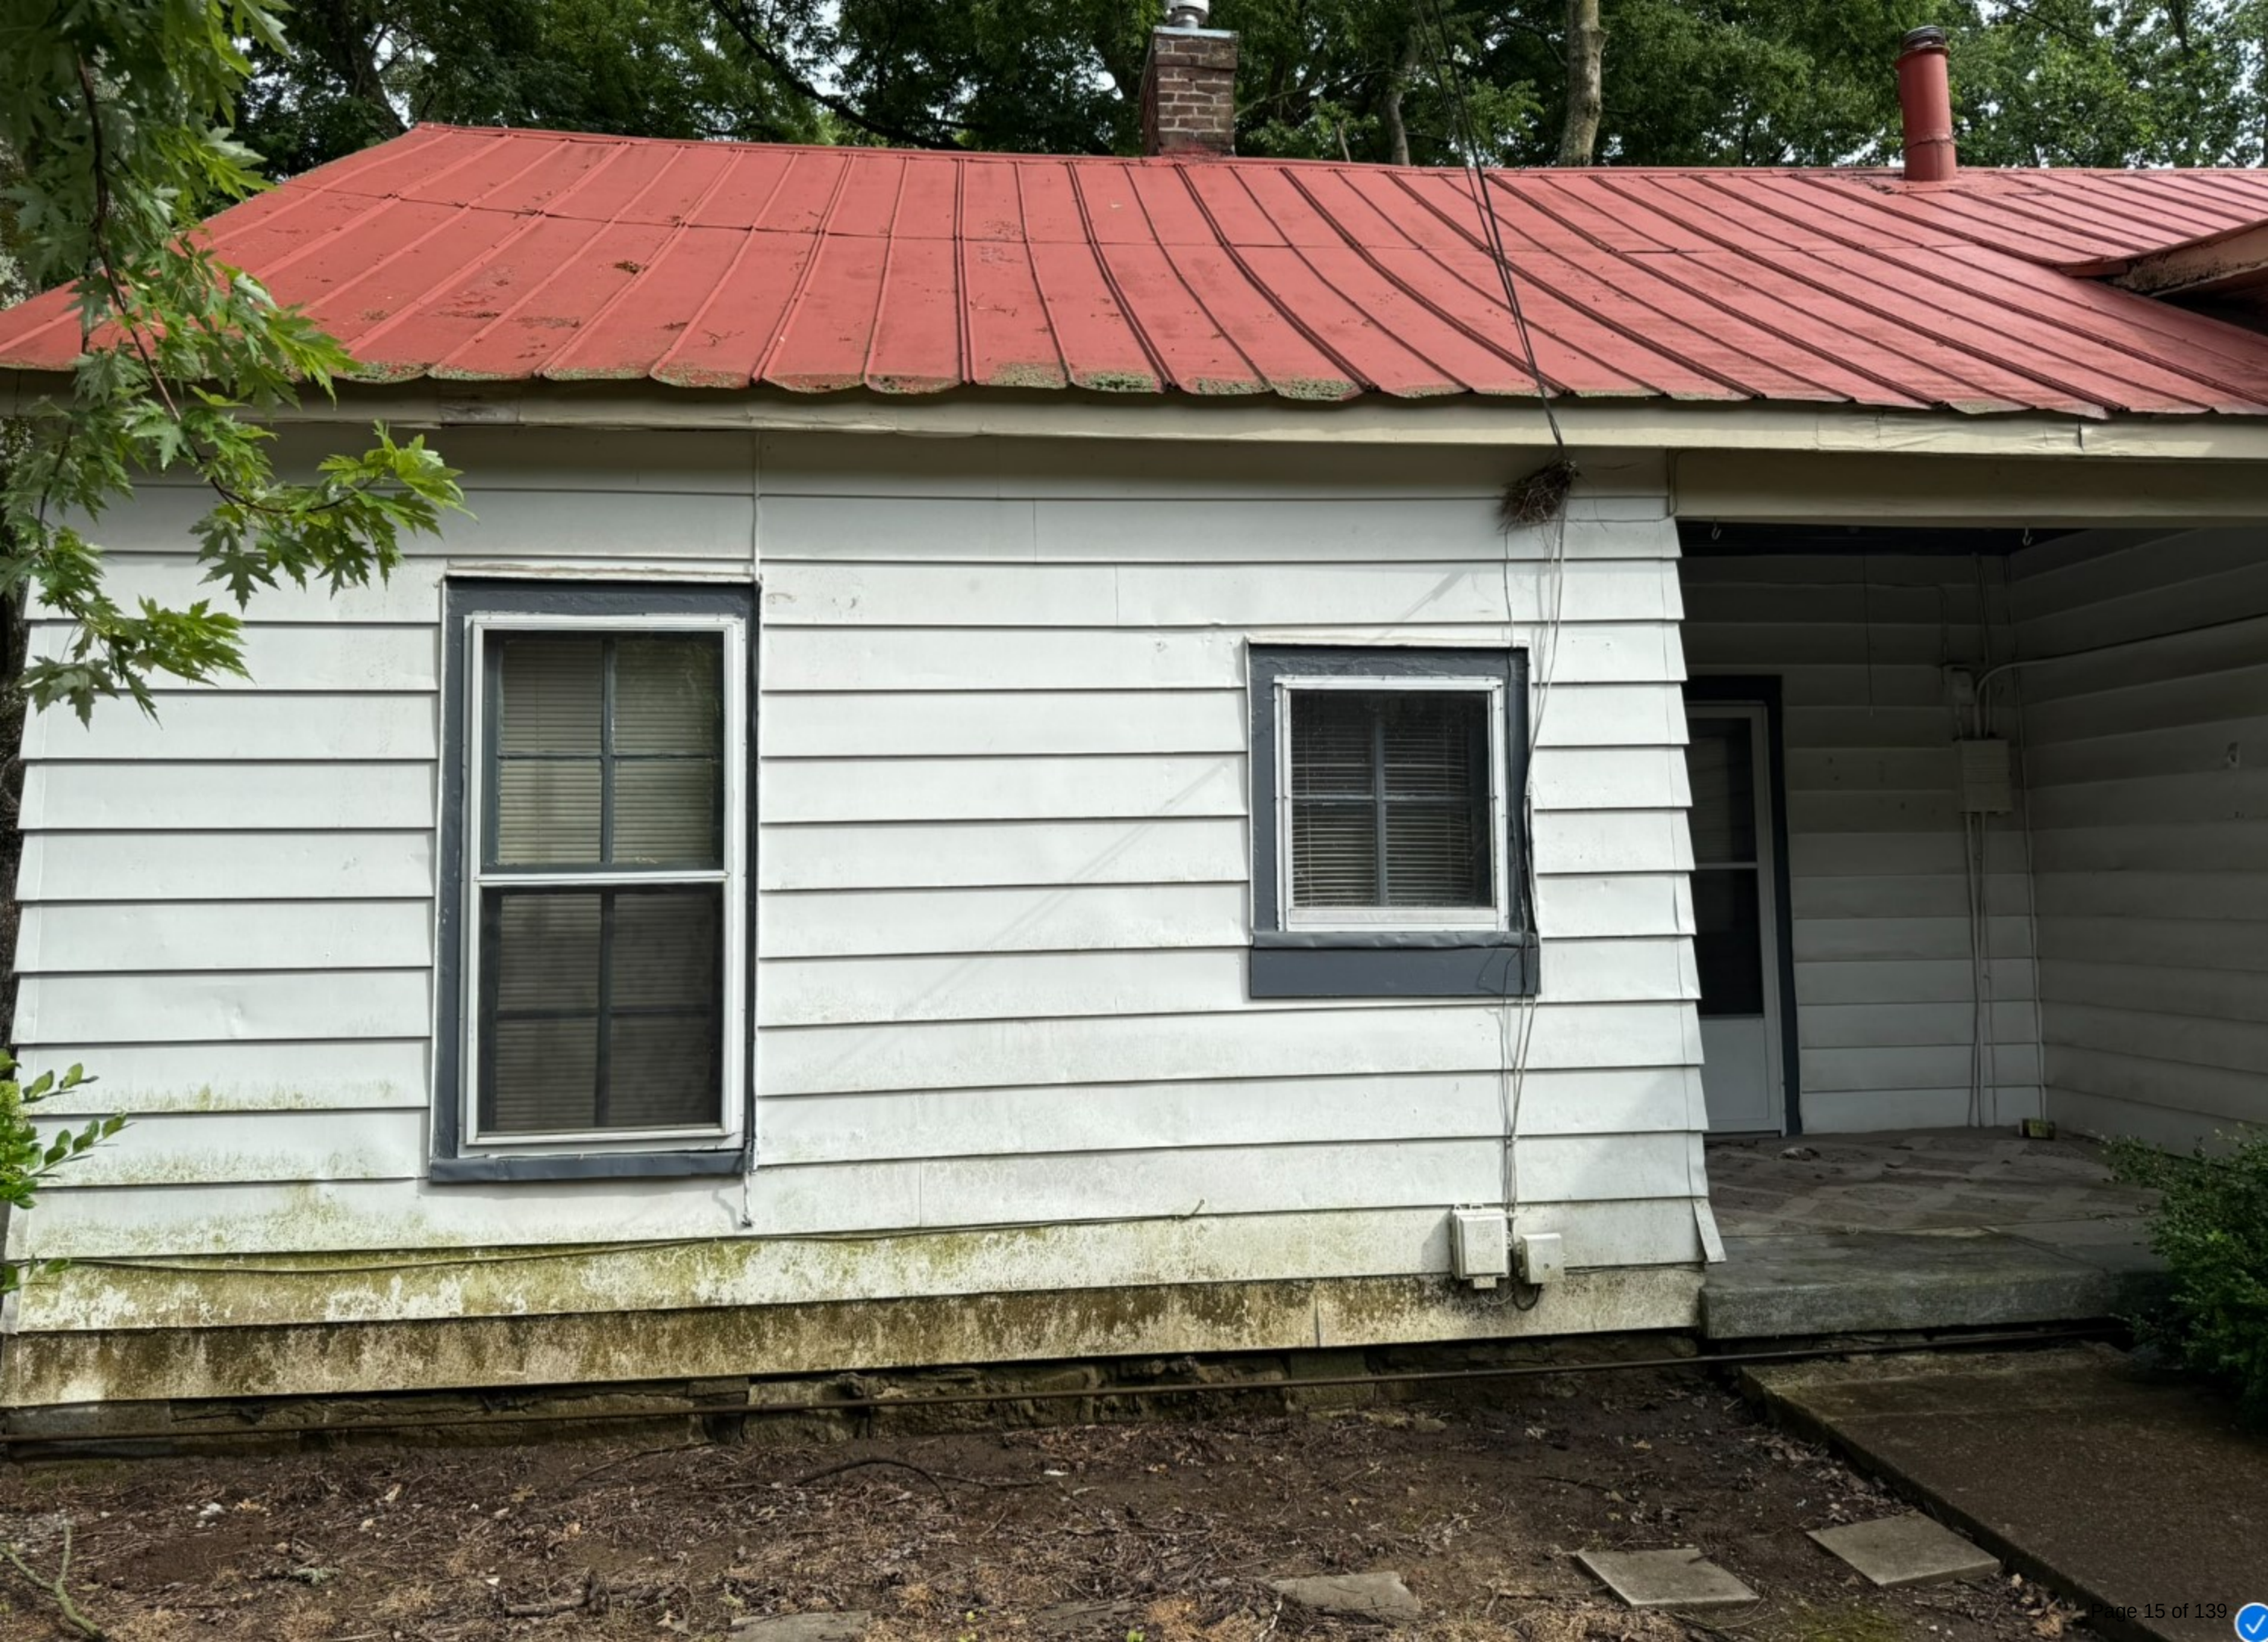
There was major damage noted in the rear of the house. A large tree that fell on the right rear section of the house. (See Photos 8-11.)

It is obvious that there was rotted lumber long before the tree fell on the building and the framing became moisture laden.

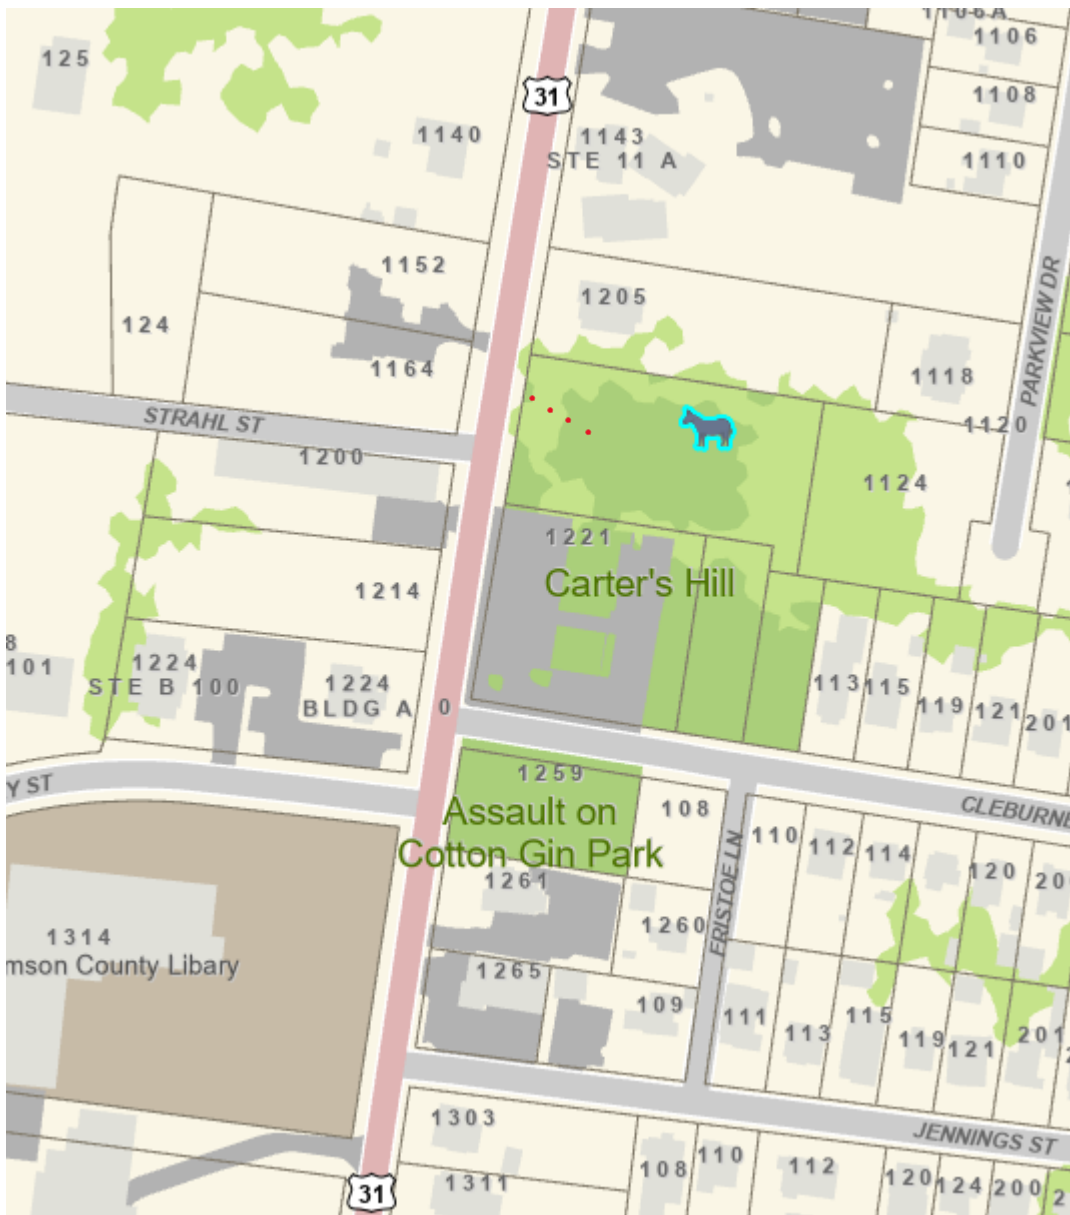
Anticipated location of

### May Me the Mule

\* WIDEST NOT INCLUDING HEAD  
38"

? HOW WIDE SHOULD BASE BE? 64"

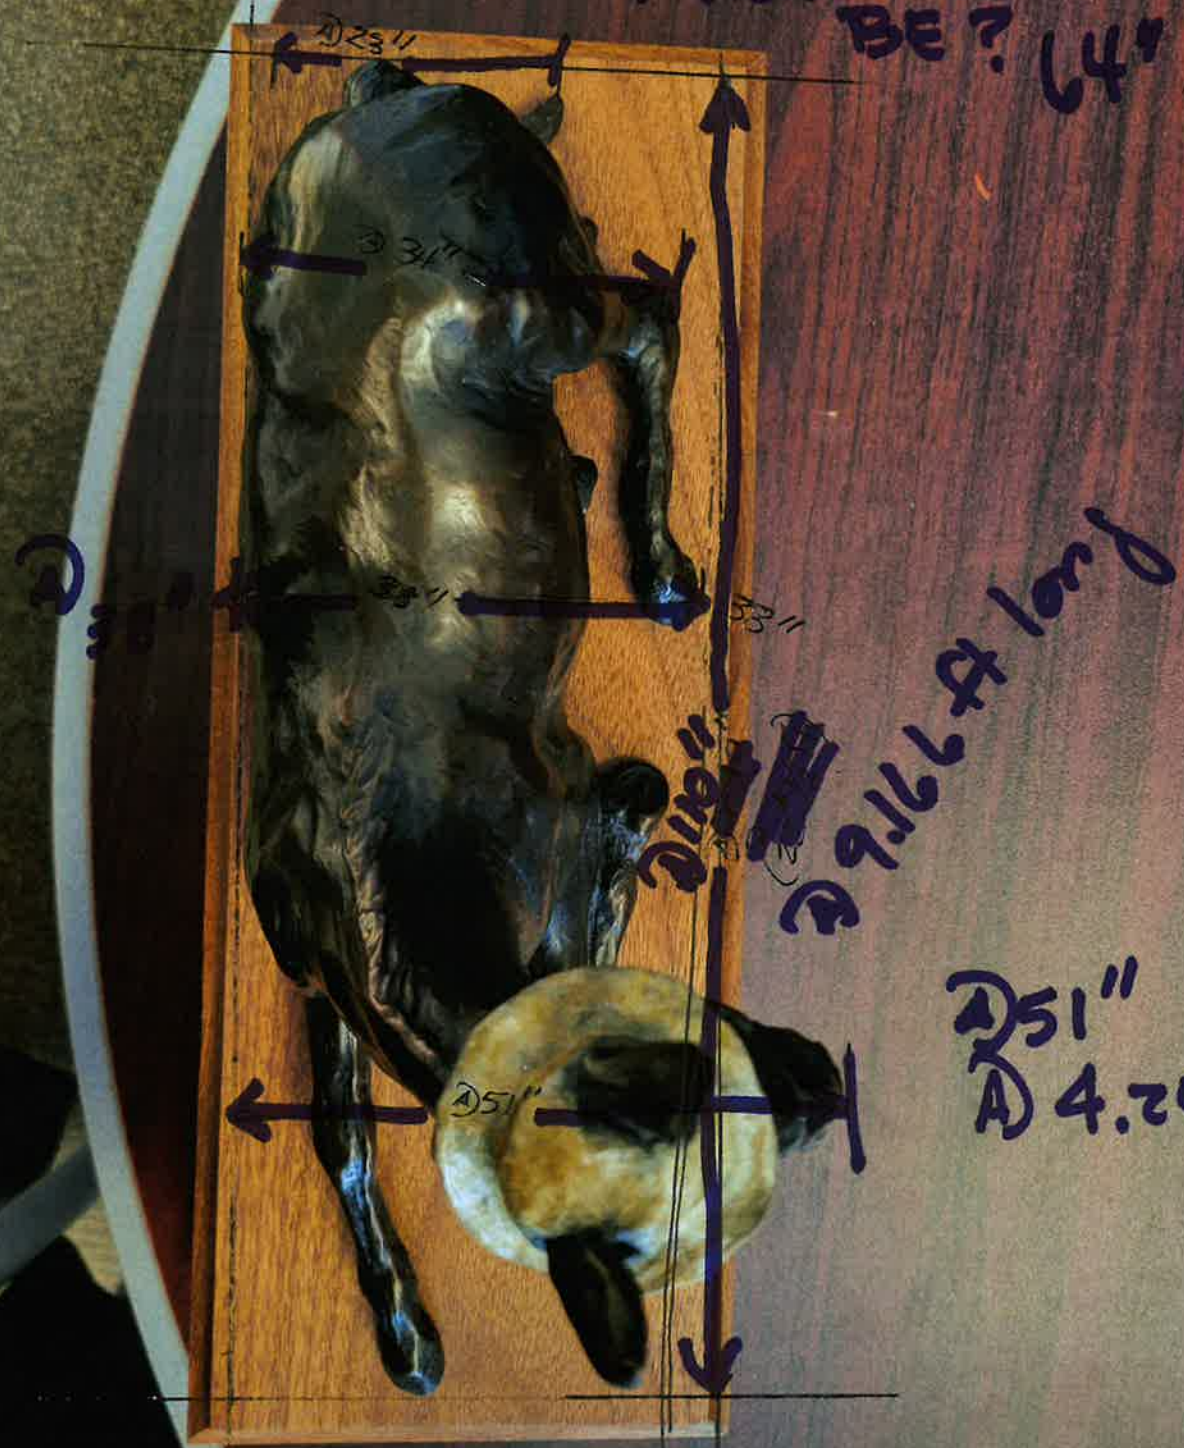
9.16 ft long

51"  
4.25 ft

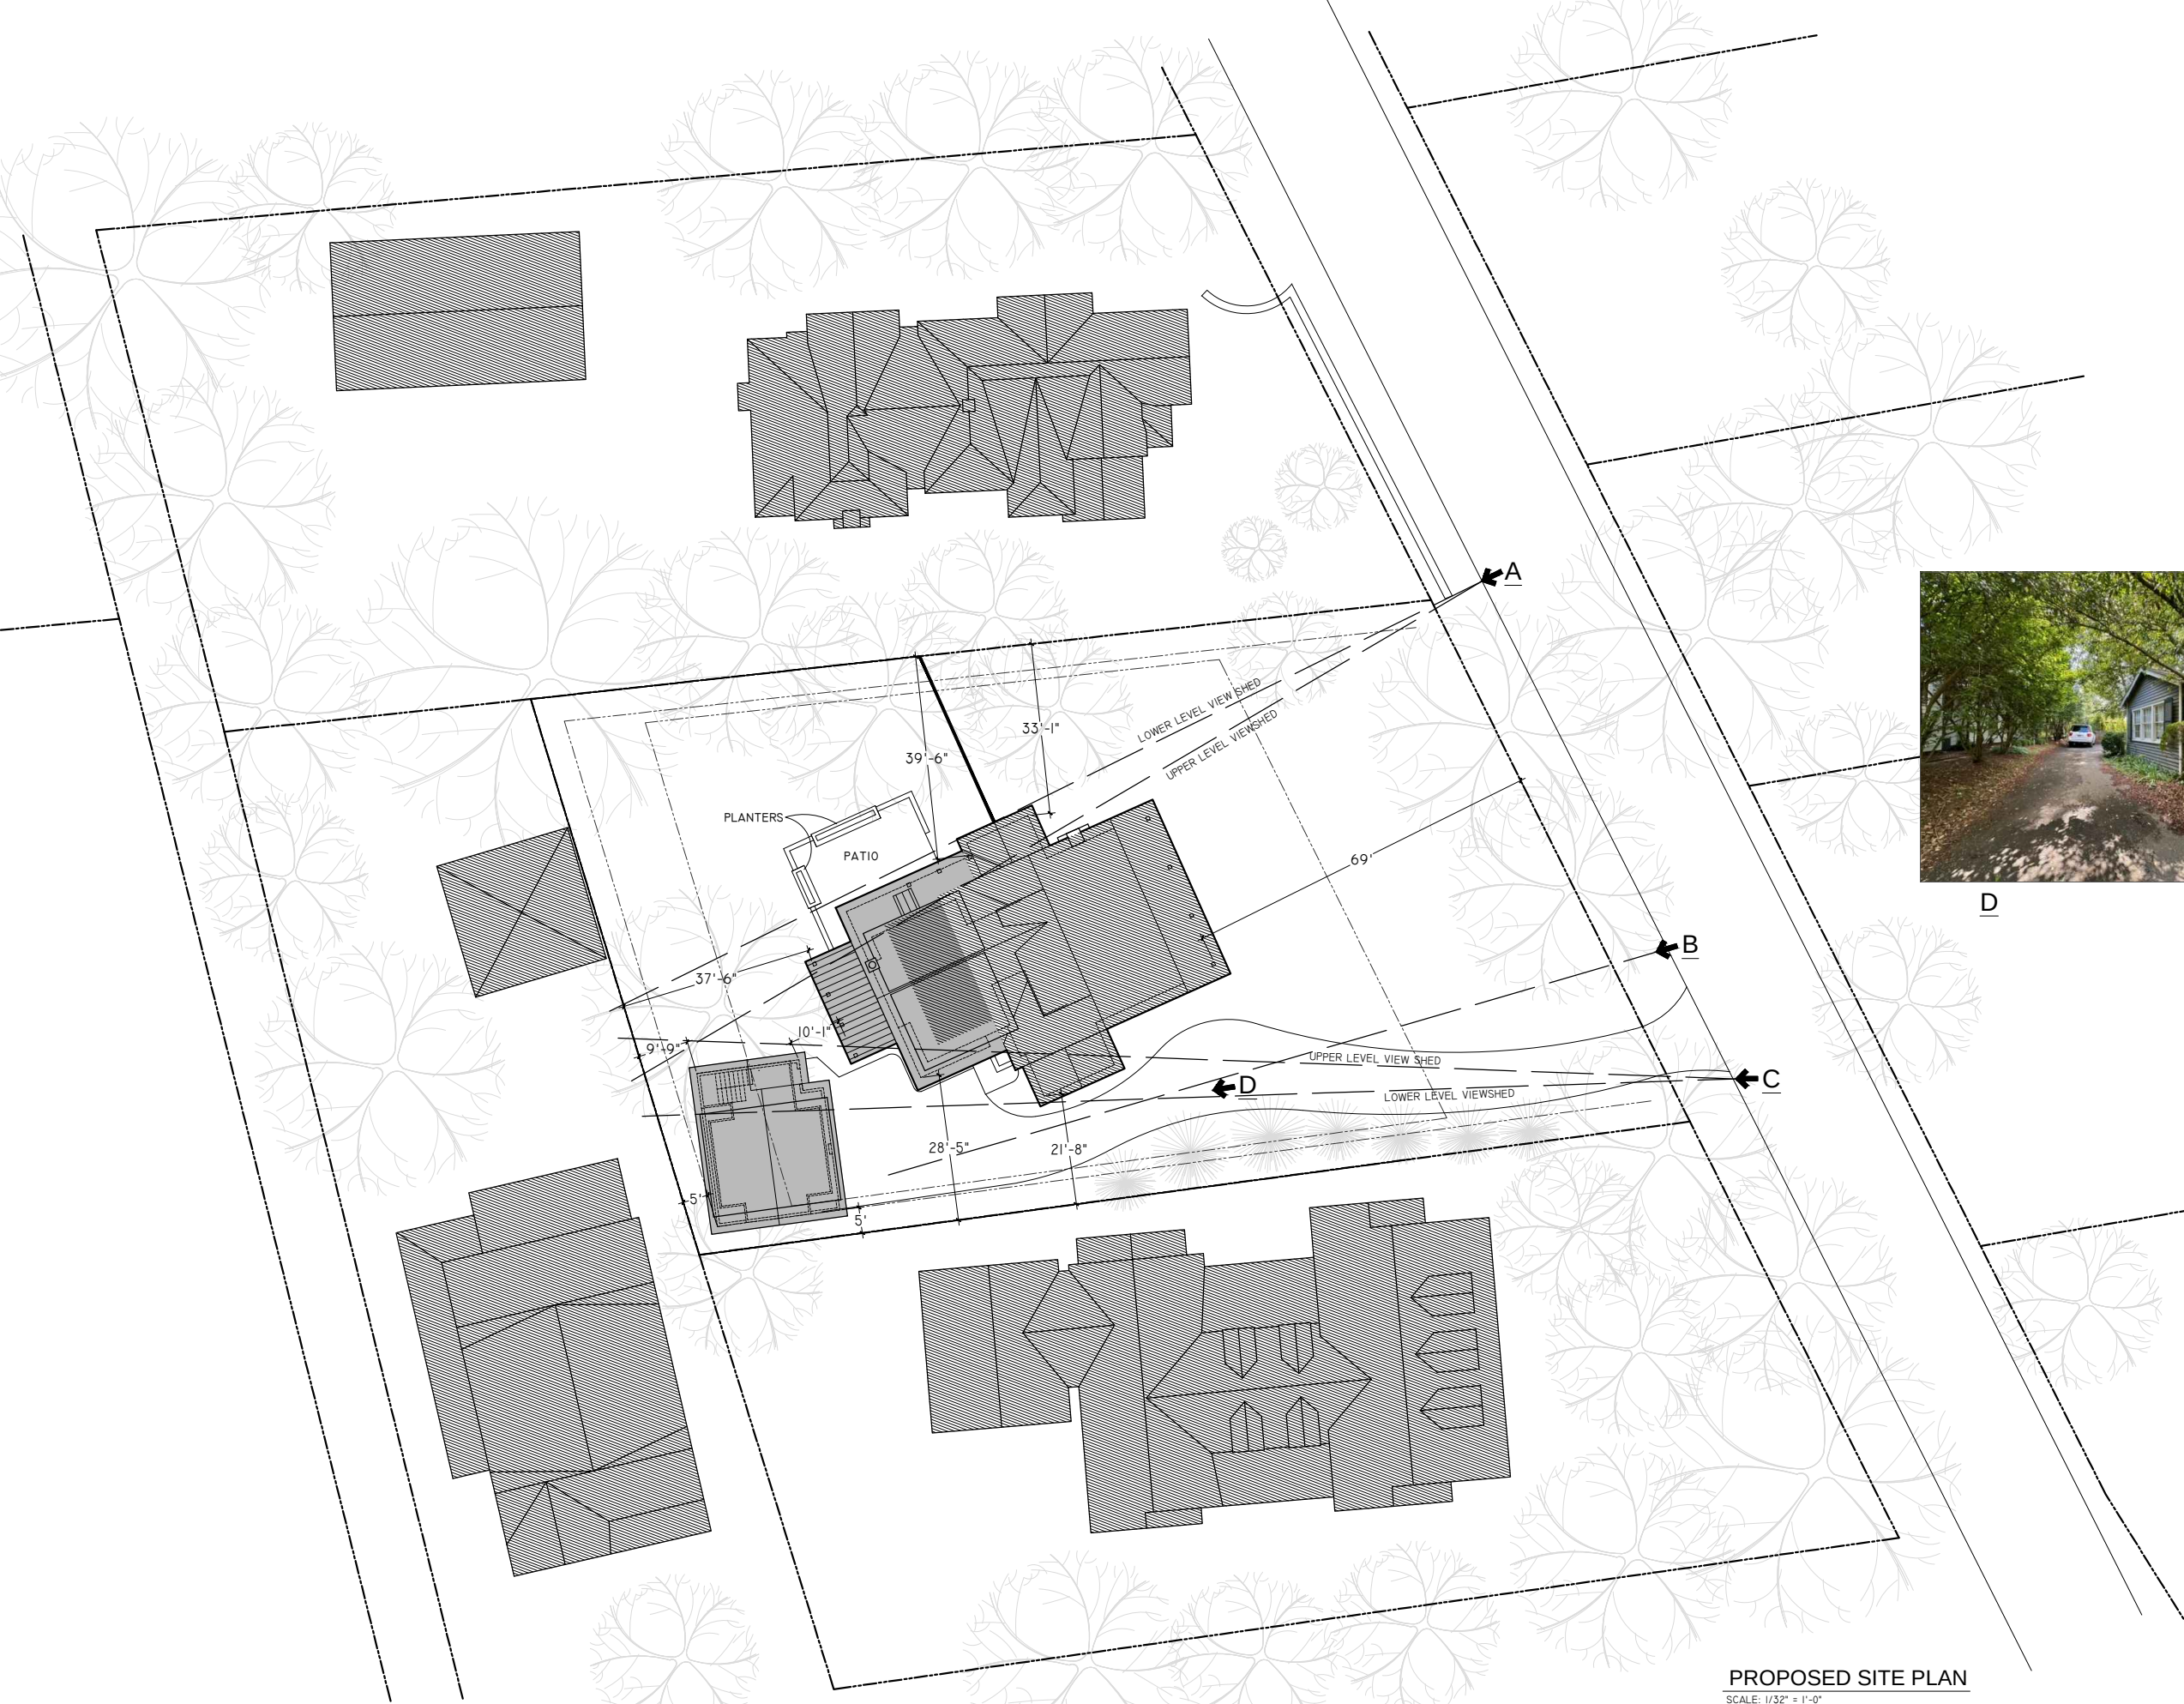
PROPOSED SITE PLAN  
SCALE: 1/32" = 1'-0"

+ TOTAL PROPOSED HARDSCAPE: 3,028 SQFT  
TOTAL IMPERVIOUS: 6,862 SQFT  
PROPOSED RATIO: 34%

ALLOWABLE RATIO: 35%

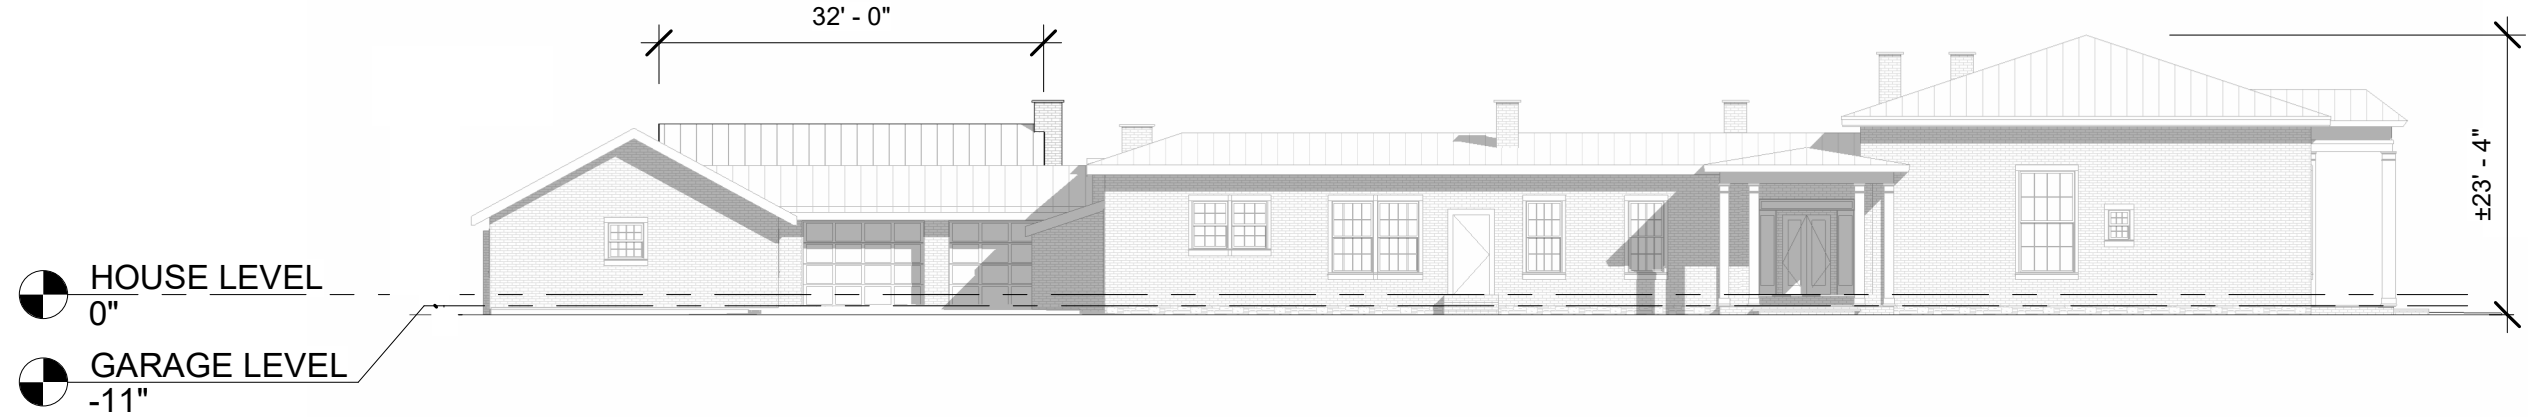
2 S. MARGIN ST. ELEVATION - WEST  
1/16" = 1'-0" 0' 8' 16' 32'
