## City of Franklin

#### Design Review Committee

1. Discussion of Demolition At 119 Church St.; John Ligon, Applicant.
2. Discussion Of A Historic Zoning Commission Recommendation For Public Art At 1221 Columbia Ave.; Laurie McPeak, Applicant.
3. Discussion Of Awning Alterations At 900 Fair St.; Stephen Scott, Applicant.
4. Discussion Of Partial Demolition And An Addition (Principal) At 212 Lewisburg Ave.; Don Burke, Applicant.
5. Discussion Of An Addition (Principal) And Partial Demolition (Accessory Structure) At 305 3rd Ave. S.; Brandon Priddy, Applicant.
6. Discussion Of New Construction At 1845 William Campbell Ct. (Lot 7 At Magnolia Hall); Maria Ortiz, Applicant.
7. Discussion Of New Construction At 1855 William Campbell Ct. (Lot 11 At Magnolia Hall); Maria Ortiz, Applicant.

Preferred Builders and Associates – 119 Church St – Framing

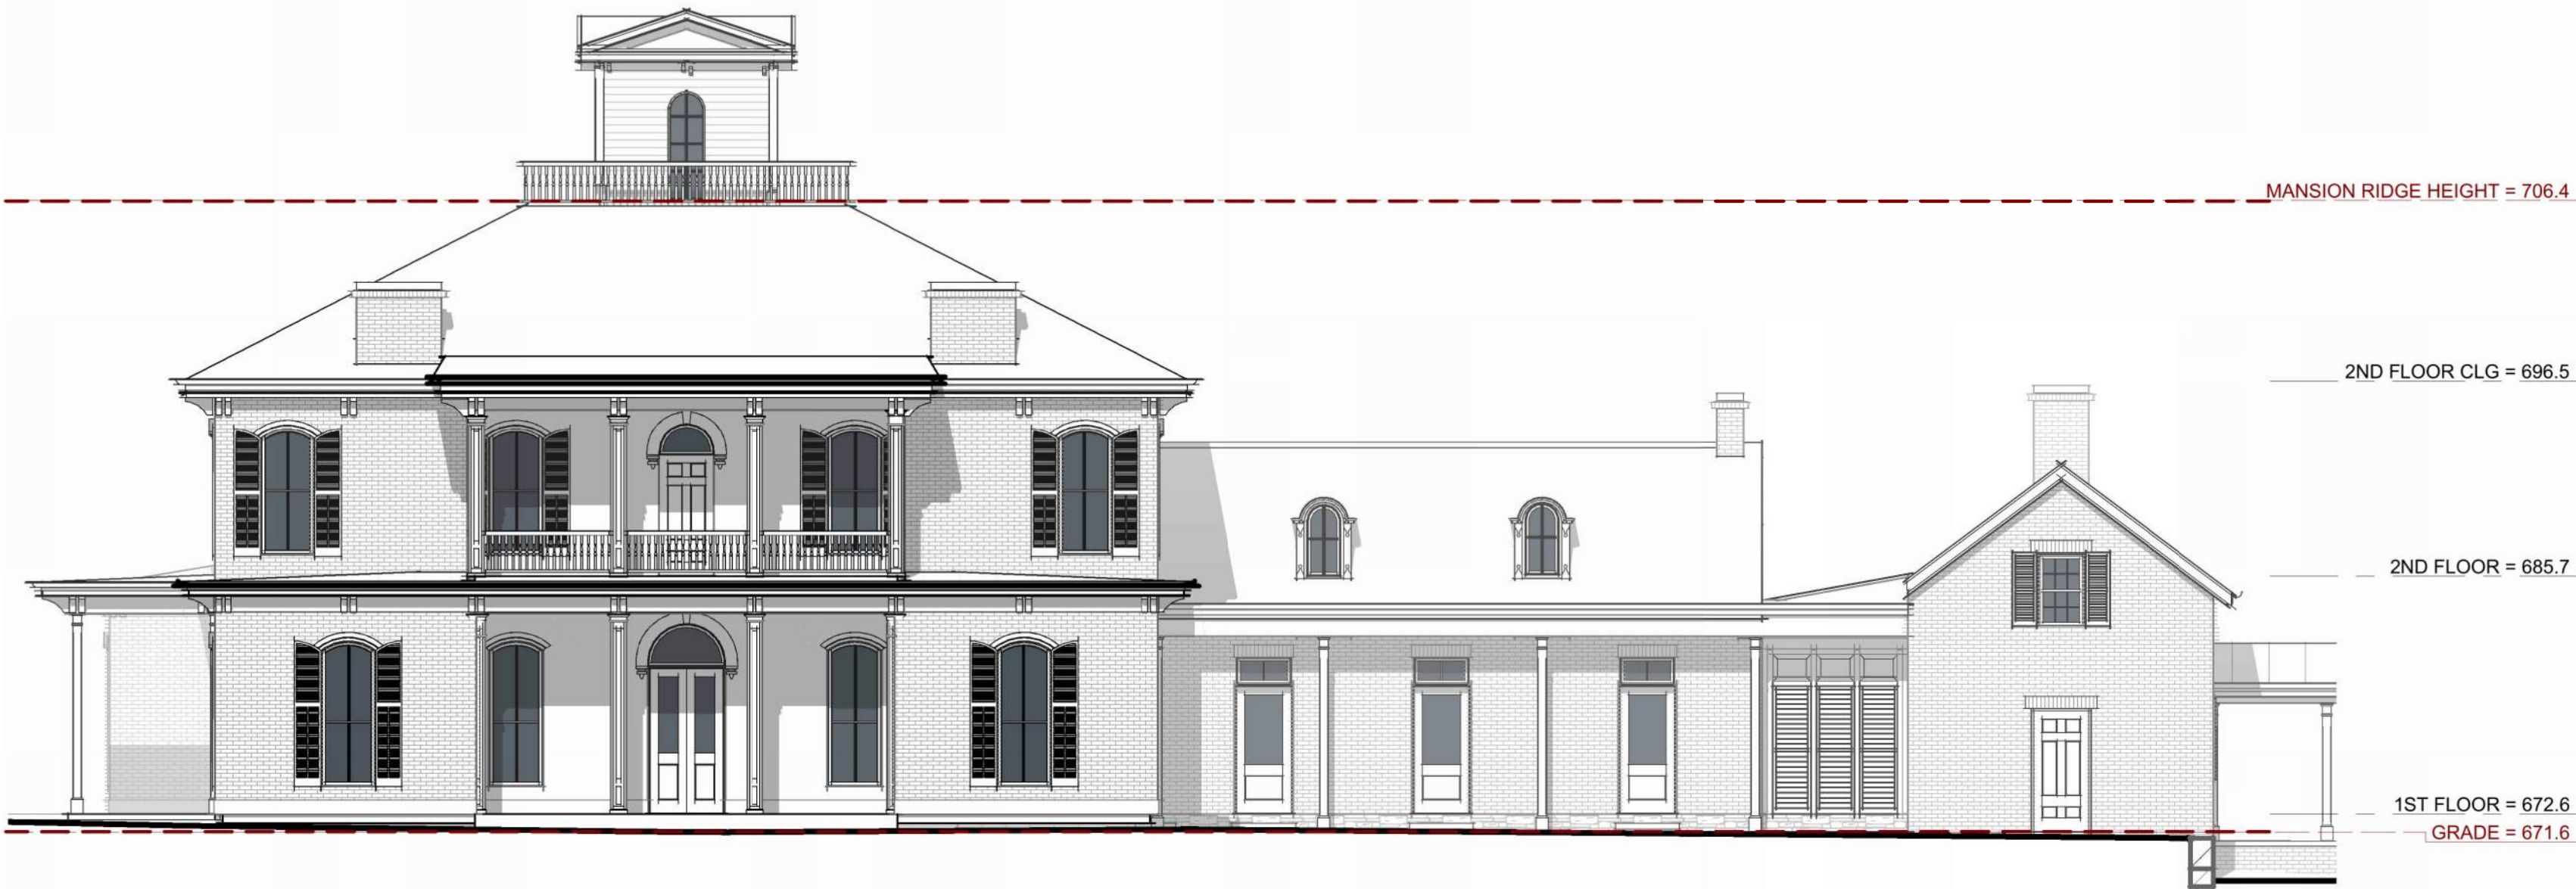
LOT 11 & MANSON HEIGHT DIAGRAM

1/8" = 1'-0"

PERVIOUS AREA = 4,191 SQ. FT  
LOT AREA = 13,230 SQ. FT  
LSA MIN. REQUIREMENT = 20%

LOT 11 LSA = 32%

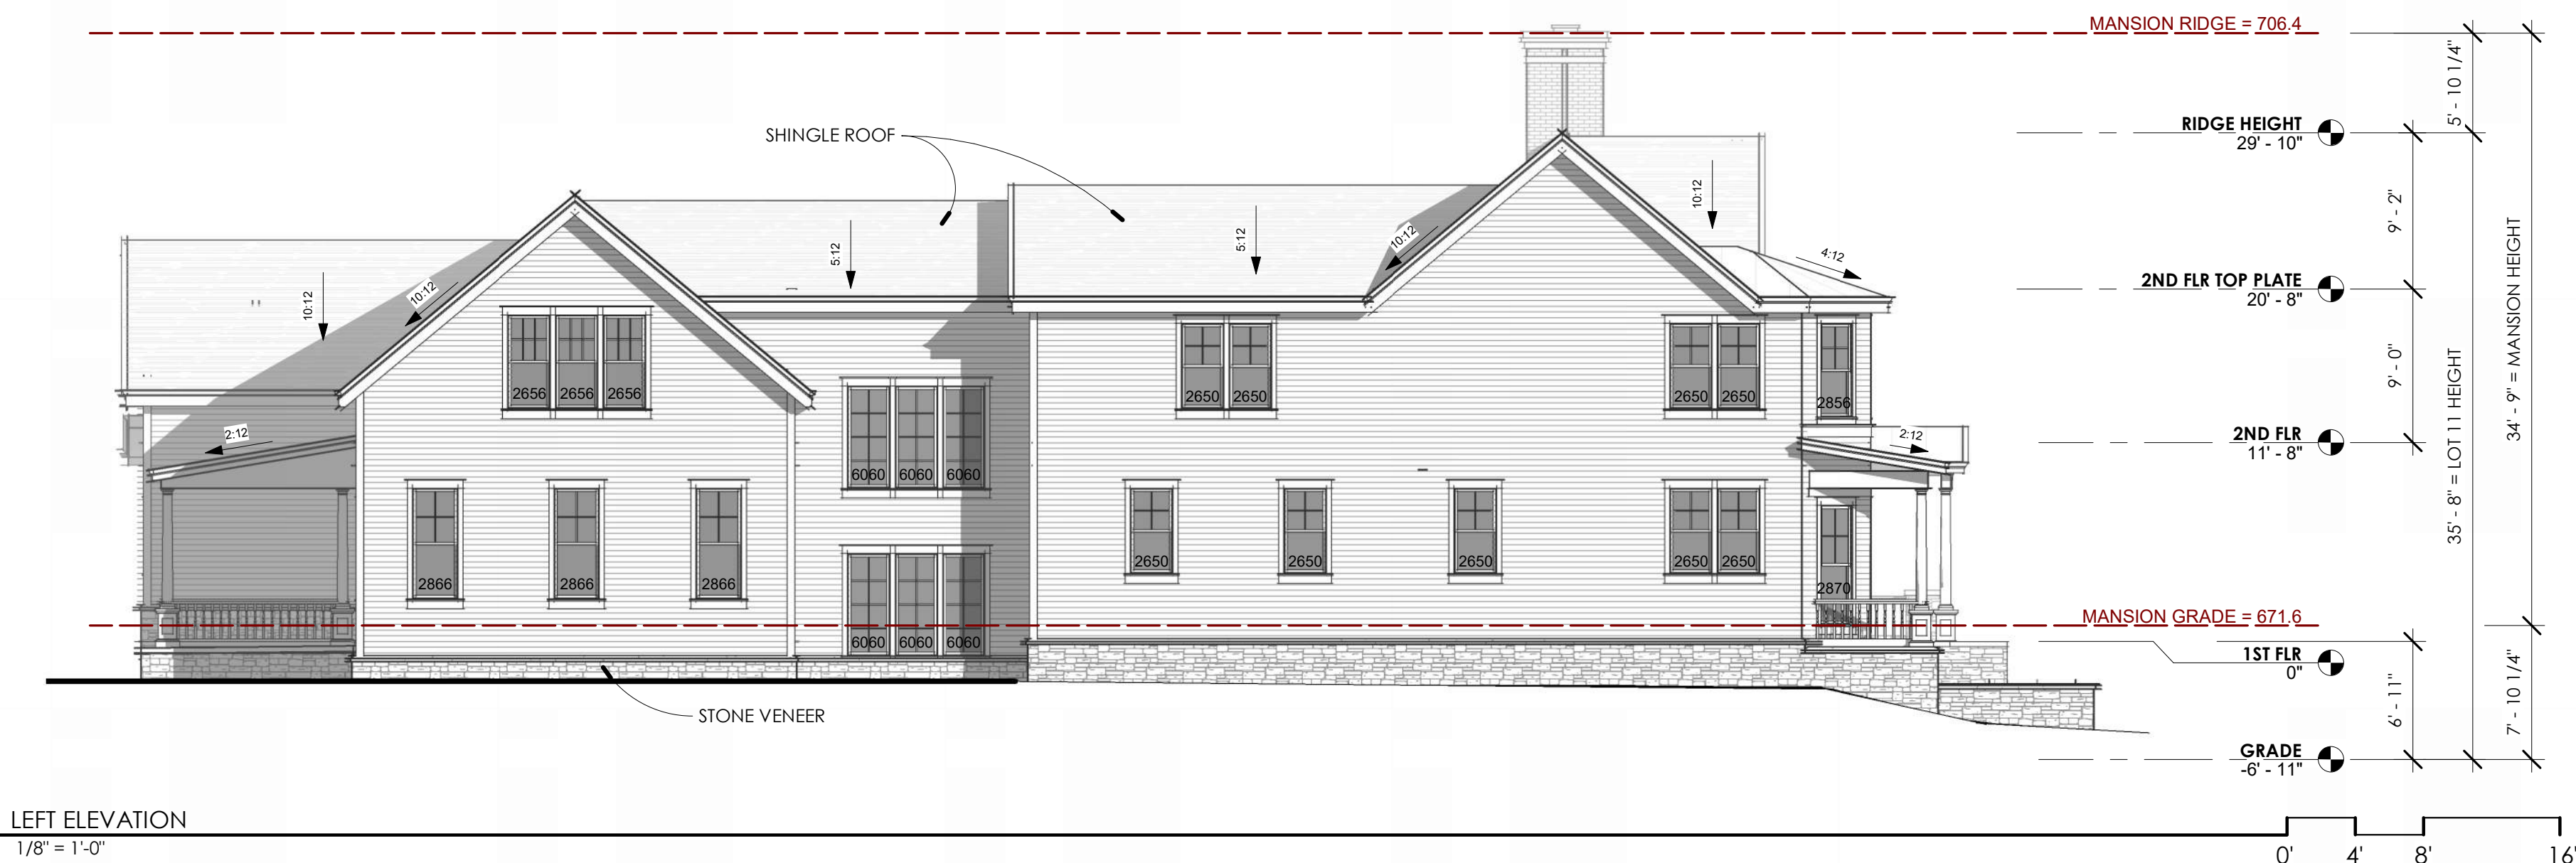
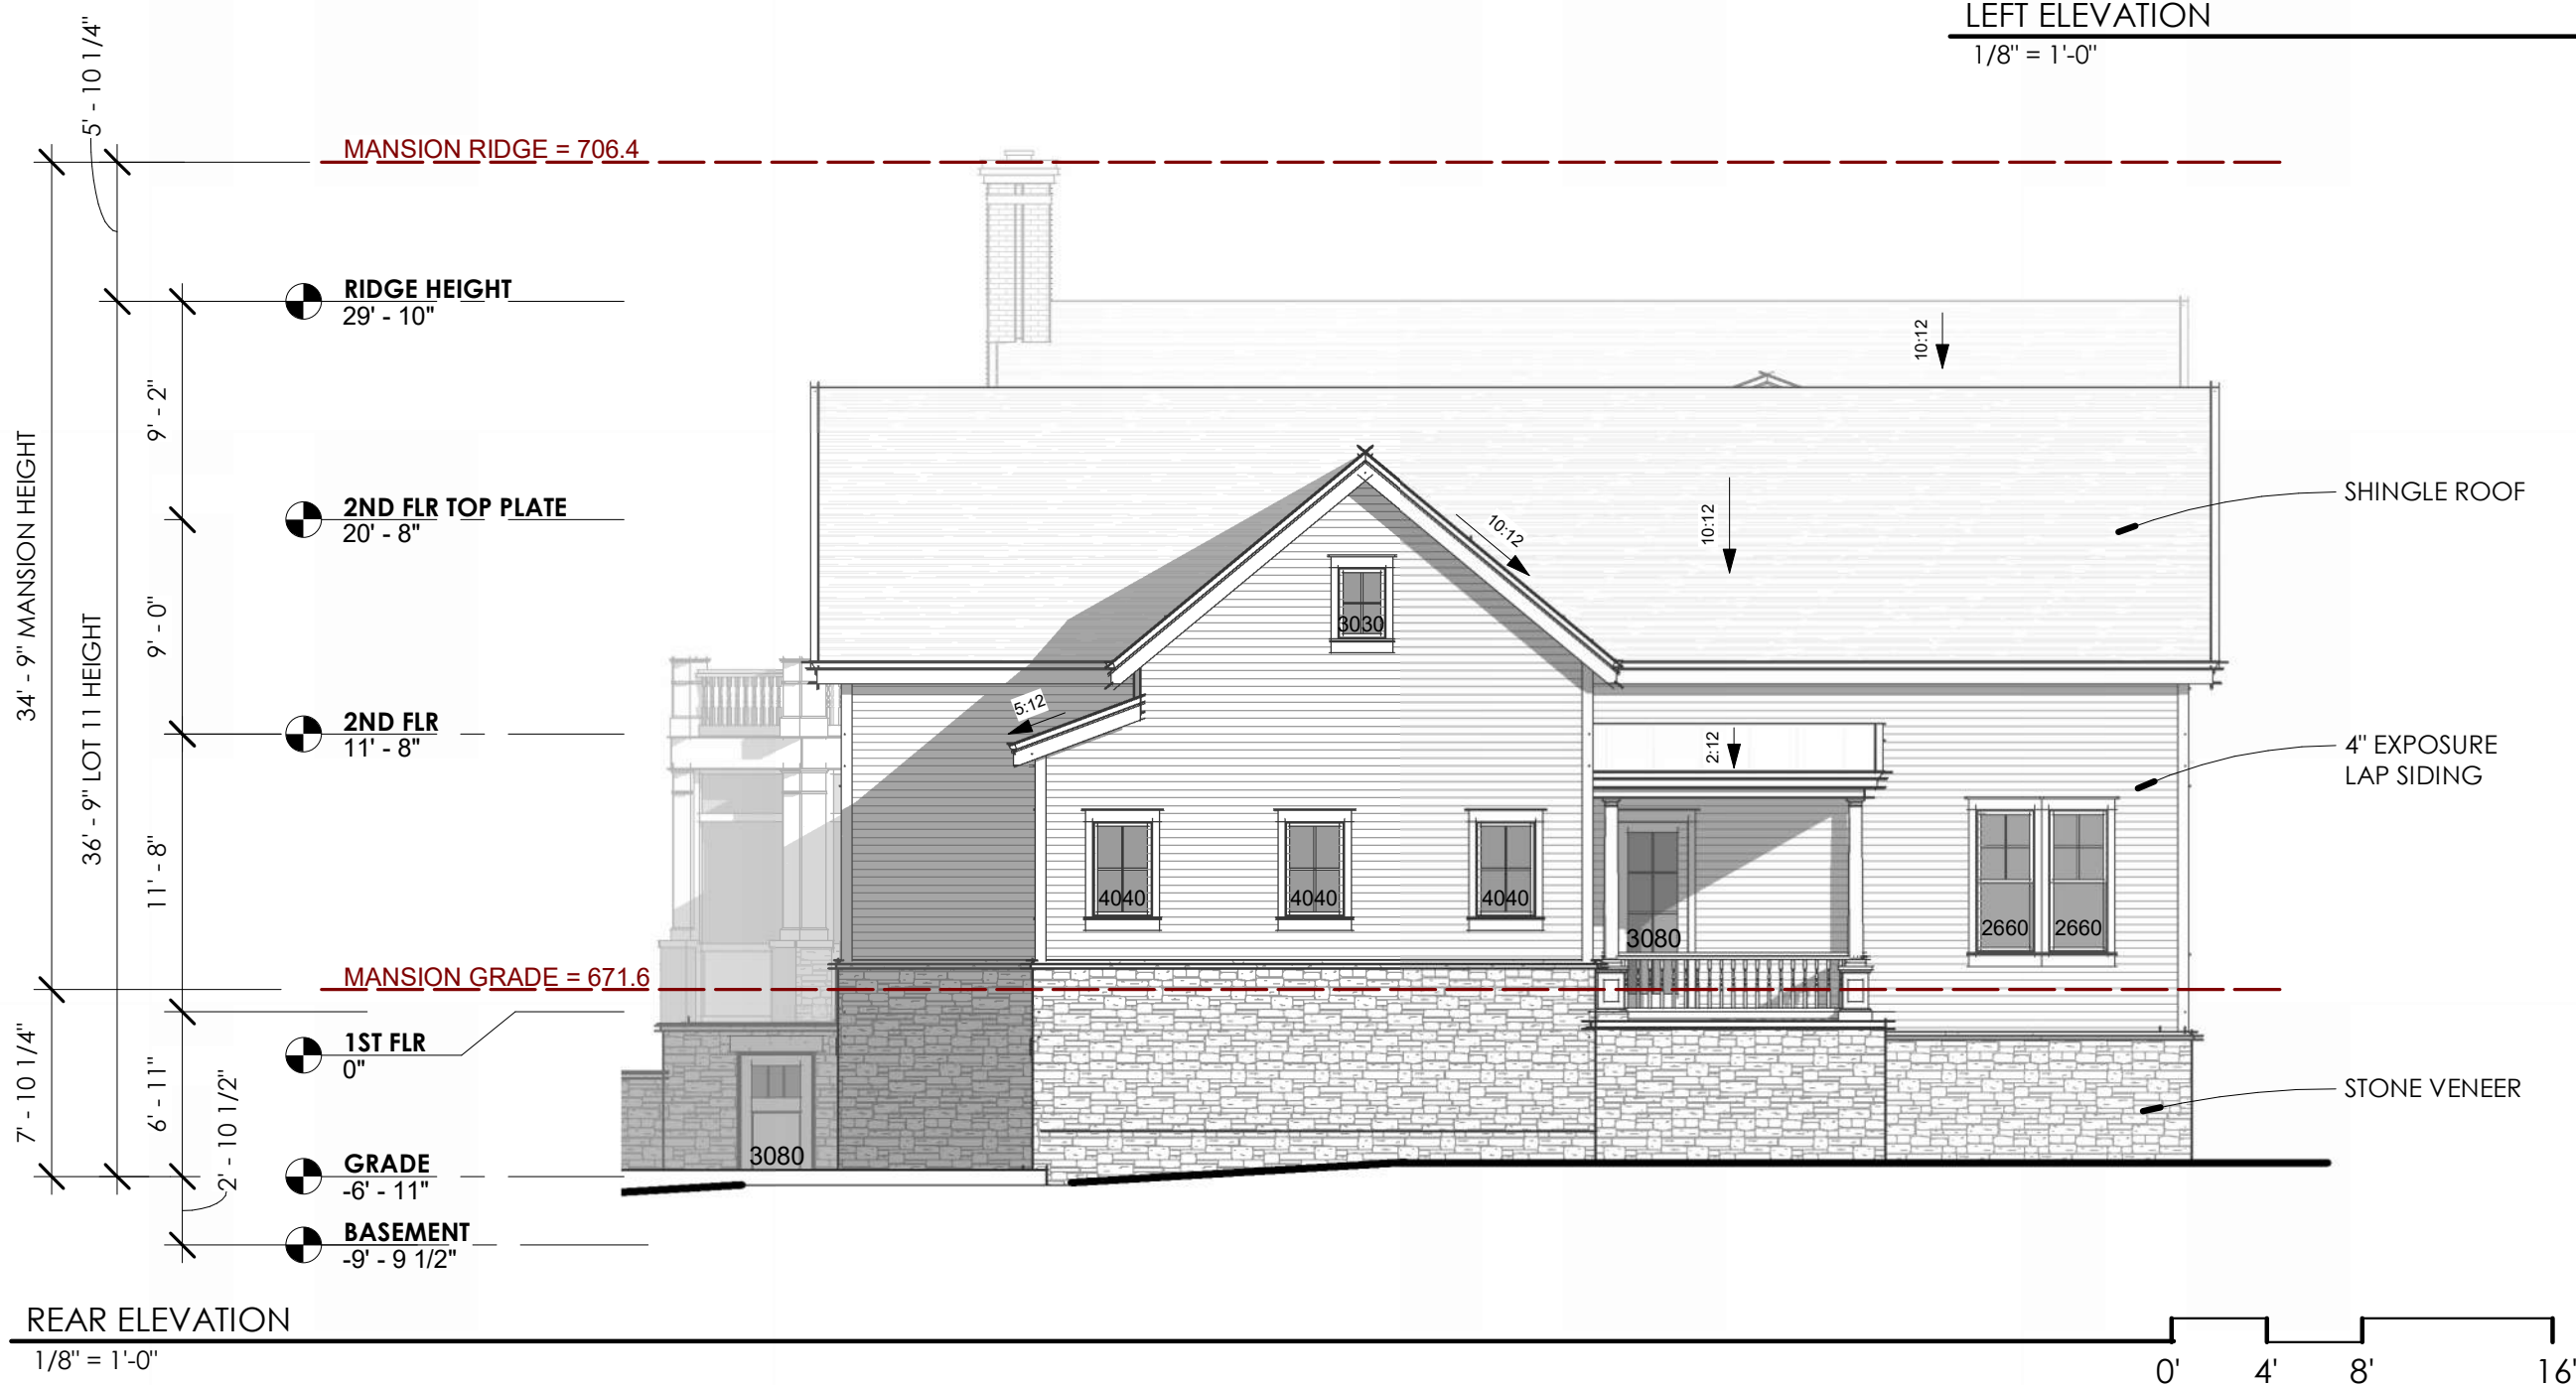
## HZC.04

NOTES:  
1. FOUNDATION HEIGHT IS 22" FROM GRADE AT FRONT STEPS TO FIRST FLOOR.  
2. FIRST FLOOR CEILING HEIGHT IS 10'-0".  
3. SECOND FLOOR CEILING HEIGHT IS 9'-0".  
4. OVERALL HEIGHT IS MEASURED FROM GRADE AT FRONT STEPS TO TOP OF HIGHEST ROOF RIDGE, TYPICAL.

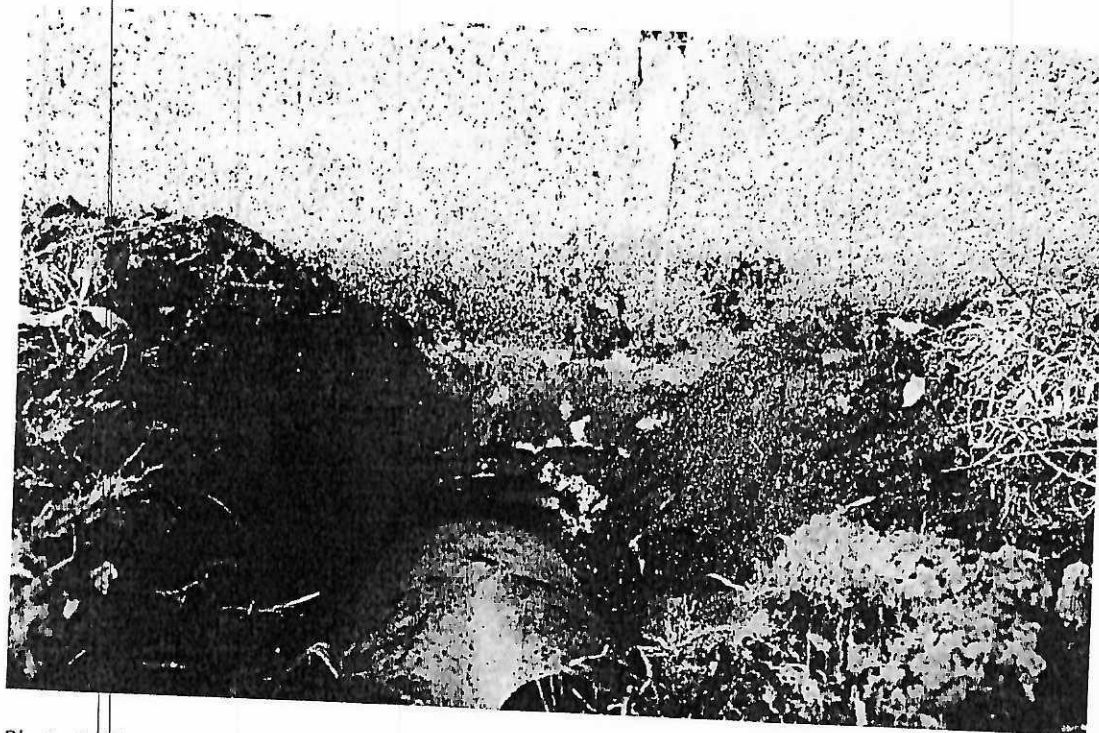
Photo 2: The block foundation walls bear on a leveling pad not a reinforced footing.

The block used as a foundation wall appears to have been installed after original construction and bears to a nominal 4-inch-thick mortar/concrete leveling pad and not a reinforced perimeter strip footing as required by current building codes (Photo 2).

- A new block foundation on a reinforced perimeter strip footing would be required for the building to meet current building code standards.
